BUILDING PERFORMANCE: HURRICANE ANDREW IN FLORIDA

OBSERVATIONS, RECOMMENDATIONS,
AND TECHNICAL GUIDANCE

FEDERAL EMERGENCY MANAGEMENT AGENCY
FEDERAL INSURANCE ADMINISTRATION

DECEMBER 21, 1992

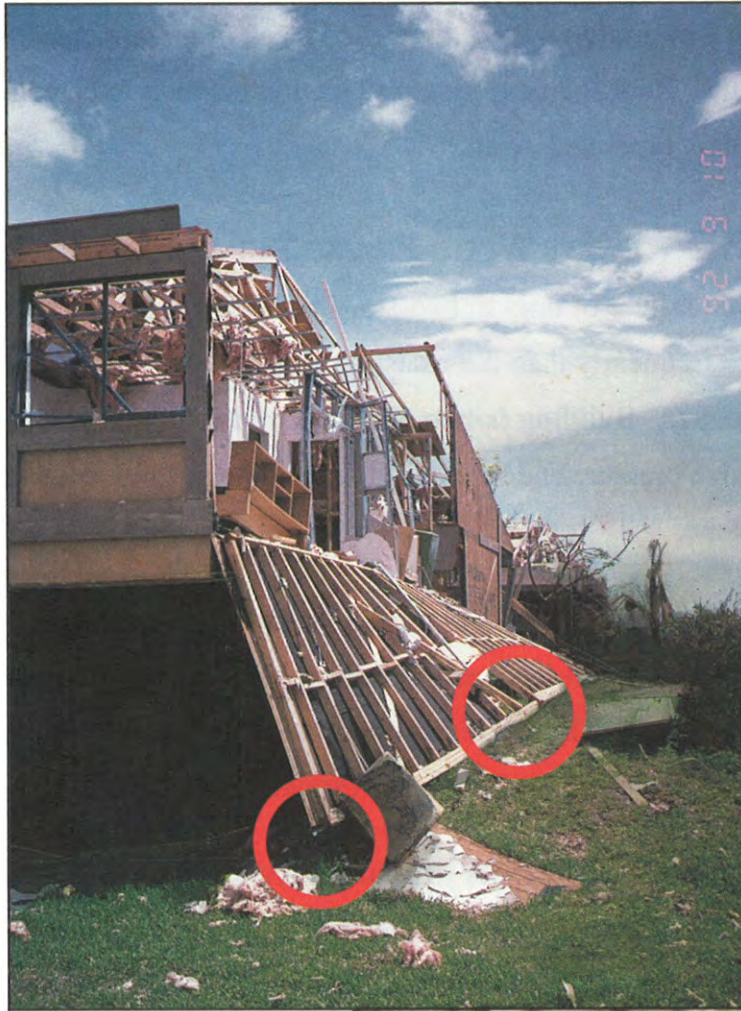
An absence of or improper installation of framing connections, load transfer straps, or bracing from non-loadbearing walls to connecting wall and roof components was noted. This condition contributed significantly to the primary failure of the framing system (SEE FIGURES 4 AND 5).

FIGURE 4.
Exterior wood-frame non-loadbearing wall. Transfer of wind forces from wall to adjoining structure was not sufficient.

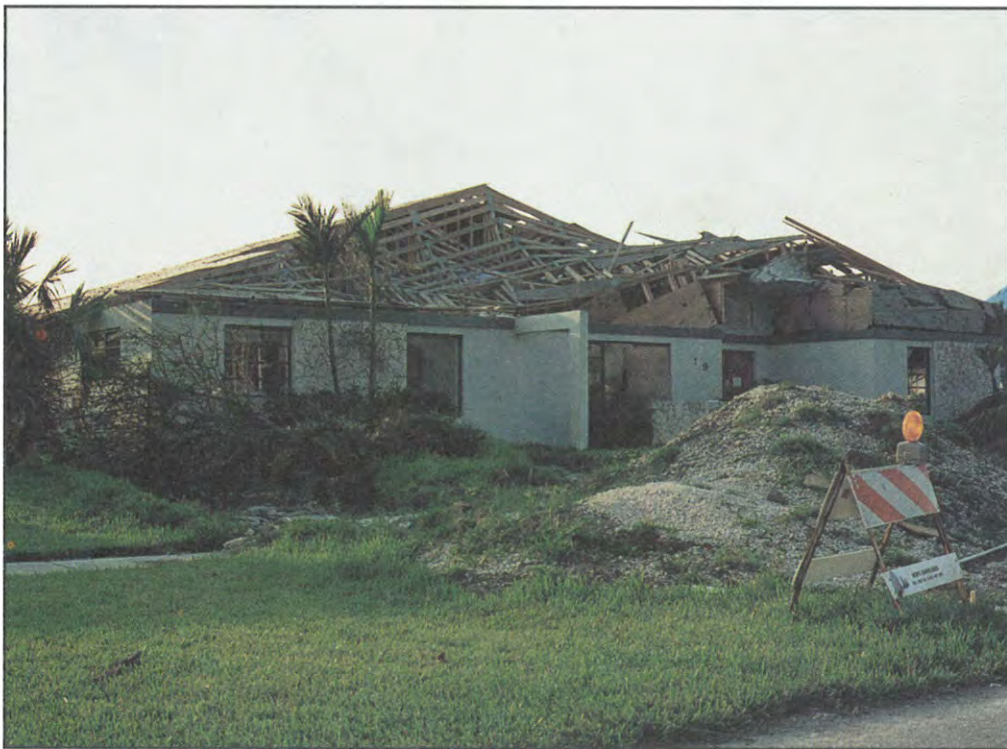
FIGURE 7. *Typical gable failure. Inadequate bracing support and ridge blocking evident in inward collapse.*

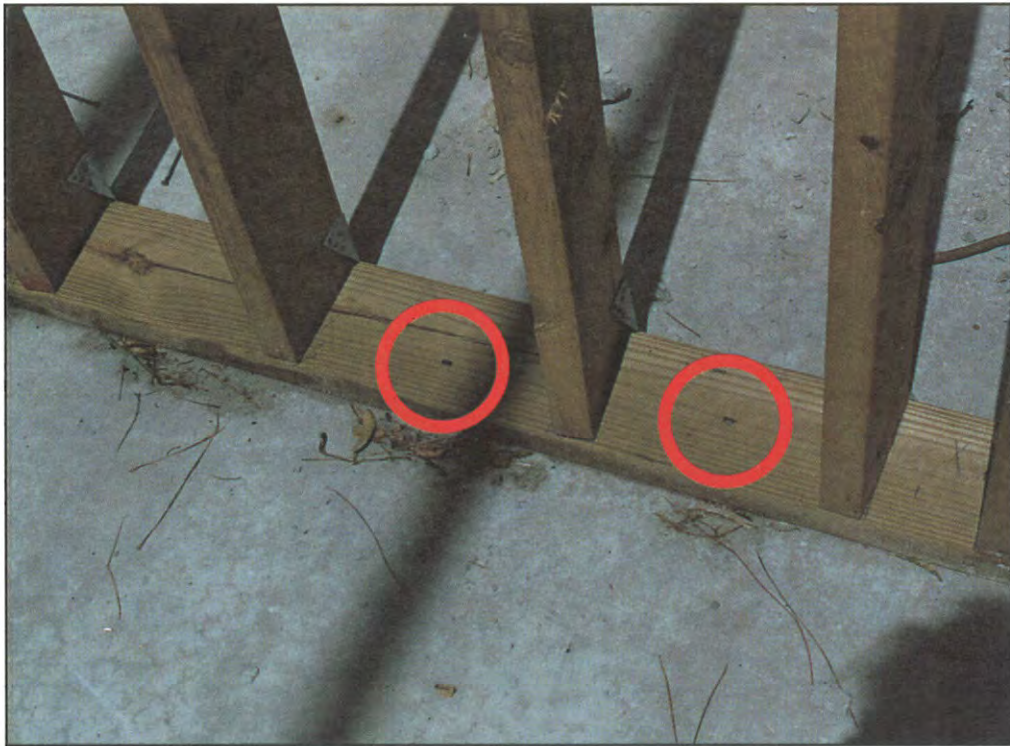
FIGURE 8. *Bolts not used in sill plate. Cut nails had no capacity to prevent pullout.*

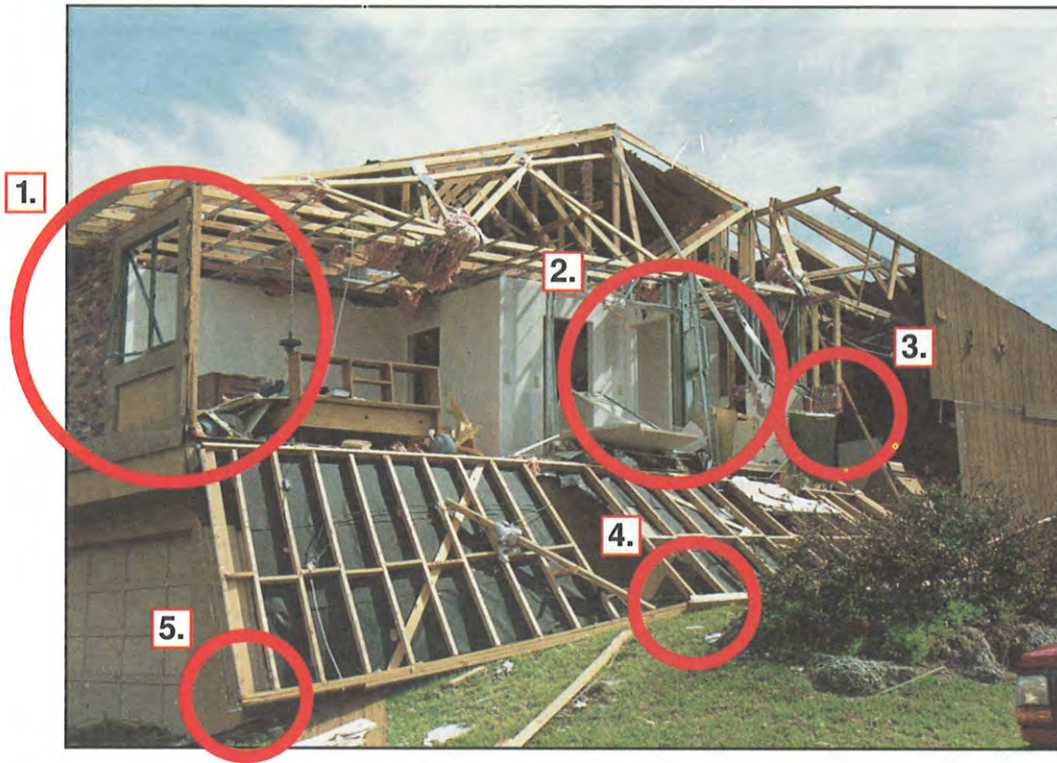
FIGURE 9. *Failure of non-loadbearing wall. Connections of exterior wall were not adequate.*

- 1. End column separated from roof.*
- 2. Load transfer from outside wall to interior shear wall inadequate.*
- 3. Beam separated from beam seat/connector.*
- 4. Improperly spliced composite tie-beam/connector.*
- 5. End of top plate connection inadequate.*

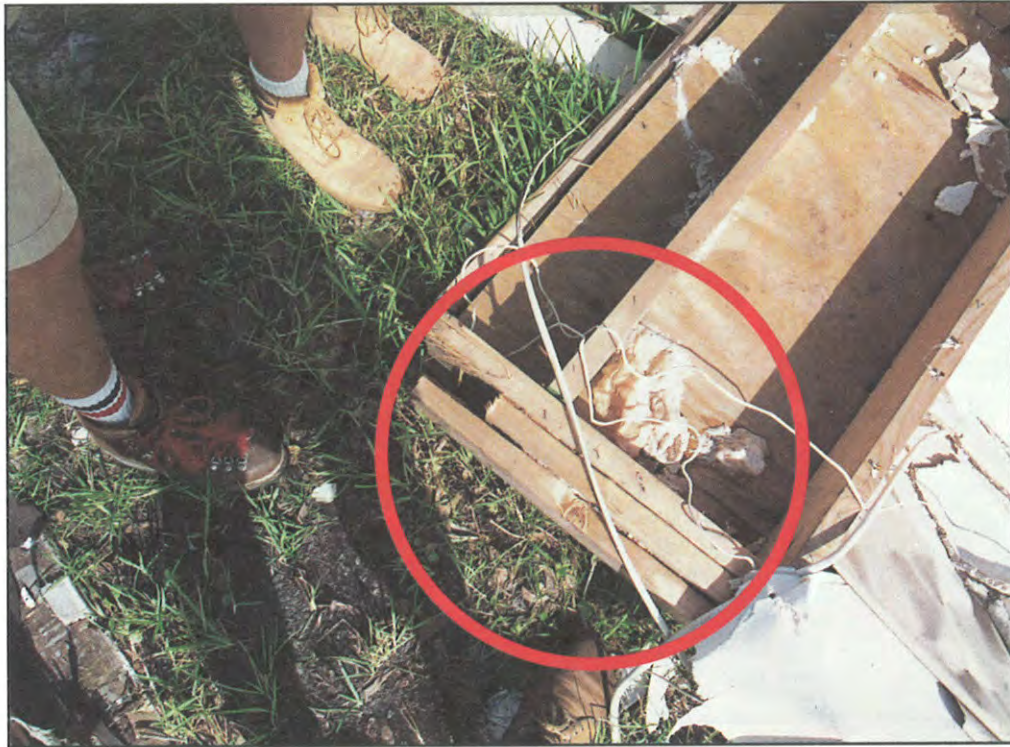
FIGURE 10. *Top plate splice not able to transfer horizontal loads.*

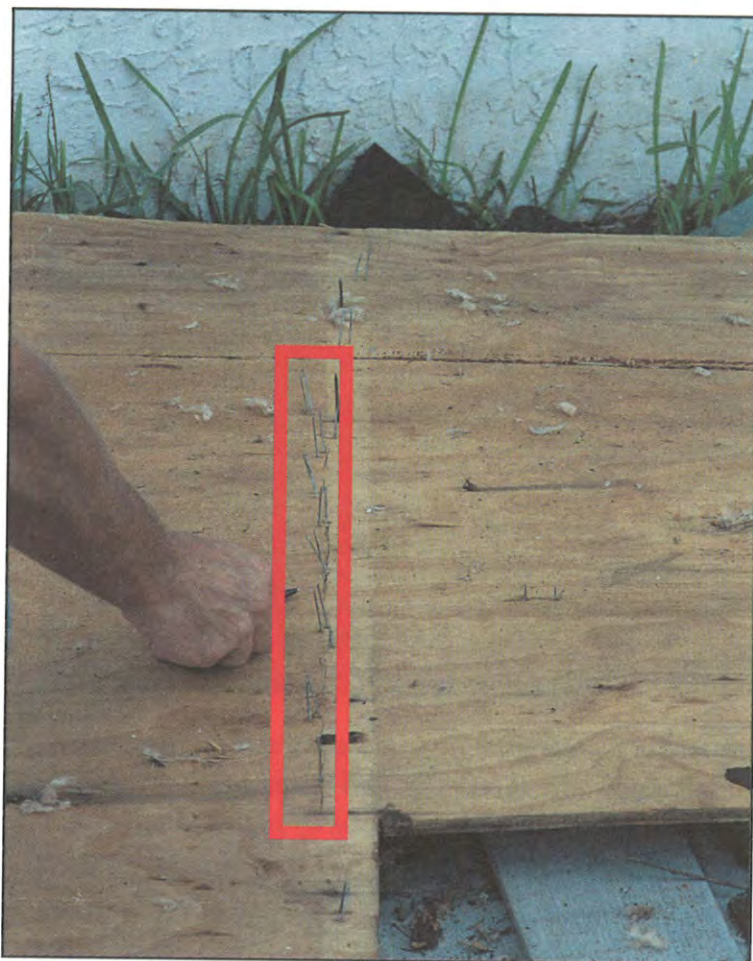
The roof framing systems observed were composed typically of prefabricated light wood trusses and plywood sheathing. While the trusses were found to have performed well under the wind forces, the connection of the sheathing (which forms the horizontal diaphragm of the building system) to the trusses was inadequate. Substandard workmanship in the anchoring of sheathing to trusses (by either improper stapling or improper nailing) was evident (SEE FIGURE 11).

FIGURE 11.
Roof sheathing found in debris. Staples were off-line and therefore not connected to supporting truss top chord.

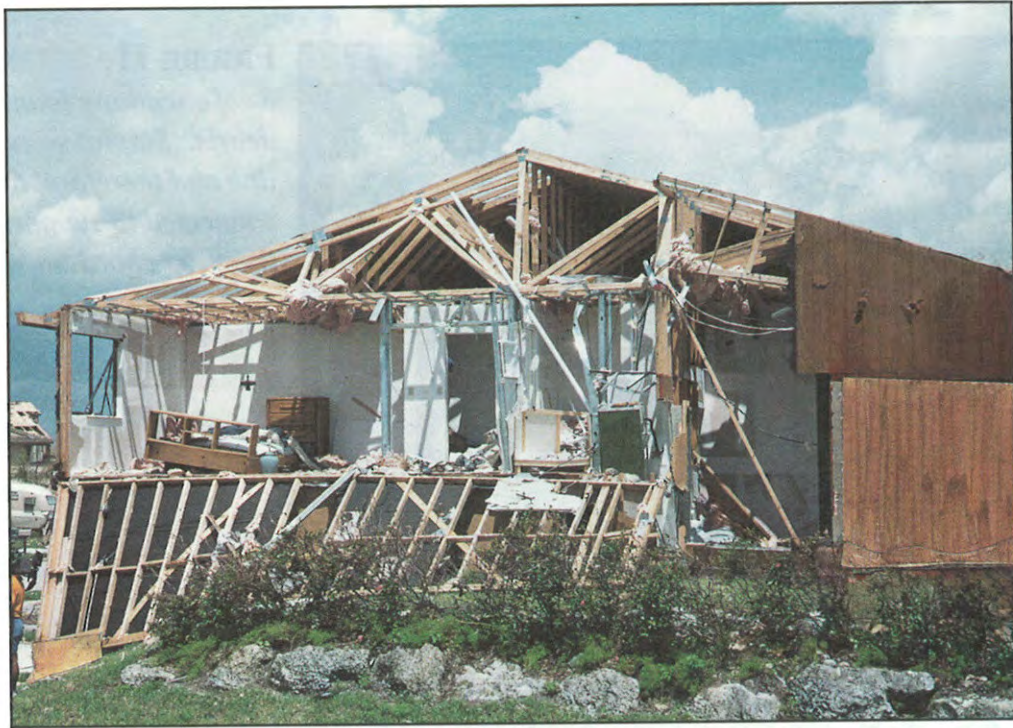
FIGURE 12. *End wall failure of typical first floor masonry/second floor wood-frame building. Truss bridging and lateral bracing, and adequately installed roof sheathing, would have greatly reduced the likelihood of such a failure.*

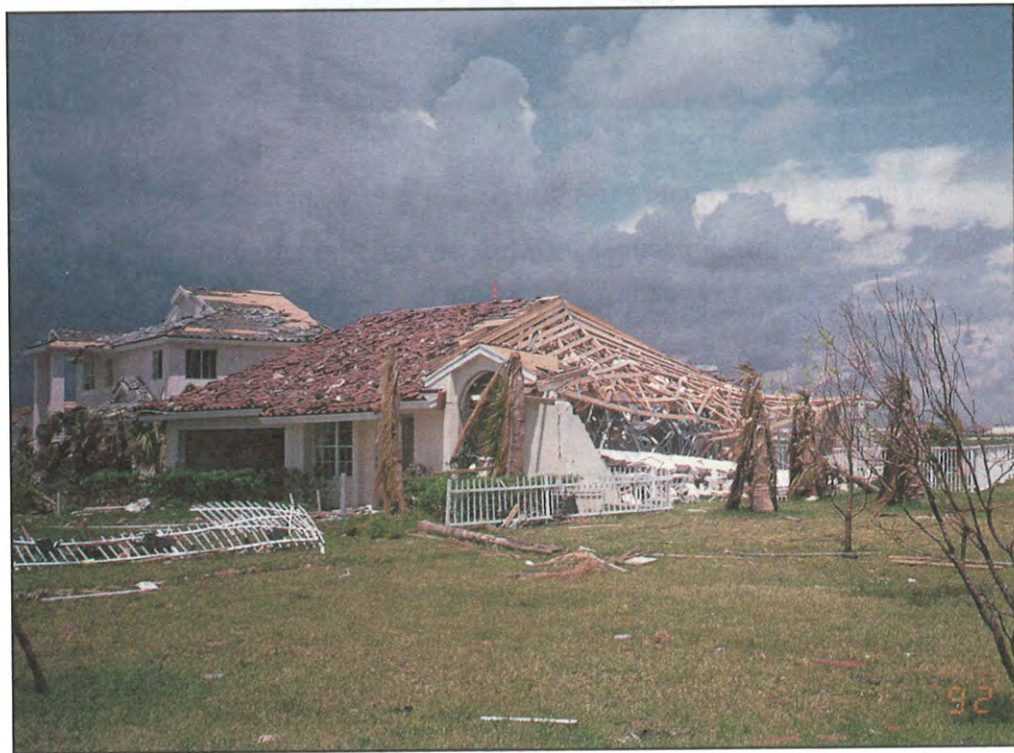
FIGURE 13. *Roof structure failure due to inadequate bracing.*

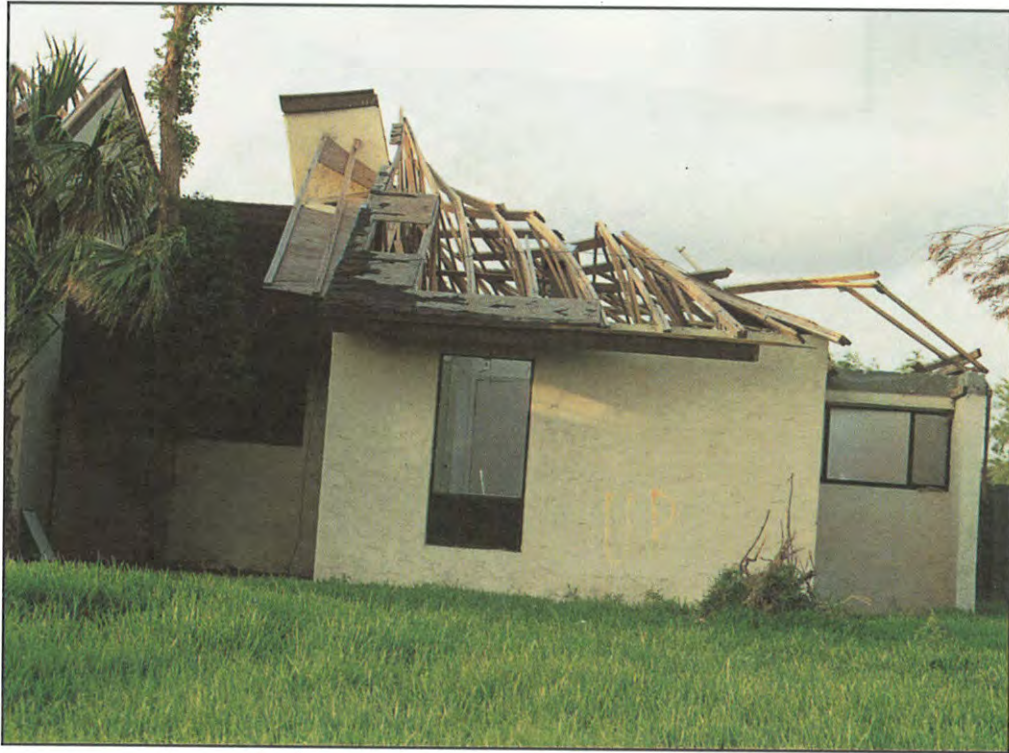
FIGURE 14. *Roof structure failure due to inadequate bracing.*

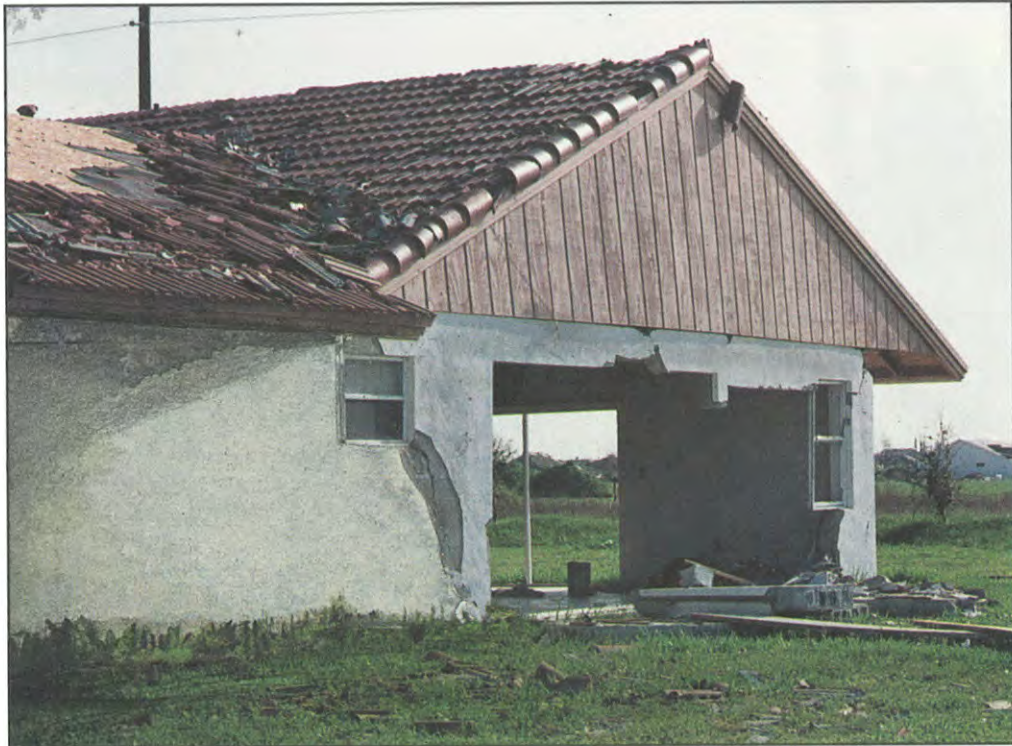
The main cause of failure of masonry buildings was a lack of vertical wall reinforcing (SEE FIGURE 15). Typically, concrete block and stucco (CBS) systems performed much better than all-wood-frame construction. This was due primarily to the heavier mass of the masonry walls and the tendency of a continuously constructed system to be less prone to failure from a lack of attention to design and construction details.

FIGURE 15. *Masonry construction building. Wall separated from building envelope due to inadequate vertical wall reinforcing in connection to horizontal tie-beam.*

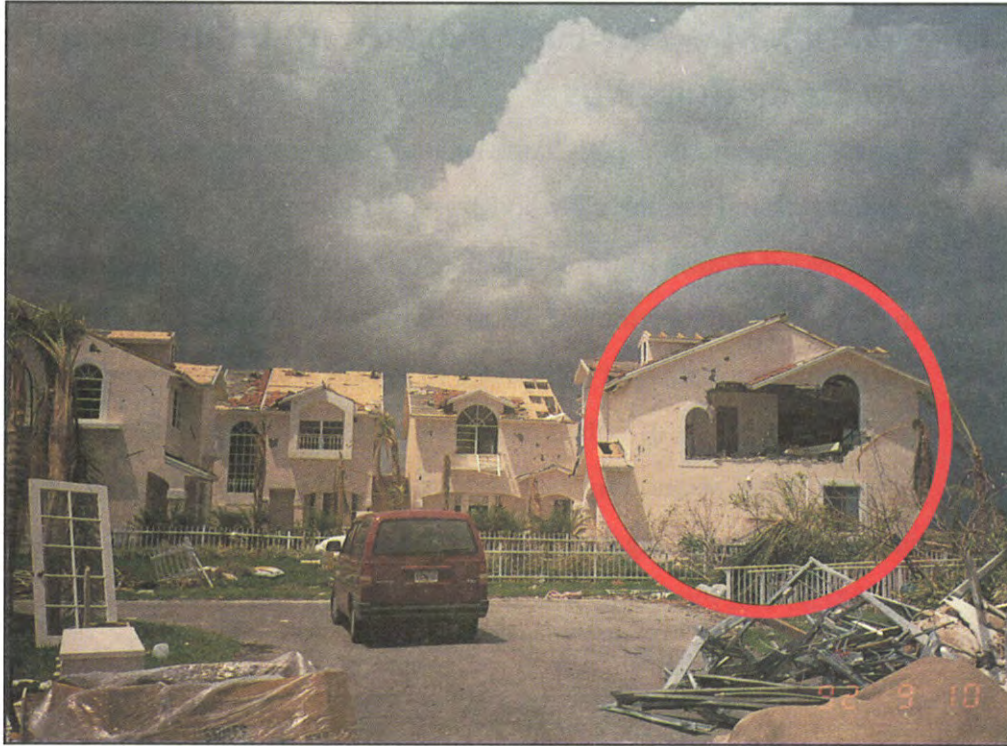
Where failures of the buildings did occur, the following conditions were observed: poor mortar joints between wall and monolithic slab pours; lack of tie-beams (SEE FIGURE 16), horizontal reinforcing, tie columns, and tie-anchors; and misplaced or missing hurricane straps between walls and roof structure.

FIGURE 16. *Two-story masonry buildings. Lack of continuous tie-beam led to failure of wall that was already weakened in design by window openings.*

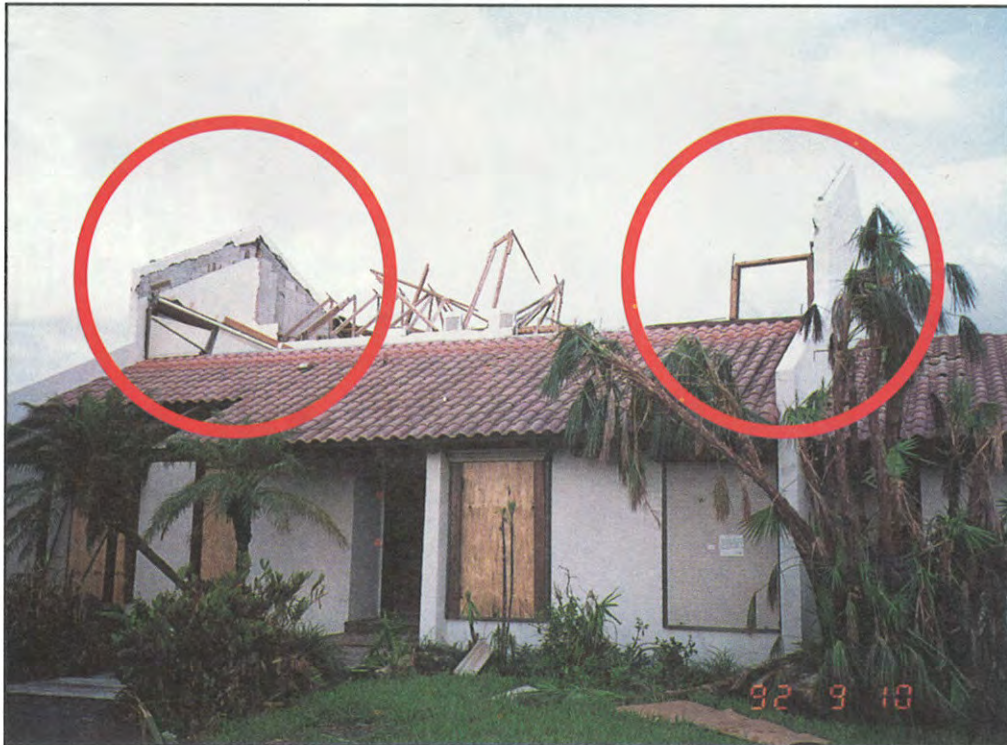
Discontinuous second-story CBS walls (typical firewall design) were prone to failure at their connecting edges and suffered separation from various building envelopes. Improved wall performance through continuous CBS construction was observed in the performance of gable ends that were CBS-constructed (SEE FIGURE 17).

FIGURE 17. *Two-story masonry building. While forces were sufficient to blow off entire roof structure, continuous masonry gables held.*

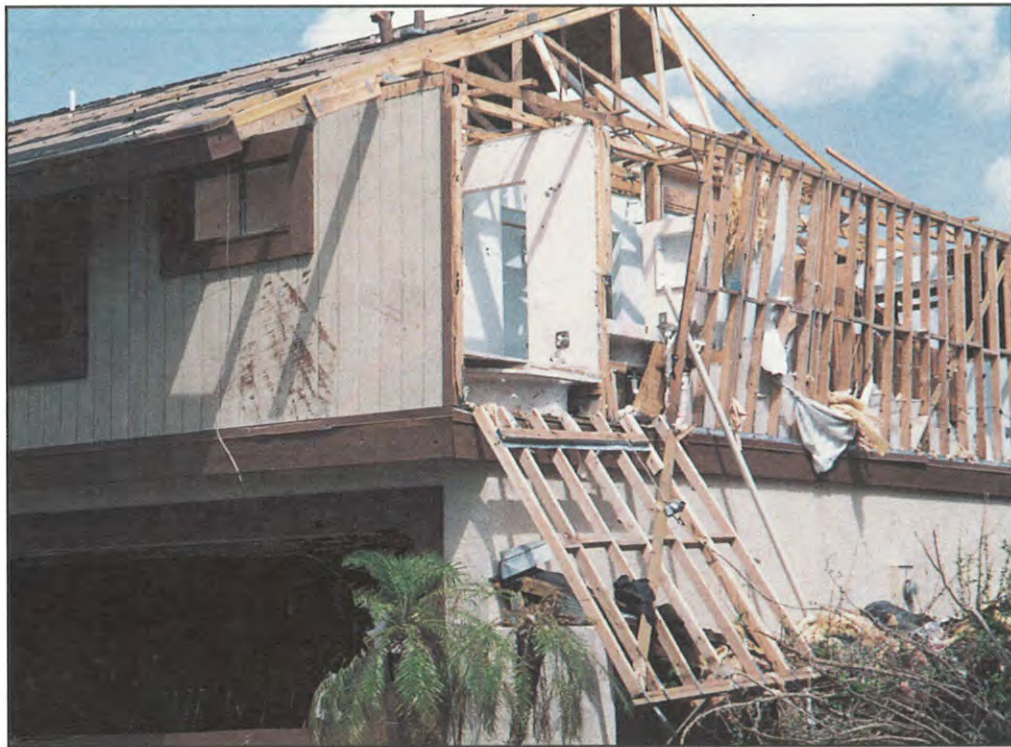
FIGURE 18. *Second story wood framing (on first story masonry). End gable and wall failure.*

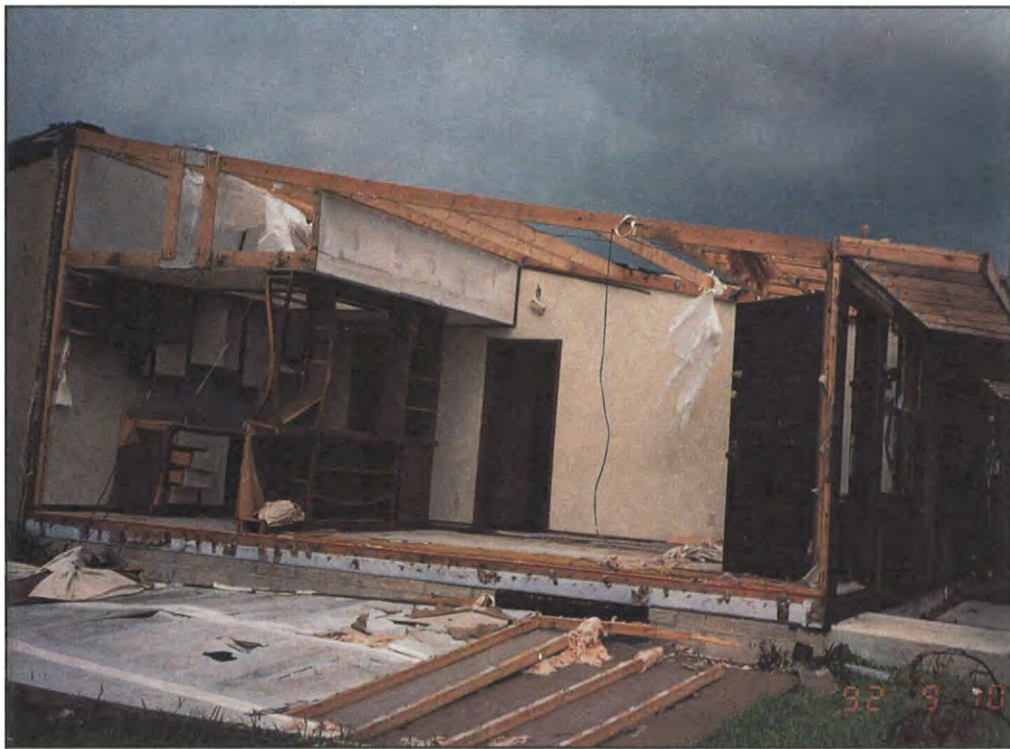
Two end-wall (end wall of end modules) failures were observed in a modular home subdivision. Poor connection of the tops of the walls to the roof diaphragms was evident in these instances. Some roof sheathing was observed missing from rafters, judged to be due either to building envelope breach (window and/or door failure) or to external wind and debris. Generally, the rafters themselves were left entirely intact, because of the inherent rigidity developed by the relatively short spans and secure connections. (SEE FIGURES 19 AND 20.)

FIGURE 19. *Modular home. End wall of end unit separated from unit; withdrawal of nails along eave line and roof sheathing failure were also observed.*

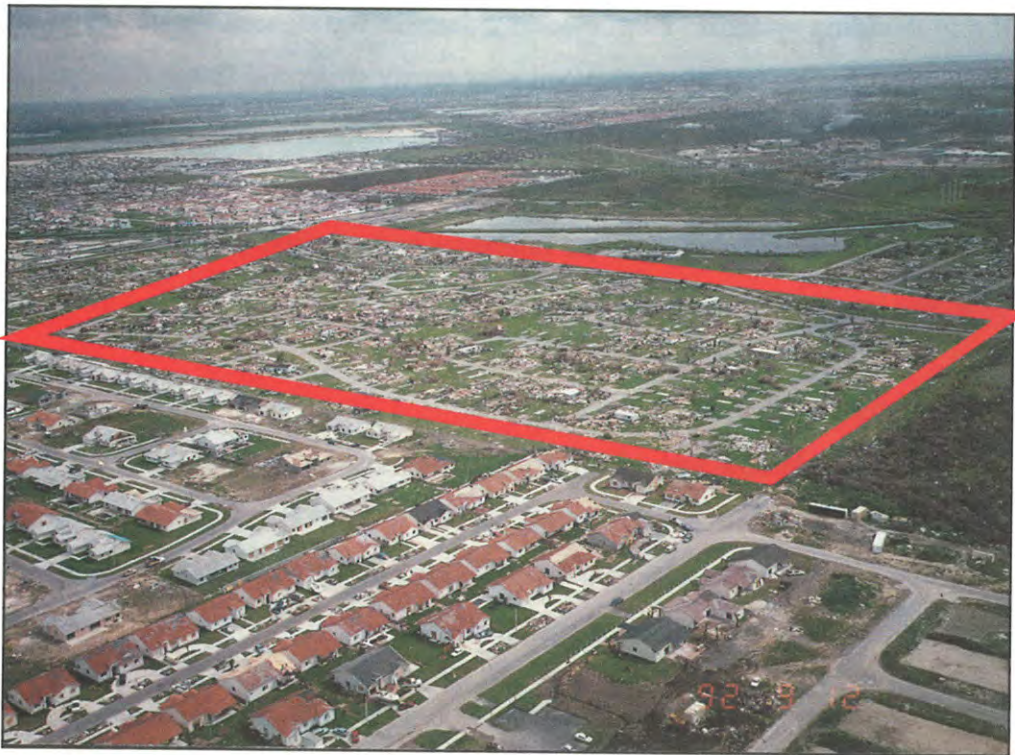
FIGURE 21. *Aerial photo of damage area. Shows building performance difference between manufactured homes (outlined in center) and conventional residential buildings (lower left).*

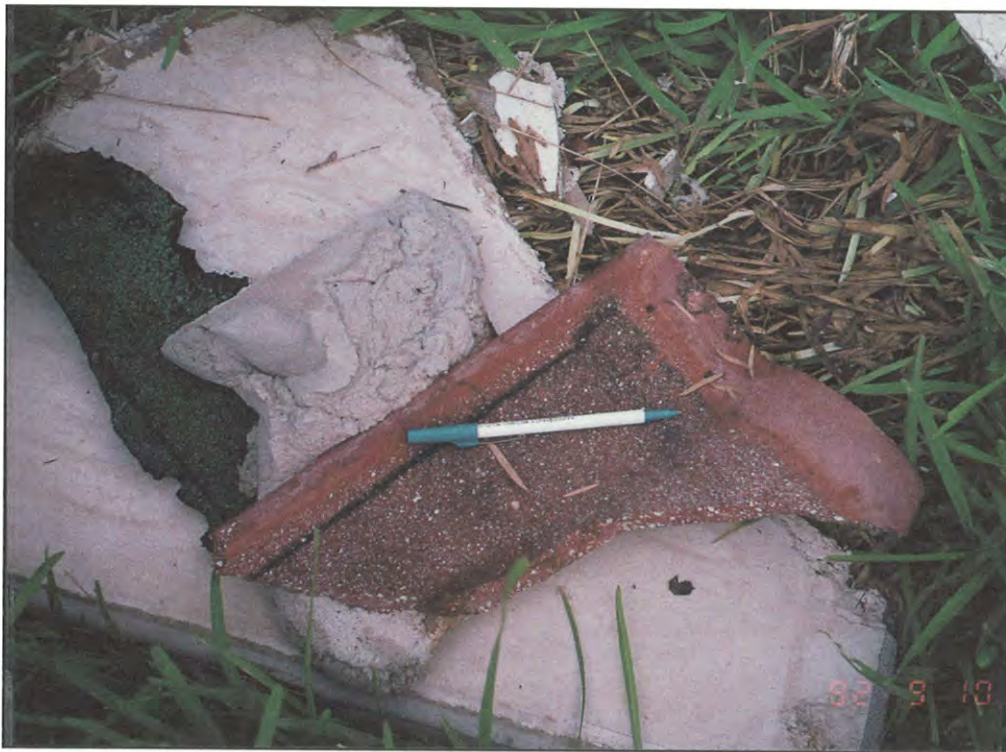
FIGURE 22. *Typical failure of roof sheathing-to-underlayment attachment. (Bond between underlayment and mortar pad, and between mortar pad and tile effective.)*

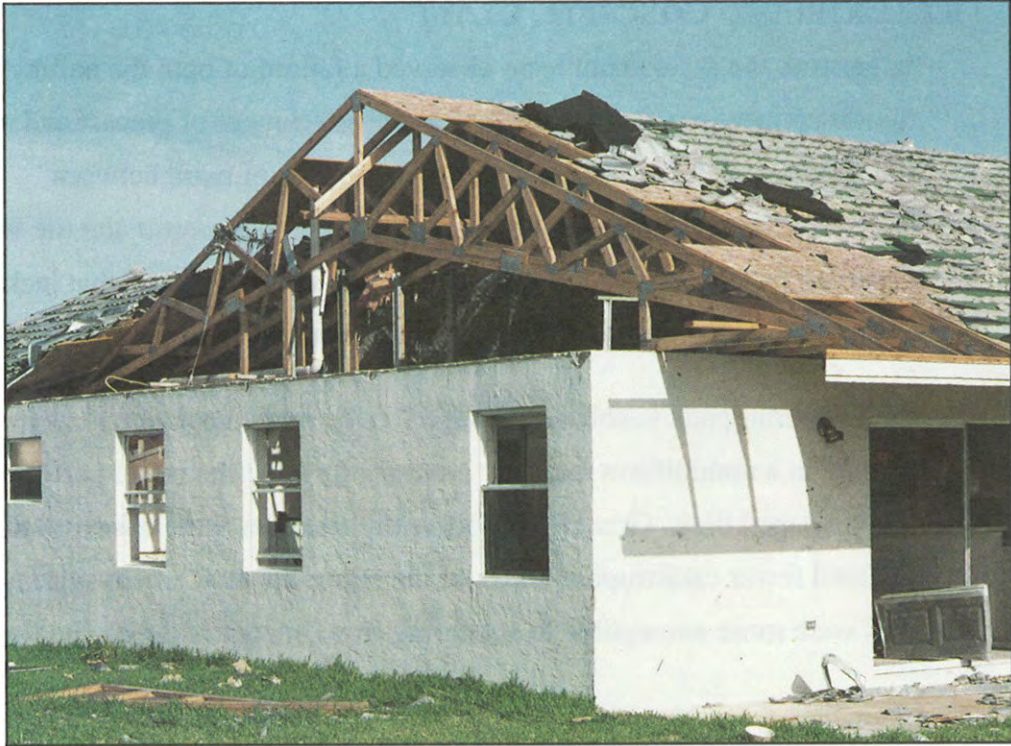
FIGURE 23. *Typical roofing failure. Failure of sheathing, underlayment, and extruded concrete tiles.*

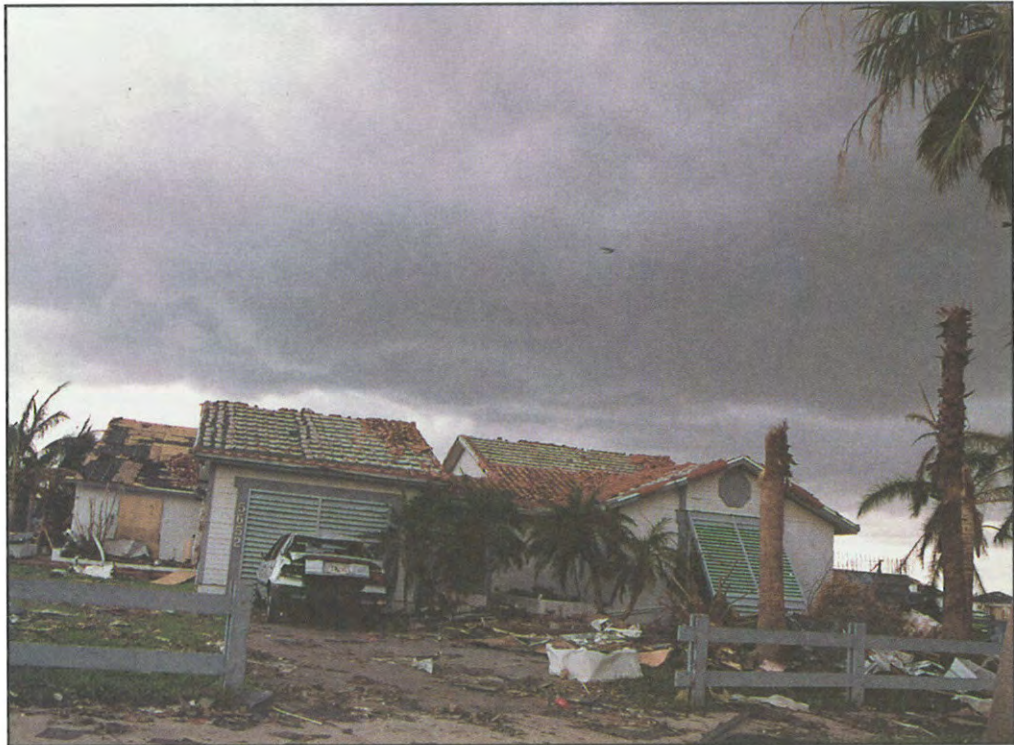
FIGURE 24. *Typical roofing failure. Failure between tiles and mortar pads.*

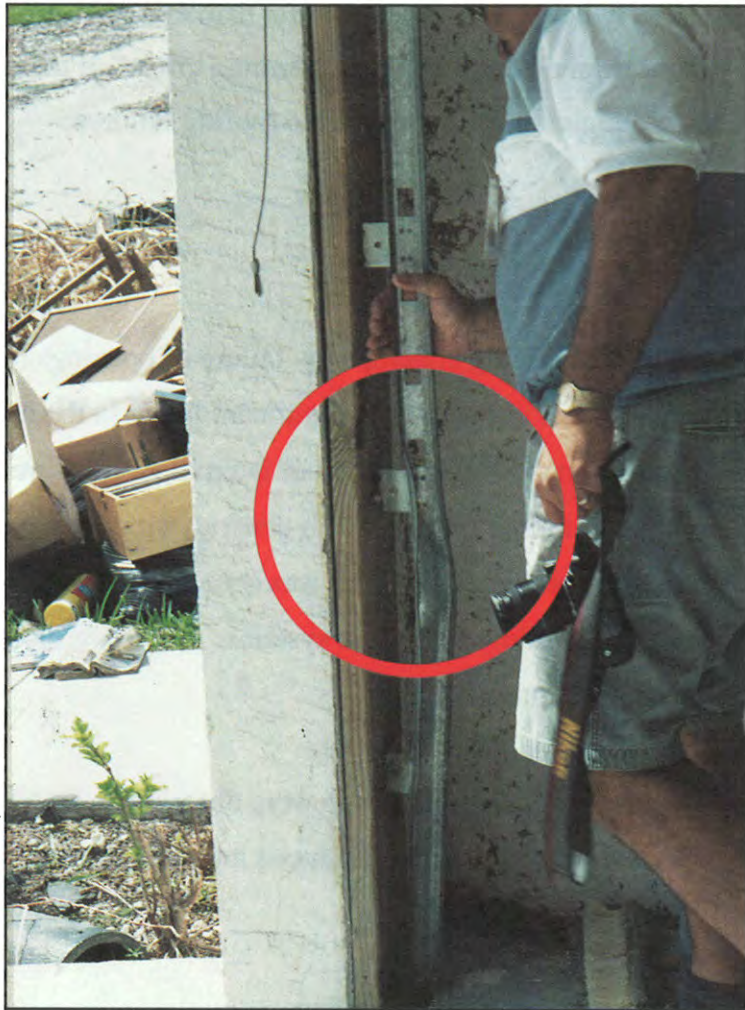
FIGURE 25. *Garage door failure. Rotation of track, and pullout of brackets at wall support.*

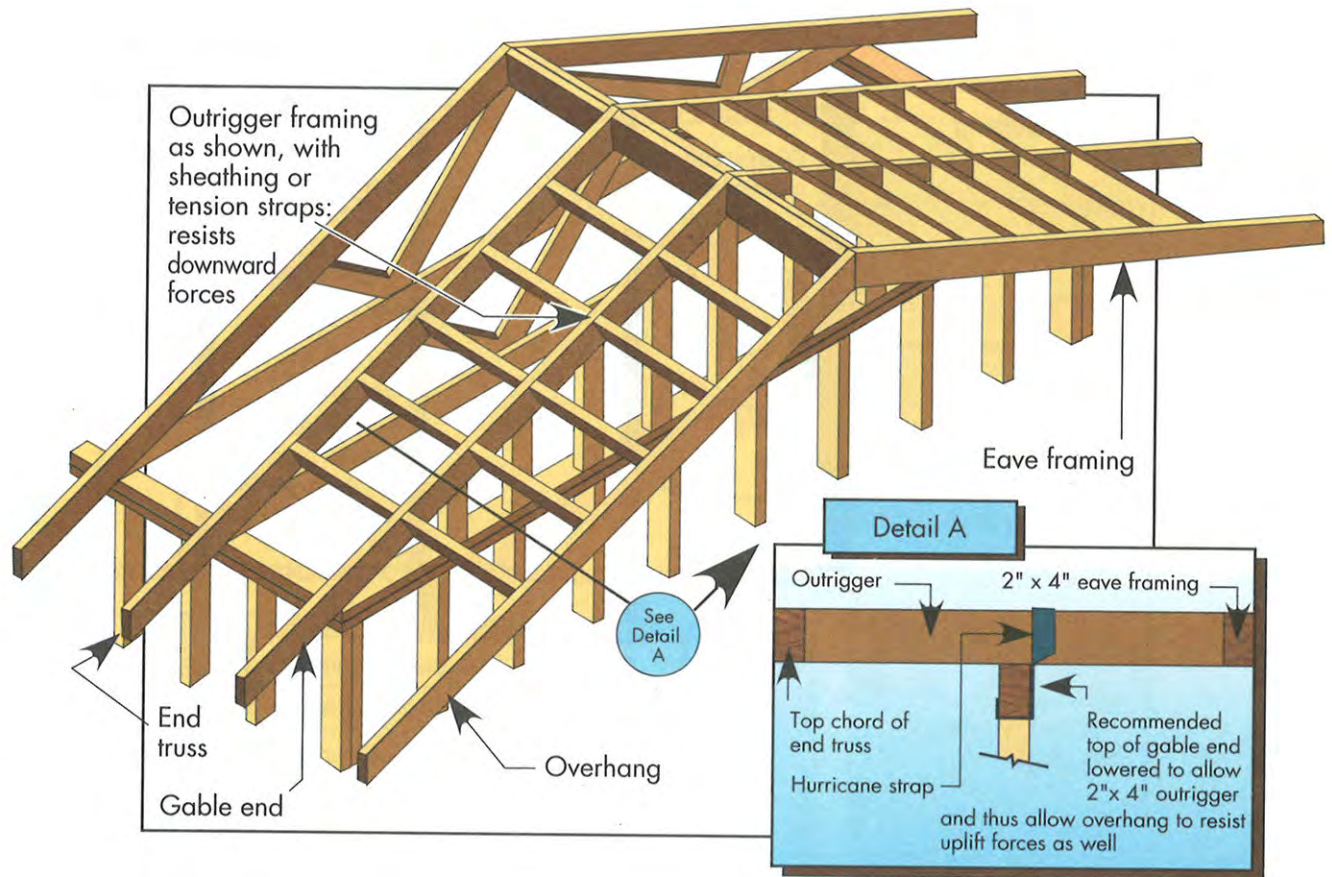
FIGURE 29. Observed roof bracing for gable roof overhang and recommended modification.

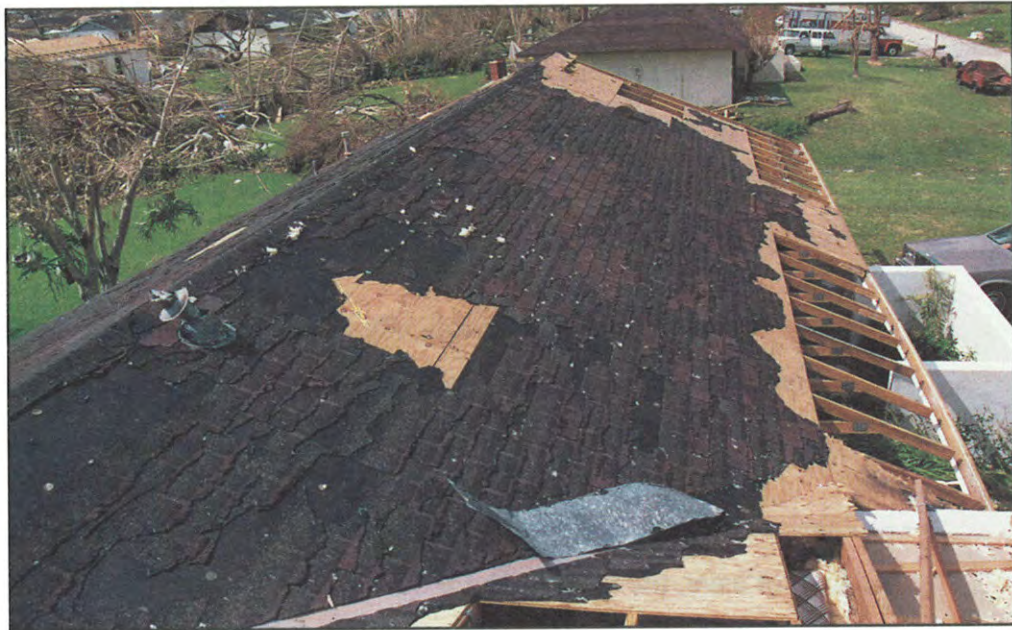
FIGURE 30. *Composition shingle and underlayment failure.*

2. Composition shingles should be manufactured and rated as satisfactory for high-wind areas. In the absence of this, a water-resistant membrane, e.g., a hot-mopped underlayment, should be installed to provide protection from the water infiltration that may result from the loss of roofing material during high-wind storms (SEE FIGURES 30 AND 31).
3. Manufacturers of roof tile products should provide testing and verification of tile performances under realistic conditions (as addressed by the Code).
 - Manufactures should verify that mortar used with extruded concrete tiles can be installed to Code requirements.

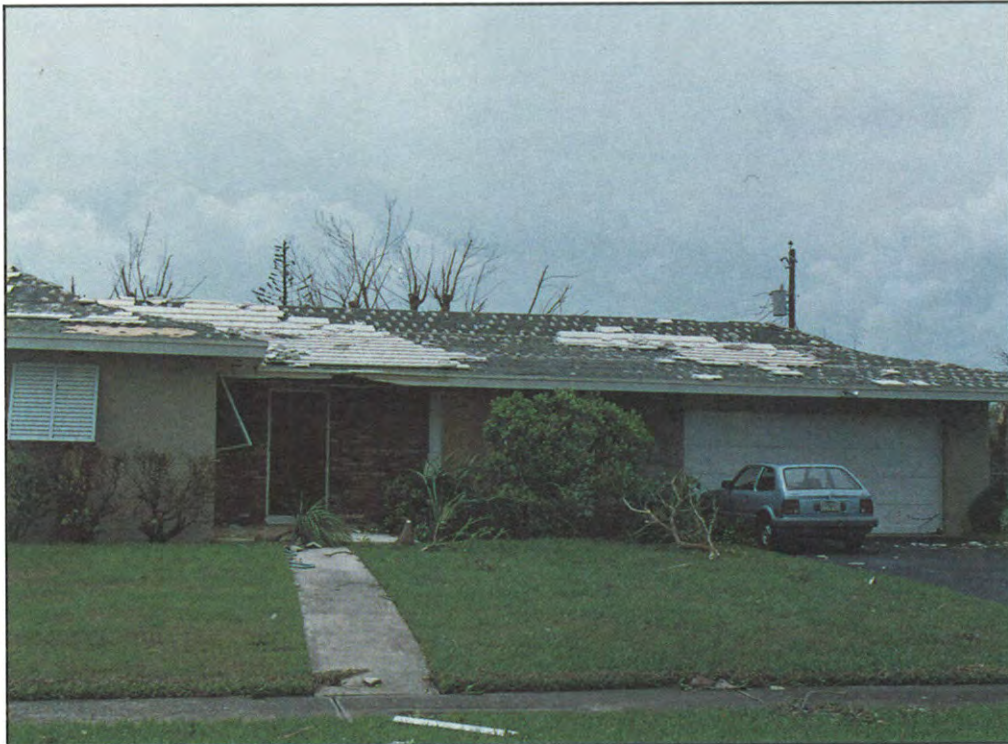
FIGURE 32. *Failure of extruded concrete flat tile roofing. Bond failure between tile and mortar and between mortar and underlayment was observed.*

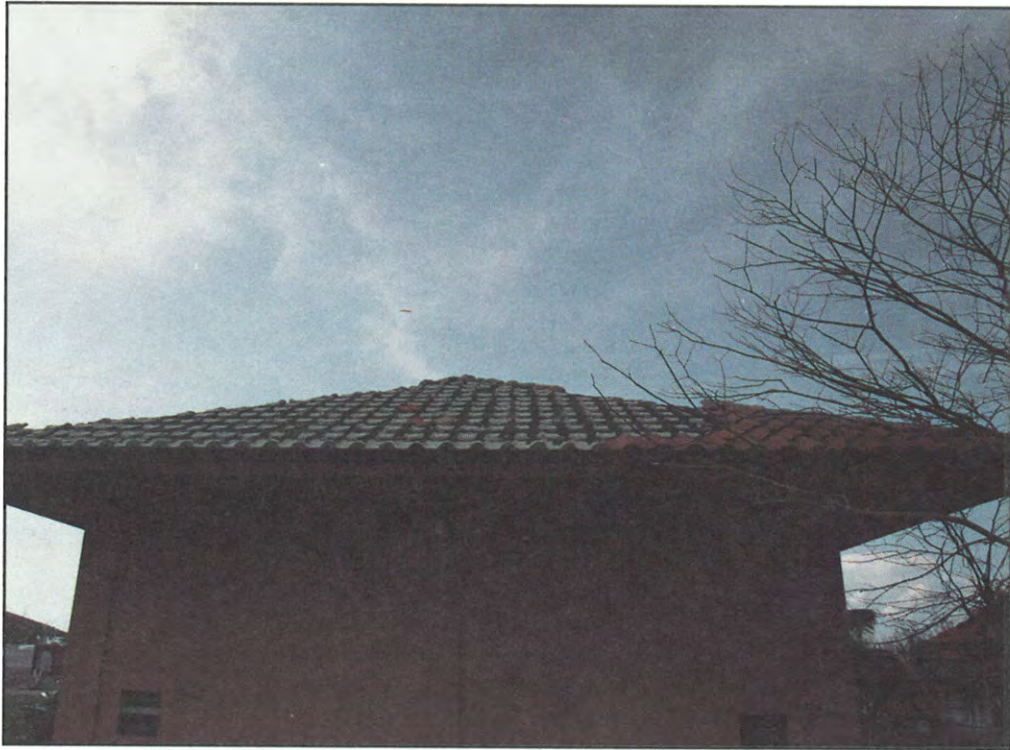
FIGURE 34. Failure of "S" tile roofing. Bond failure between mortar and tile was observed.

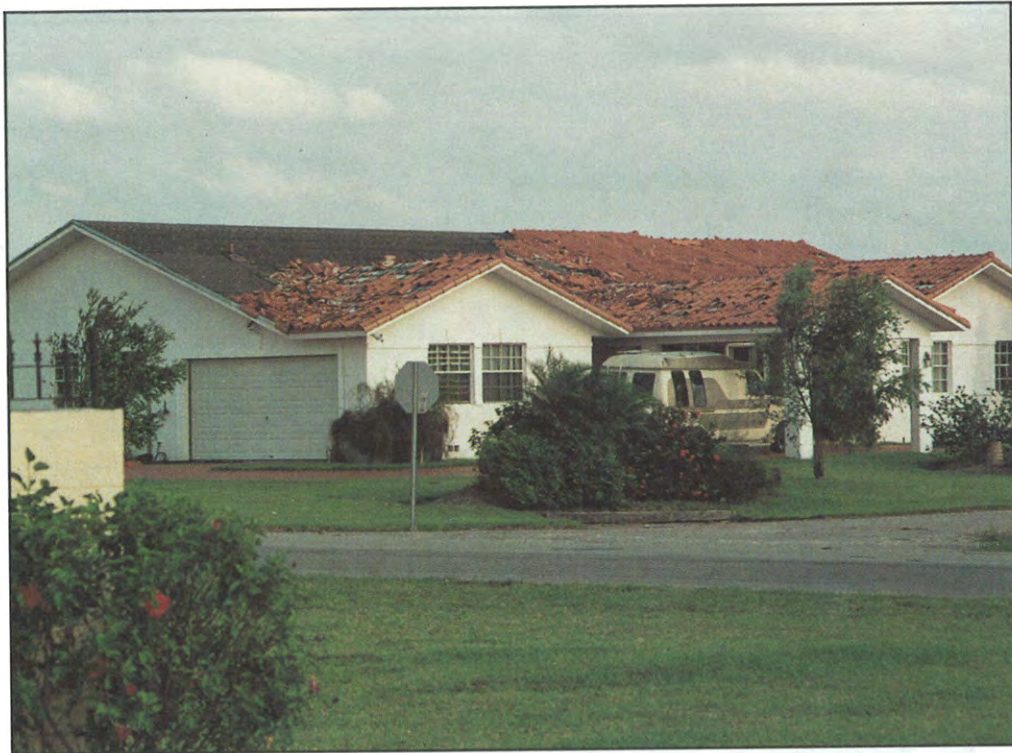
FIGURE 36. *Failure of barrel tile roofing. Bond failure between underlayment and mortar and between mortar and tile was observed.*

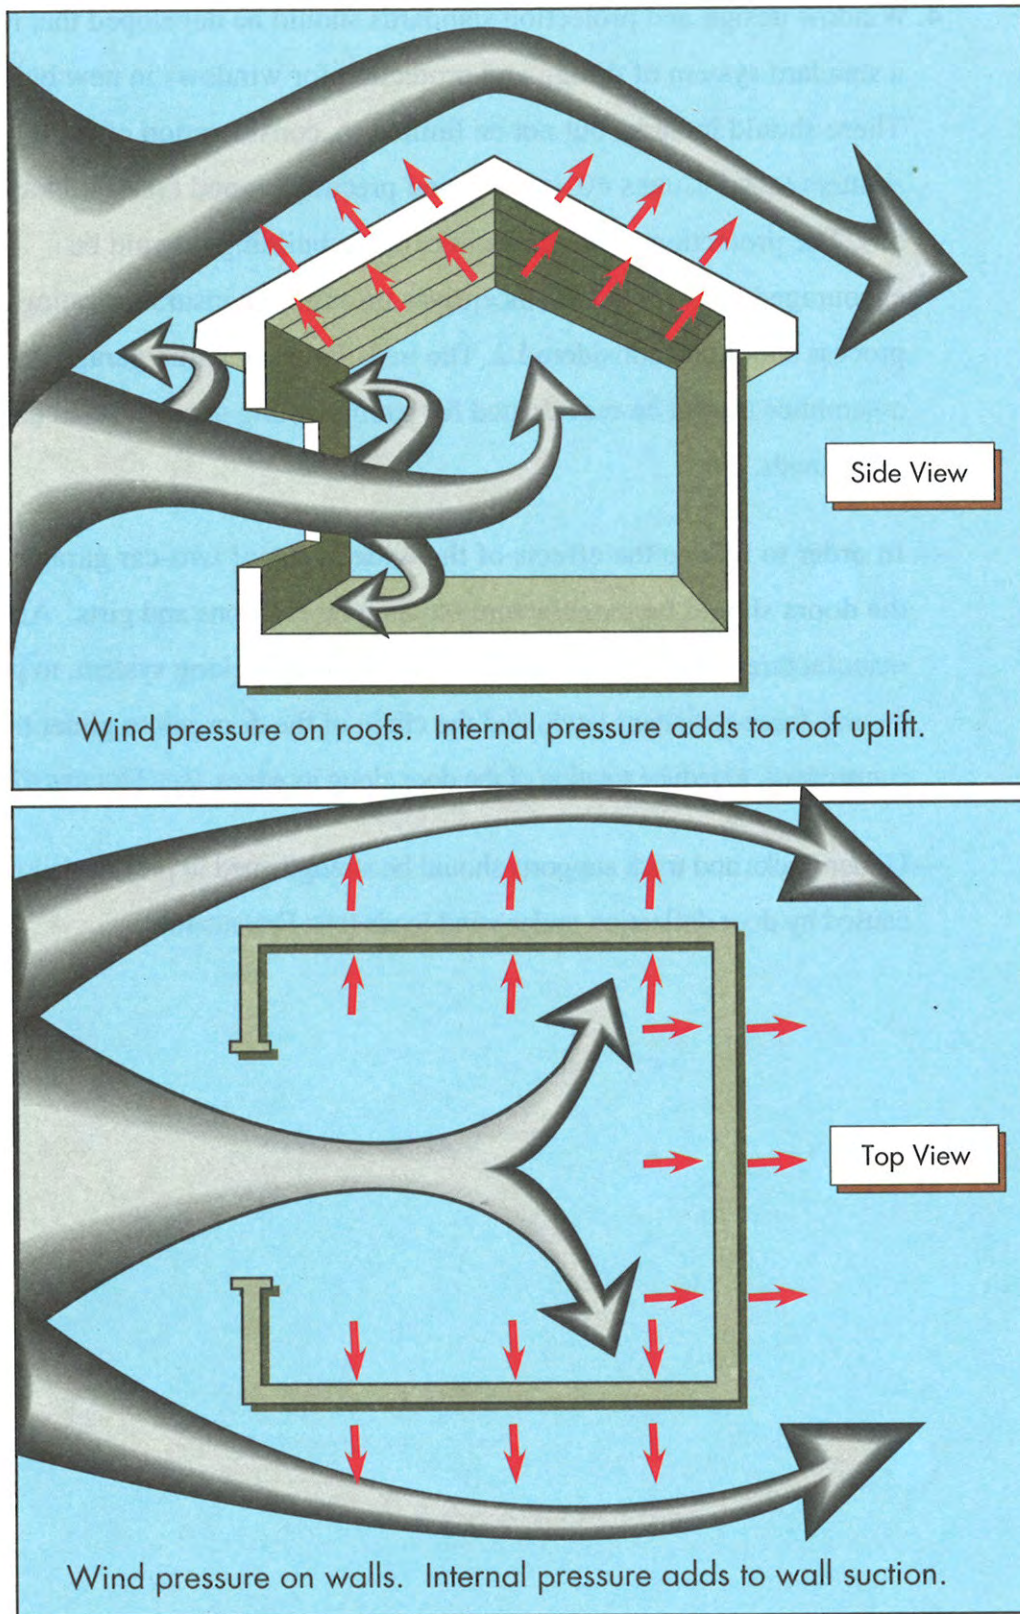
FIGURE 41. Results of building envelope breach due to failure of external doors and windows.
