BUILDING PERFORMANCE: HURRICANE ANDREW IN FLORIDA

OBSERVATIONS, RECOMMENDATIONS,
AND TECHNICAL GUIDANCE

FEDERAL EMERGENCY MANAGEMENT AGENCY
FEDERAL INSURANCE ADMINISTRATION

DECEMBER 21, 1992

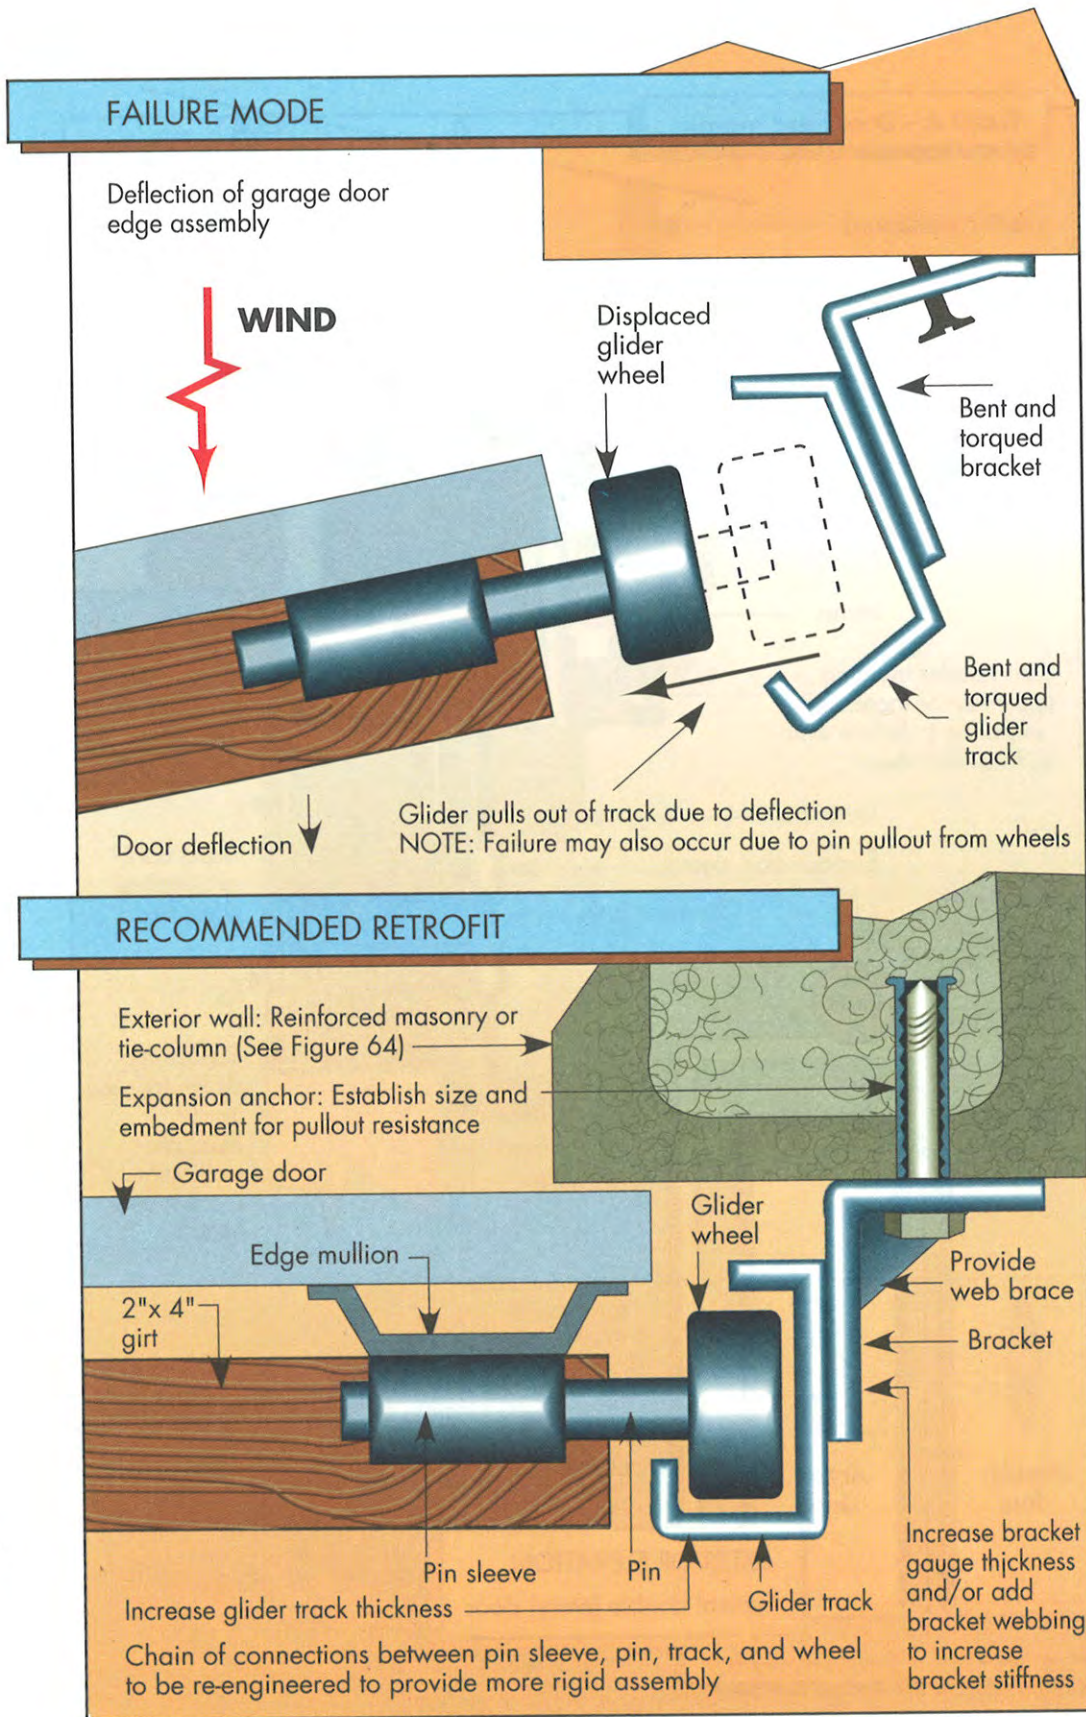
FIGURE 46. Detail B—Garage door failure at edge and recommended assembly improvements.

- Glider tracks and track supports should be strengthened to prevent failure caused by door deflection under wind loads (SEE FIGURE 46).

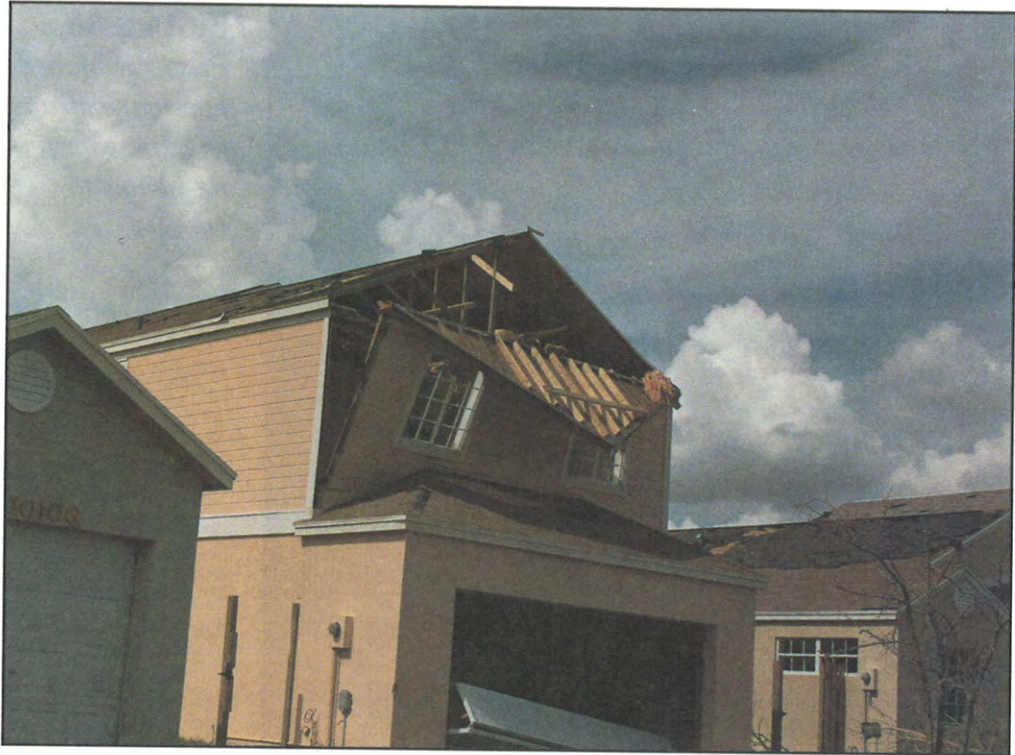
FIGURE 58. *End wall failure. Example of lack of load transfer capacity after separation.*

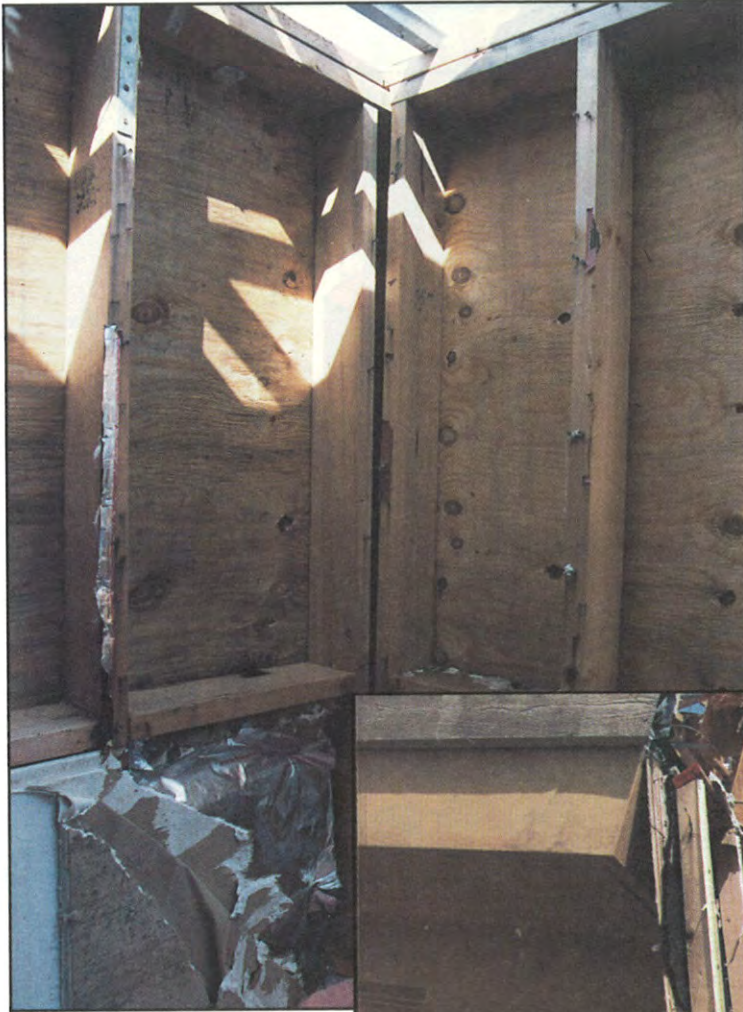
FIGURE 59.
*End column/corner post
missing from
wall.*

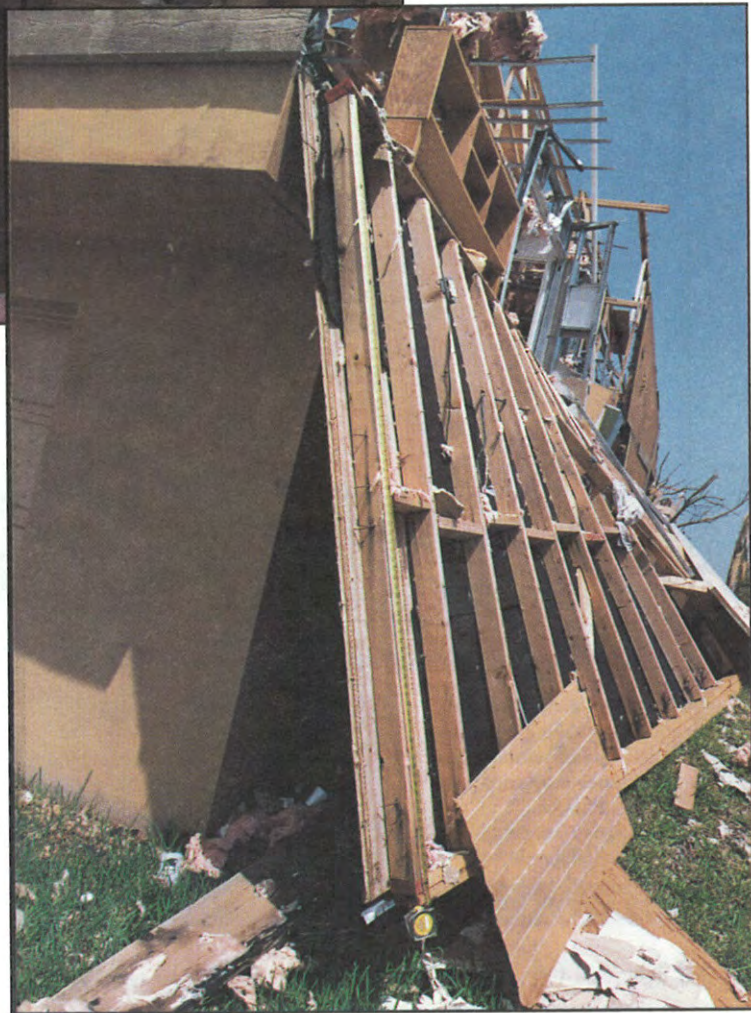
FIGURE 60.
*Side wall failure. Side
wall has no lateral load
transfer capacity due to
inadequately built-up
corner post.*

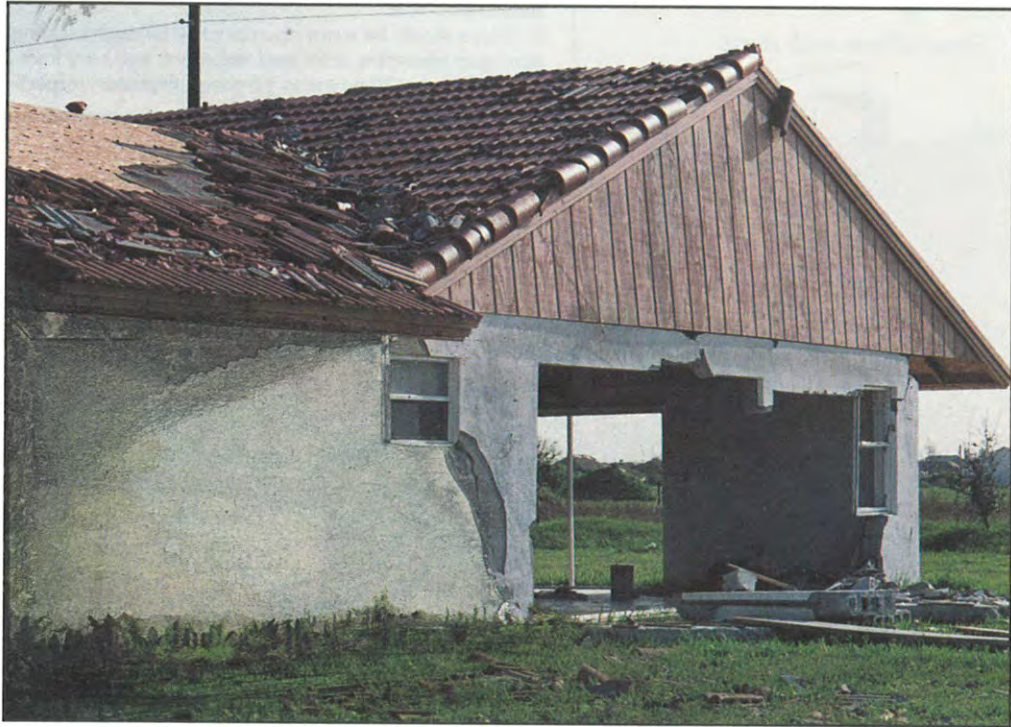
FIGURE 63. *Example of masonry construction. Wall separated from building envelope due to inadequate vertical wall reinforcing in connection to horizontal tie-beam.*

— The Code requirements for tie-beams/tie-columns, or alternative reinforced masonry construction, should be reviewed and enforced (SEE FIGURES 63 AND 64).

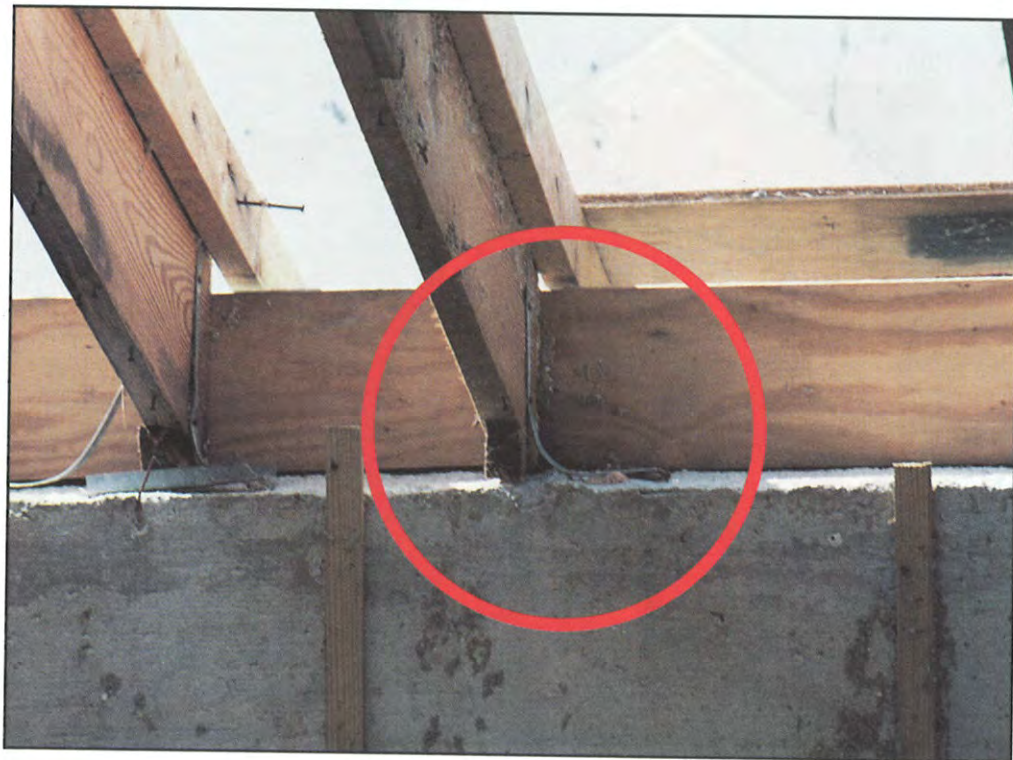
FIGURE 70. Improperly located masonry-wall-to-wood-frame straps.

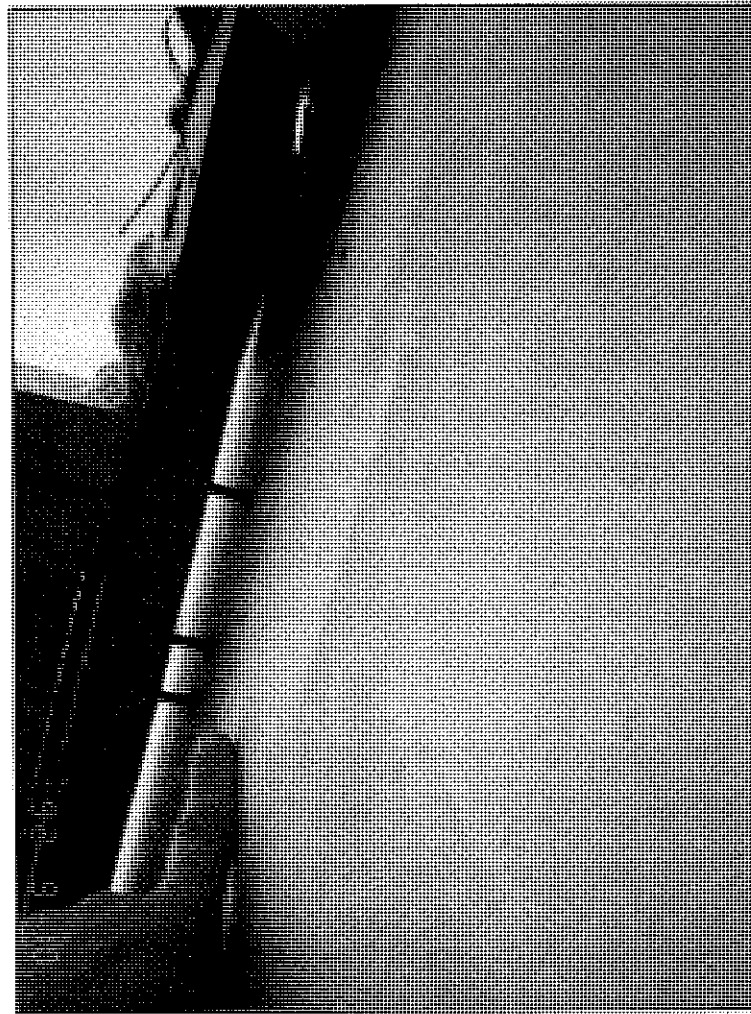
FIGURE 71. *Modular home. Partial separation of end panel (right) from roof structure (left). Evidence of failure due to nail withdrawal.*
