# When Things Go Wrong: Post-tension Repairs

Carl L. Schneeman, PE

May 12, 2026

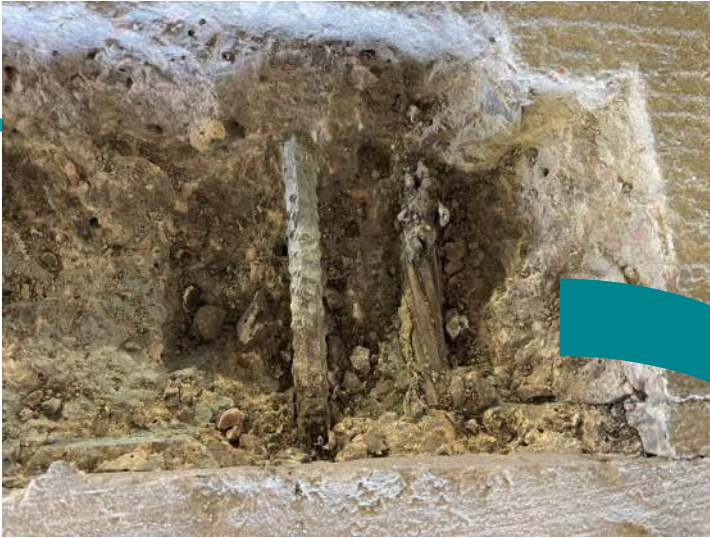
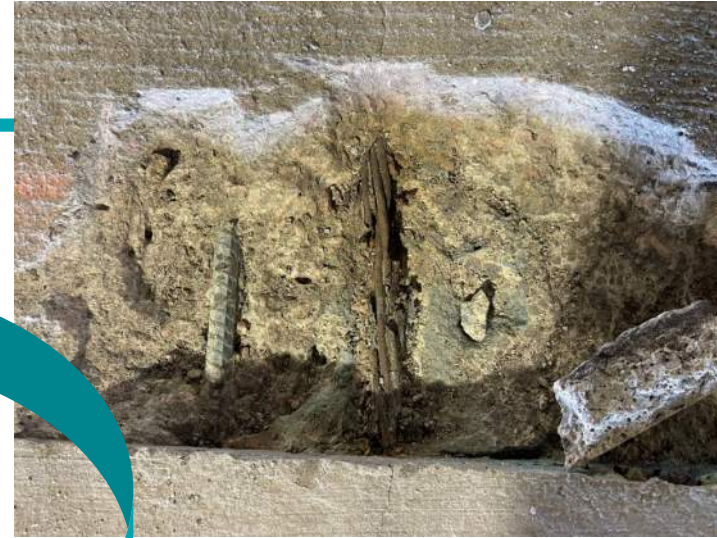
Dry, but  
OK!

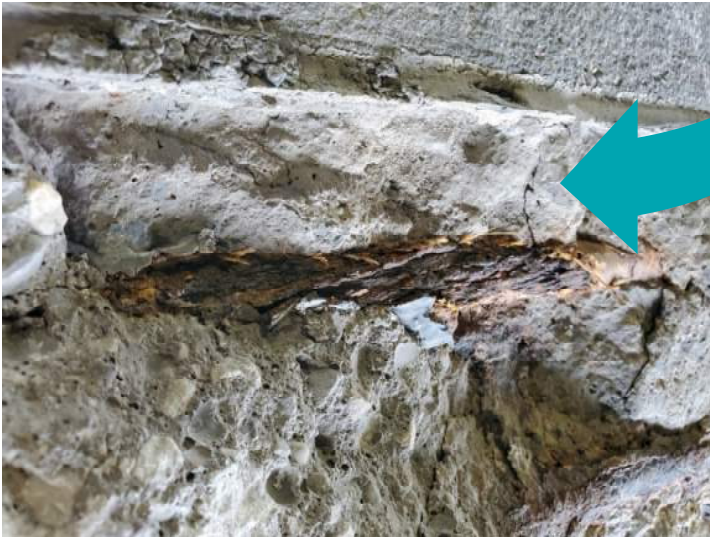
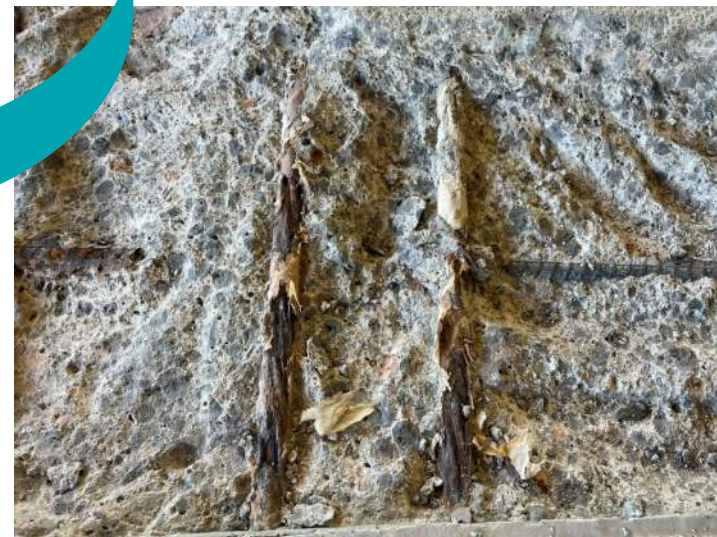
Broken  
Wires

Gone!

Severely  
Corroded

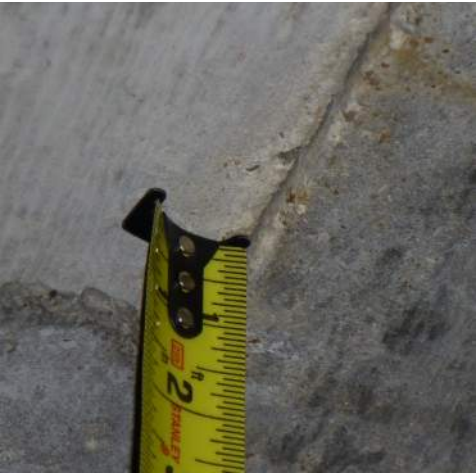
Slab deflection / offset

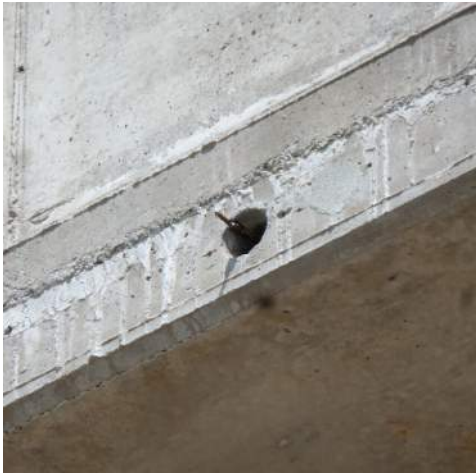
Tendon protruding, grease cap missing

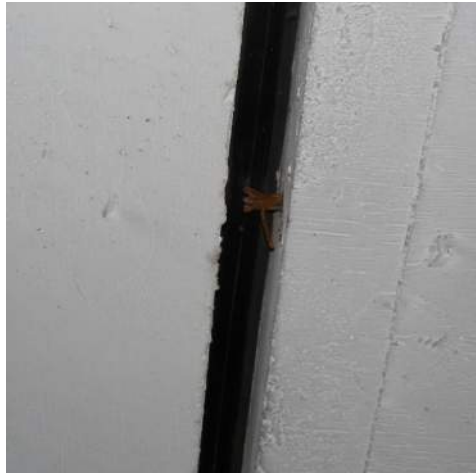
Tendon protruding at expansion joint gap

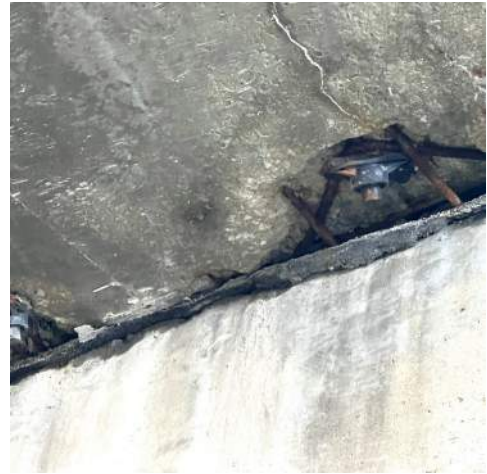
Anchor displacement

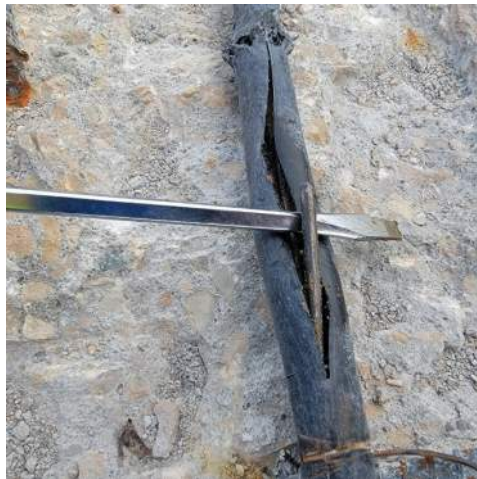
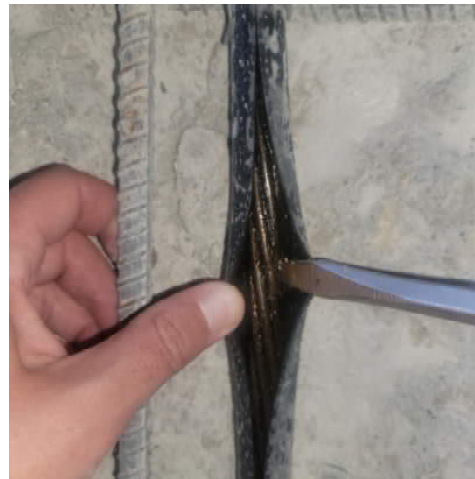
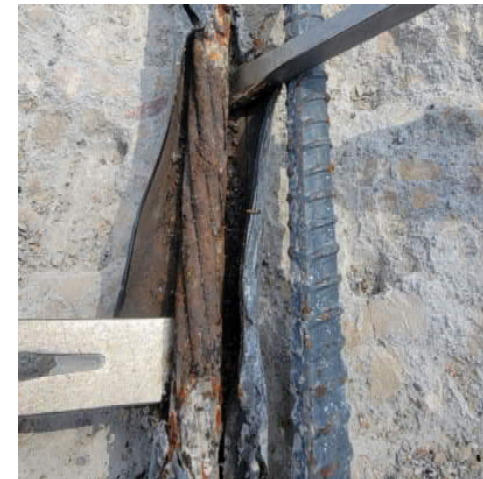
- Performed Screwdriver test
  - Penetration = no tension / failure
- Pry Bar tests (4 ft bar)
  - Displacement = no tension / failure

*Cut sheathing and characterized tendon and grease conditions – most were good...some no grease, corrosion, water*

PT Slab Investigation – June 16, 2022									
Tendon No.	Distance from grid line B	Grid	Cover	Corrosion	Grease	Pry Bar Test	Screwdriver Test	Overall Tension	General Comments
439	1'-3"	Level 1, Grid 12, A,4,B	2 1/8"	None	OK	Pass	Pass	T	
440	3'-0"	"	2"	None	Good	Pass	Pass	T	
441	4'-9"	"	2	None	OK	Pass	Pass	T	
442	4'-5"	"	1 3/8"	None	OK	Pass	Pass	T	
443	3'-1"	"	2"	None	Good	FAIL	-	B	
444	9'-0"	"	1 1/2"	None	OK	Pass	Pass	T	
445	11'-3"	"	2"	-	-	FAIL	-	B	
446	13'-4"	"	2"	None	Good	Pass	Pass	T	
447	15'-0"	"	2 1/2"	None	Good	Pass	Pass	T	
448	16'-9"	"	2"	None	Good	Pass	T	T	
449	18'-5"	"	2"	None	Good	Pass	T	T	
450	20'-2"	"	1 1/2"	None	Poor	Pass	FAIL	PT	One strand broken

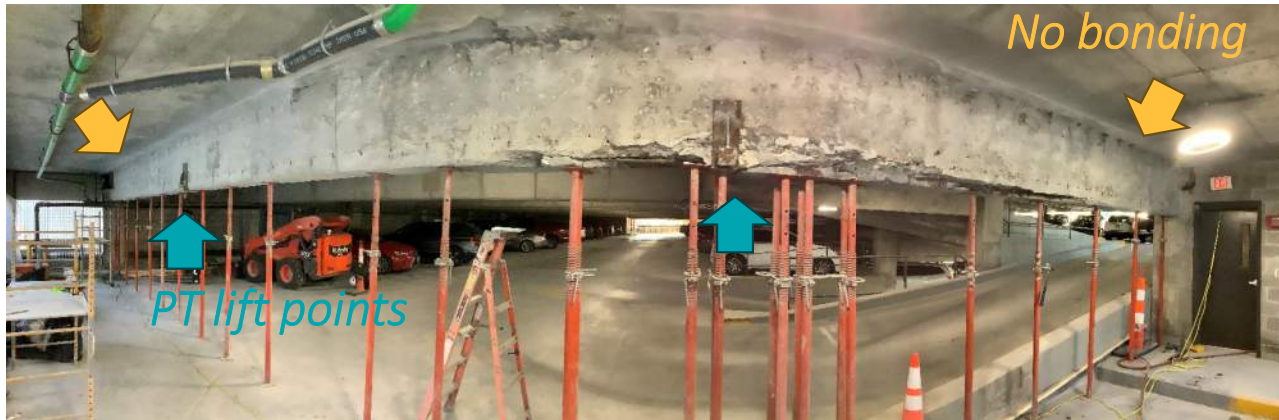
Field assessment indicated poor condition of original beam and strengthening

- Severe corrosion of original PT
- Replacement PT was poorly affixed to beam/column
