# HAZARD ALERT

## Multi-Piece Rims

### *Lethal Hazards Part of Rim Repair Work*

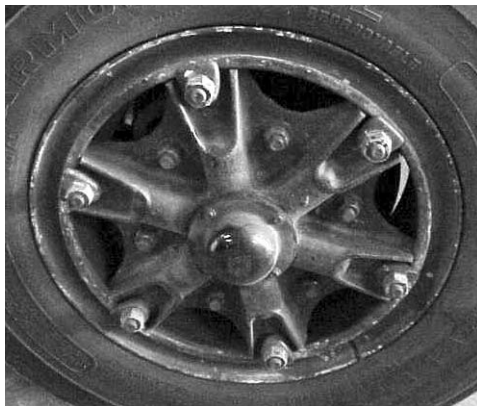
*Typical six spoke wheel on a bus.*

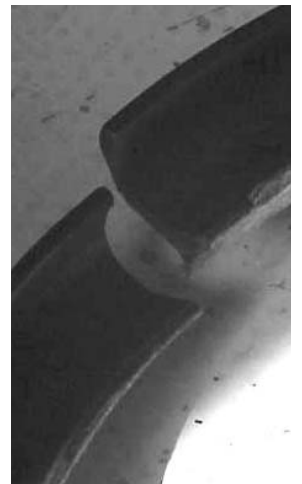
There are several variations of a multi-piece rim, including two-piece and three-piece assemblies. The rim pictured below is a tube-type demountable rim assembly with a split side ring typical of two-piece assemblies.

*Close-up of rim at split.*

- The split side ring was not completely seated and locked.
- Rim gutters and ring must be free of any surface rust that could obstruct seating of the ring.

If the rim is painted or the markings otherwise illegible, the wheel and tire assembly should not be serviced.
