NARI MINNESOTA – 2023 COTY AWARDS

PROJECT: Timeless Elegance

CATEGORY: Residential Interior: \$250K - \$500K

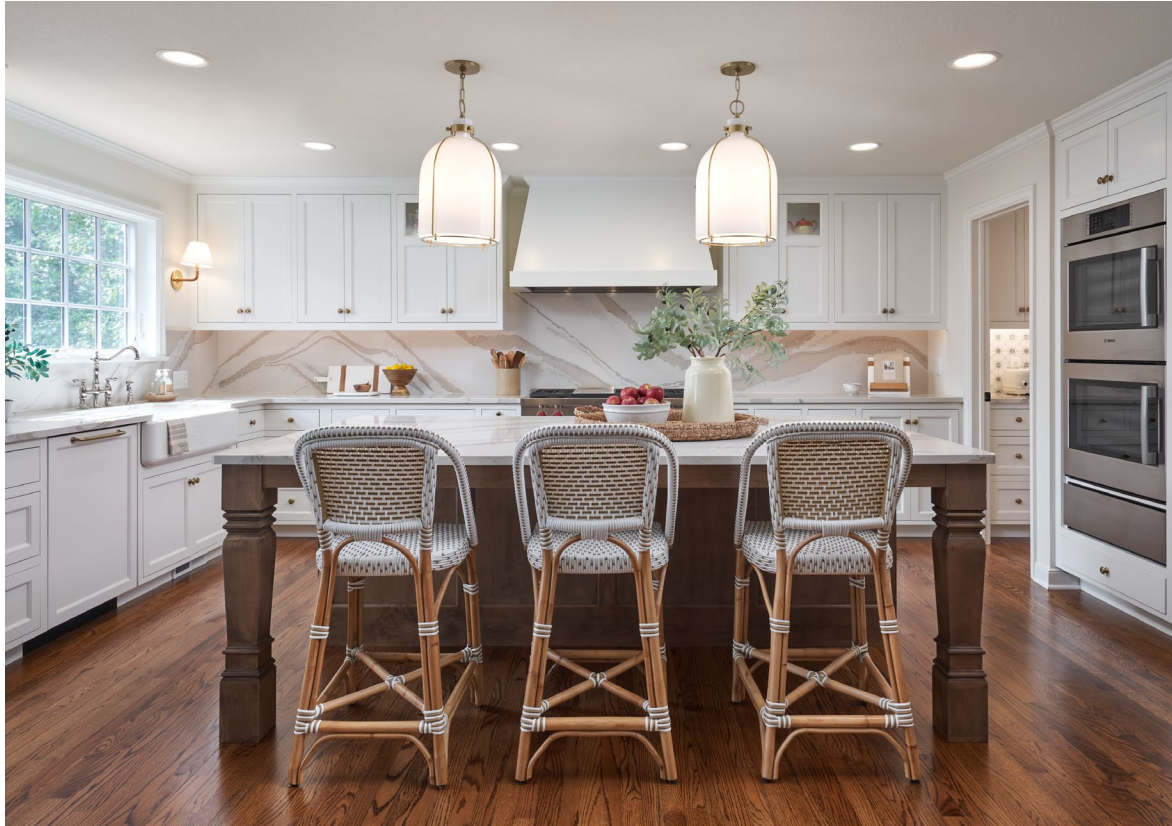
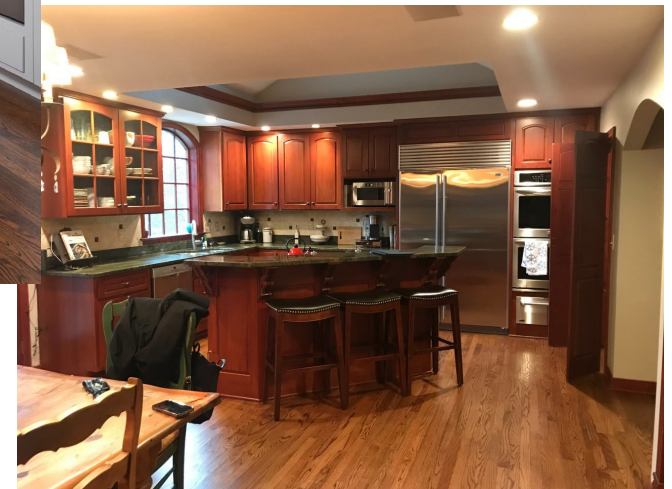
BEFORE AND AFTER

- A flush 1,700lb I-beam was installed and buried in the ceiling to allow for movement of walls and doorways – thus a wider footprint
- The vaulted ceiling was closed in allowing for a clean ceiling and light fixtures
- A new wider window installed behind the sink with no arch top
- A great sized island with tons of workspace and comfortable seating

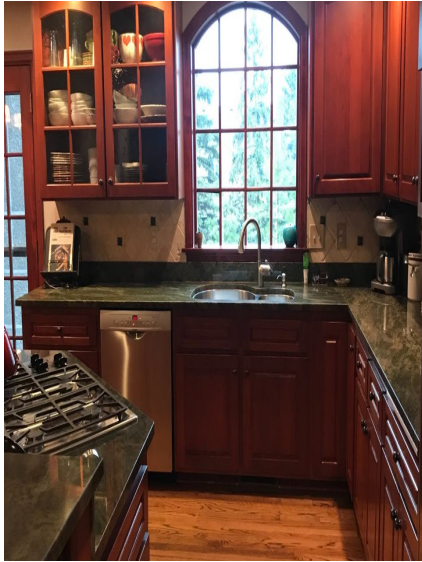
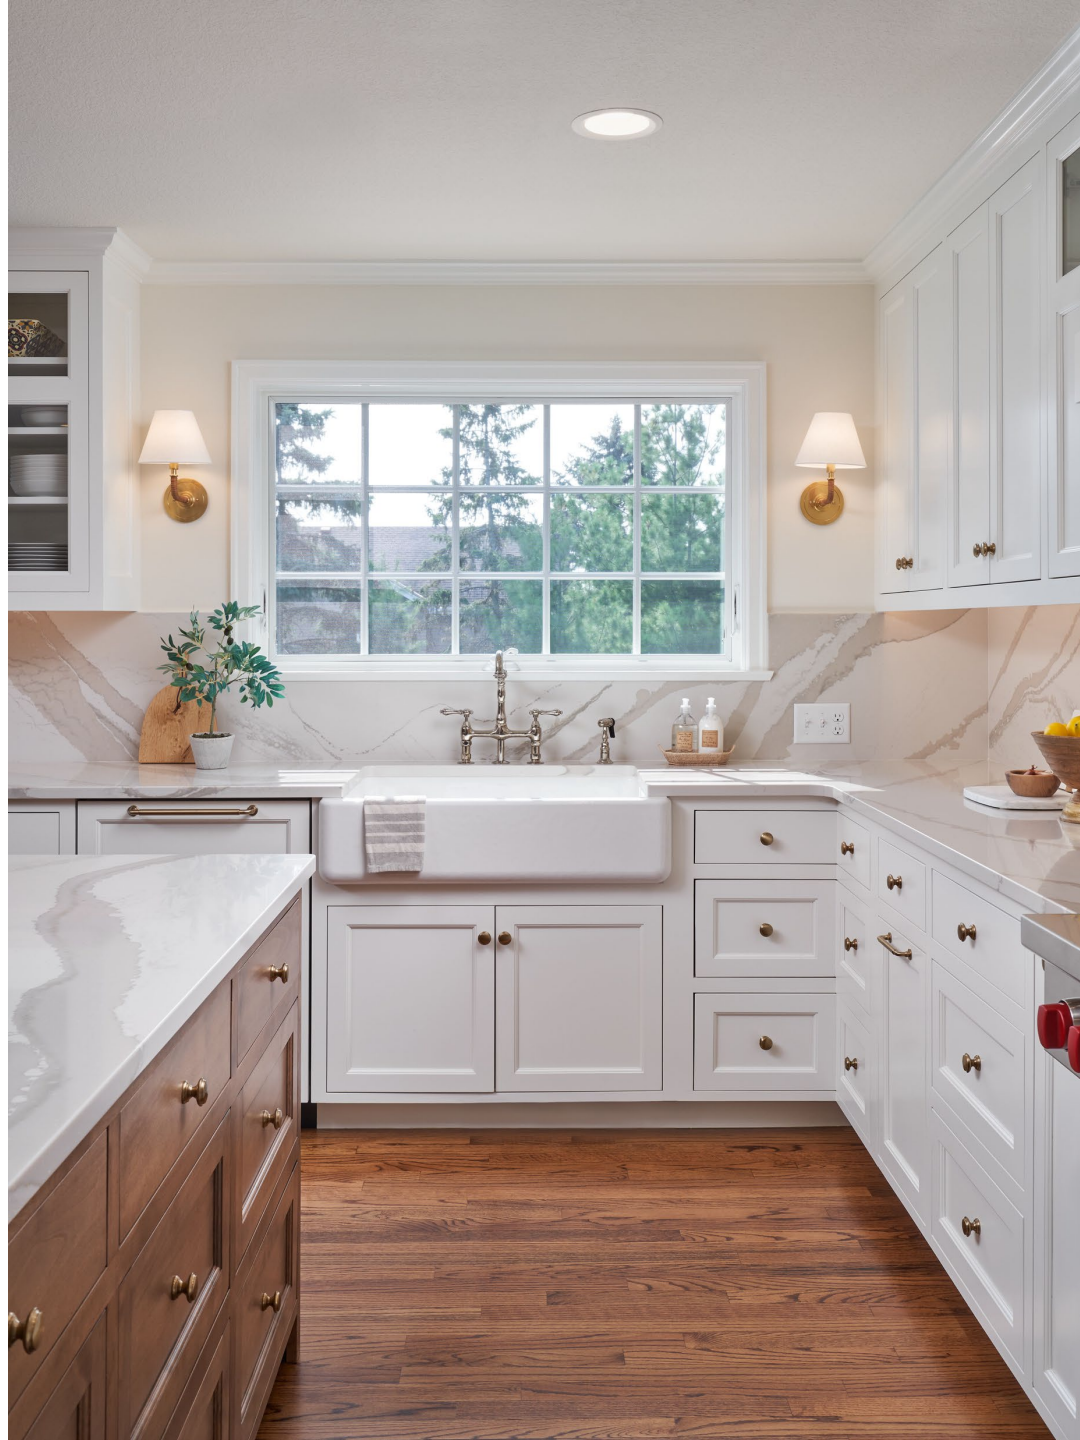
BEFORE AND AFTER

- A new wider window installed behind the sink with no arch top
- The vaulted ceiling was closed in, window removed and roof patched
- Wider walkways
- Drawers, Drawers and more Drawers for great access to storage

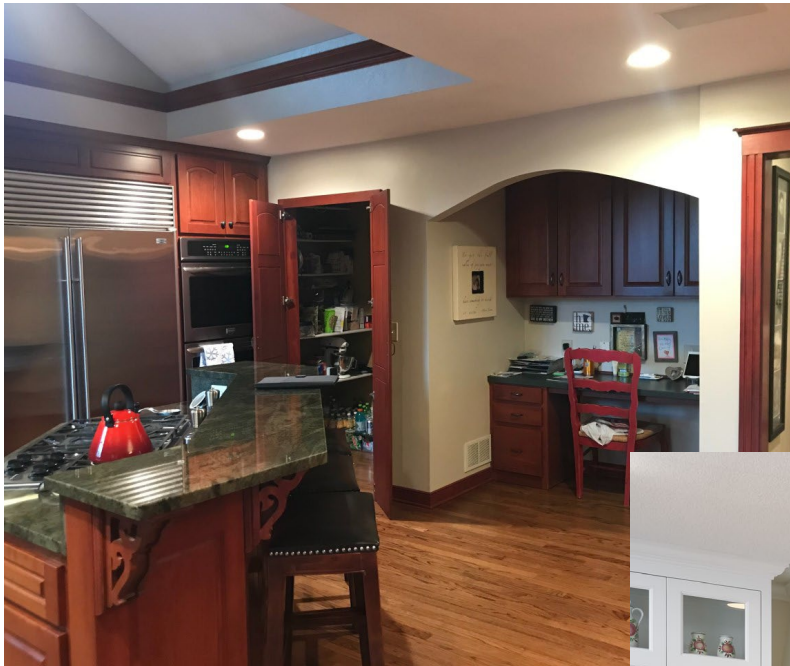
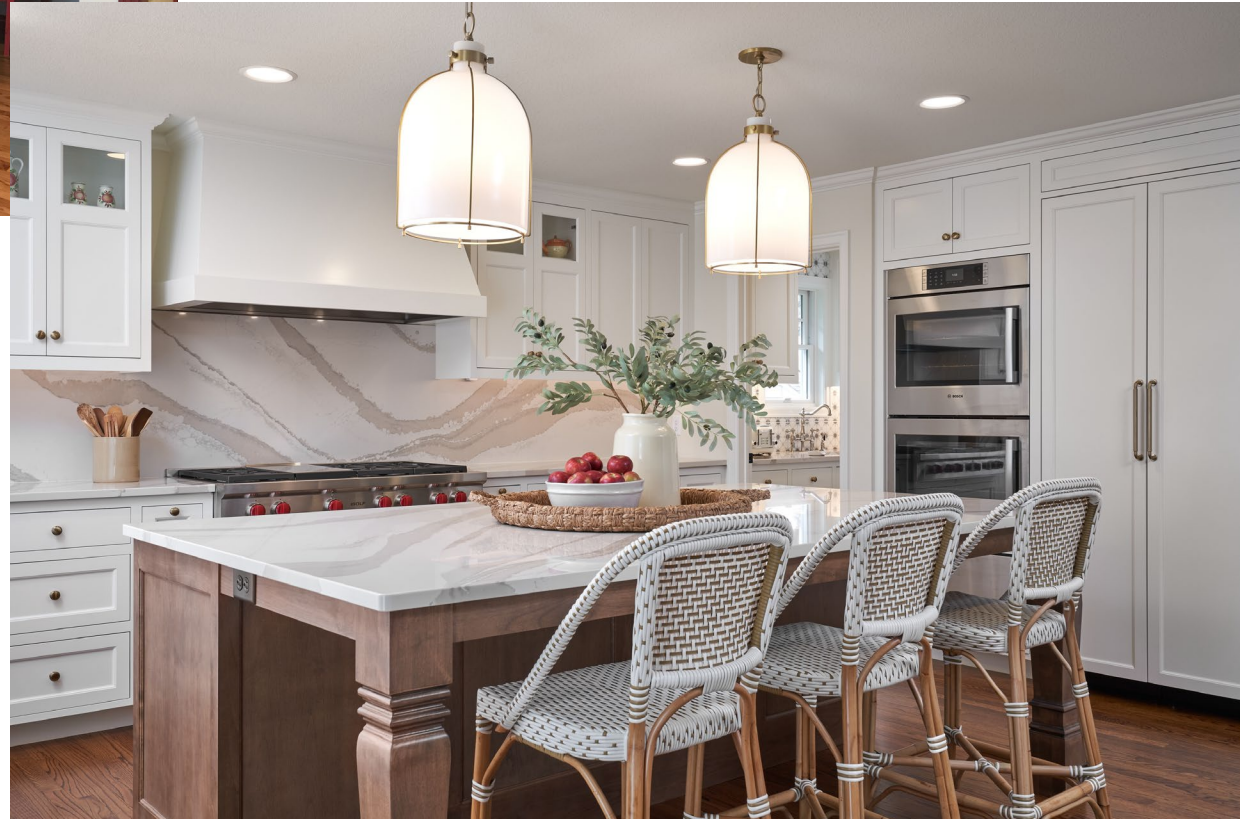
BEFORE AND AFTER

- A flush 1,700lb-beam was installed and buried in the ceiling to allow for movement of the walls and doorways – thus a wider footprint
- The vaulted ceiling was closed in allowing for a clean ceiling and light fixtures
- Unused desk area space was reclaimed
- Small pantry eliminated

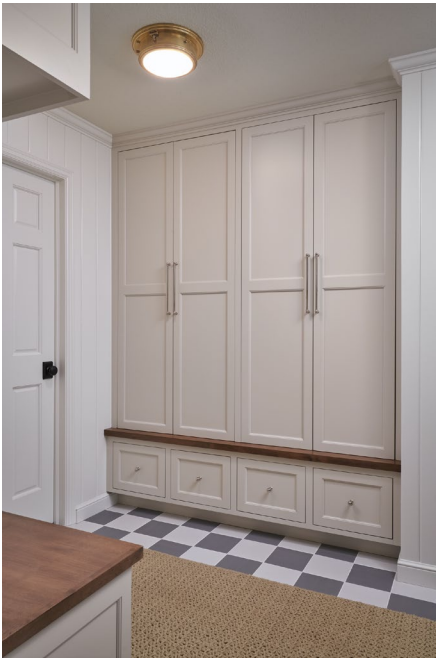
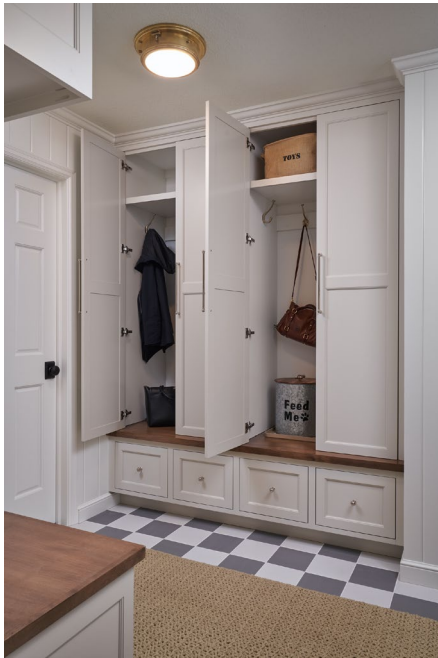
BEFORE AND AFTER

- Wider opening into the kitchen for better sightlines
- Updated finishes and deeper cabinets for increased storage
- Updated finishes throughout

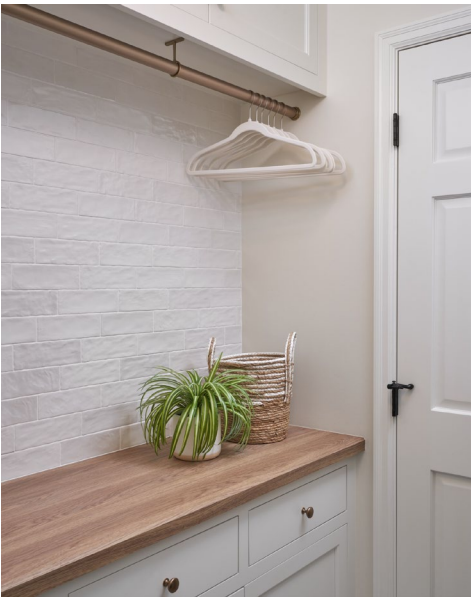
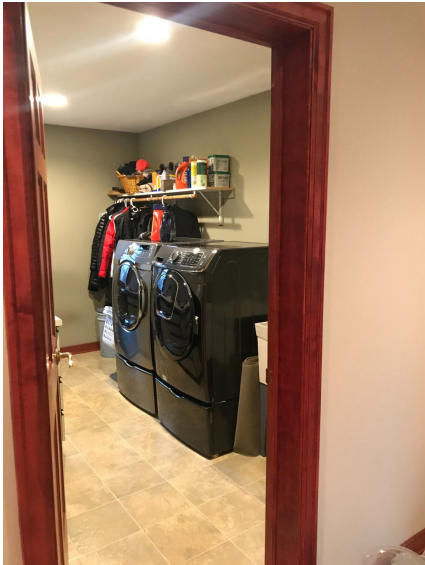
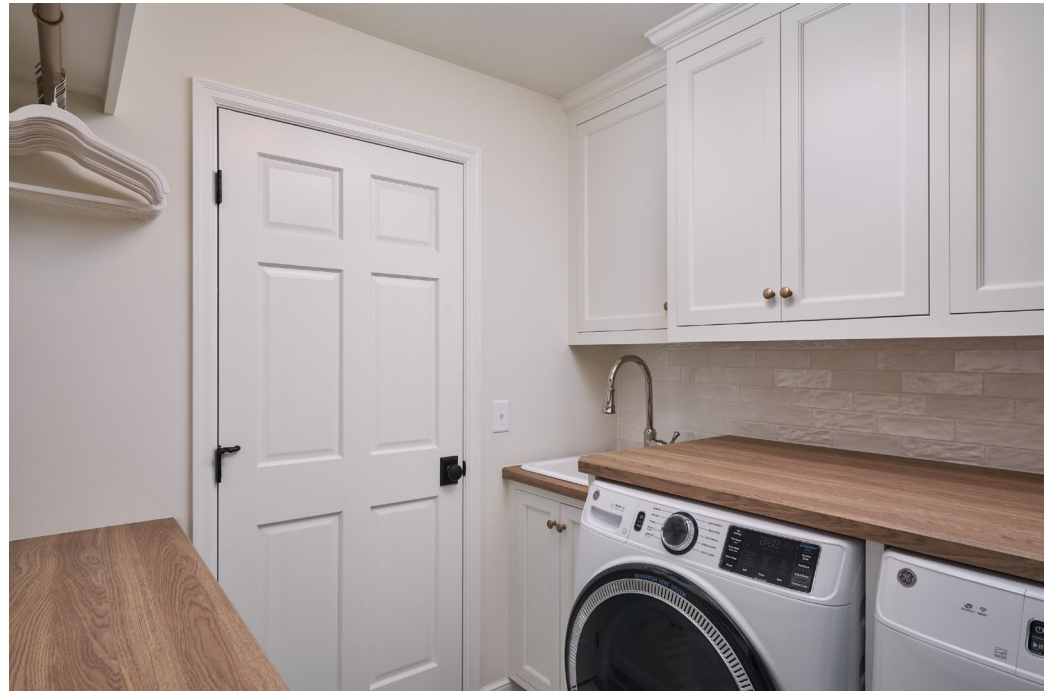
BEFORE AND AFTER

- Laundry was relocated and downsized for more pantry space
- Closed storage with accessible hanging
- Lots for flat space for folding
- Updated finishes

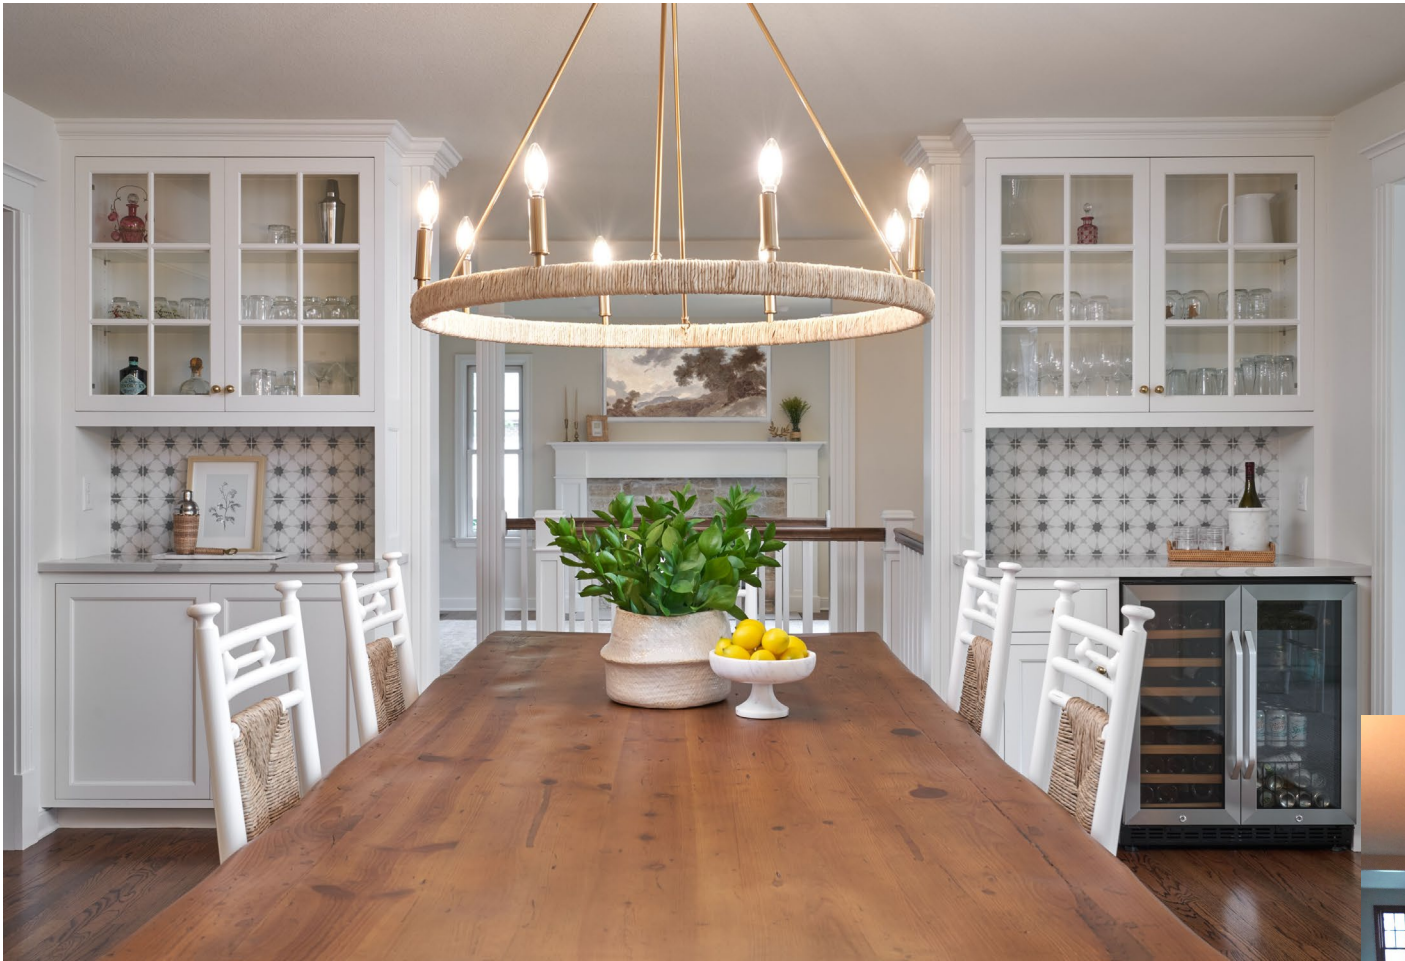
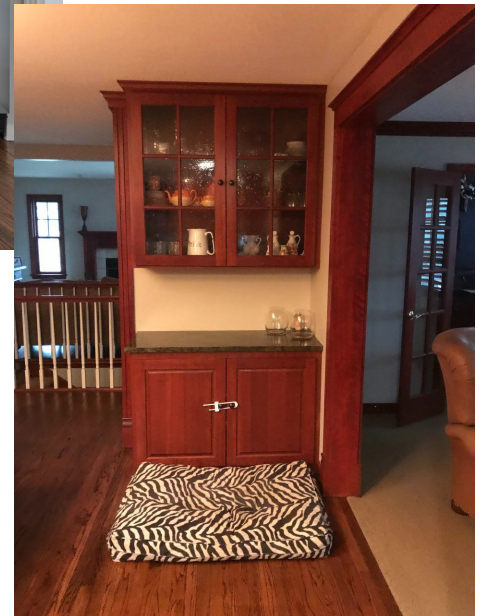
BEFORE
AND
AFTER

- Updated service / display cabinetry with new and updated finishes
- Refinished millwork, ceilings and flooring throughout
