Residential bathroom over
\$150k

The homeowners lived in the same neighborhood as this home, and we were about halfway through planning a project to renovate their current home when they discovered this diamond in the rough. It was only a few blocks away and had just come up for sale. The primary bathroom was large and poorly laid out. The homeowner saw this as an opportunity to get their dream bathroom. The quickly changed course, purchased the home, and we began the planning process, again!

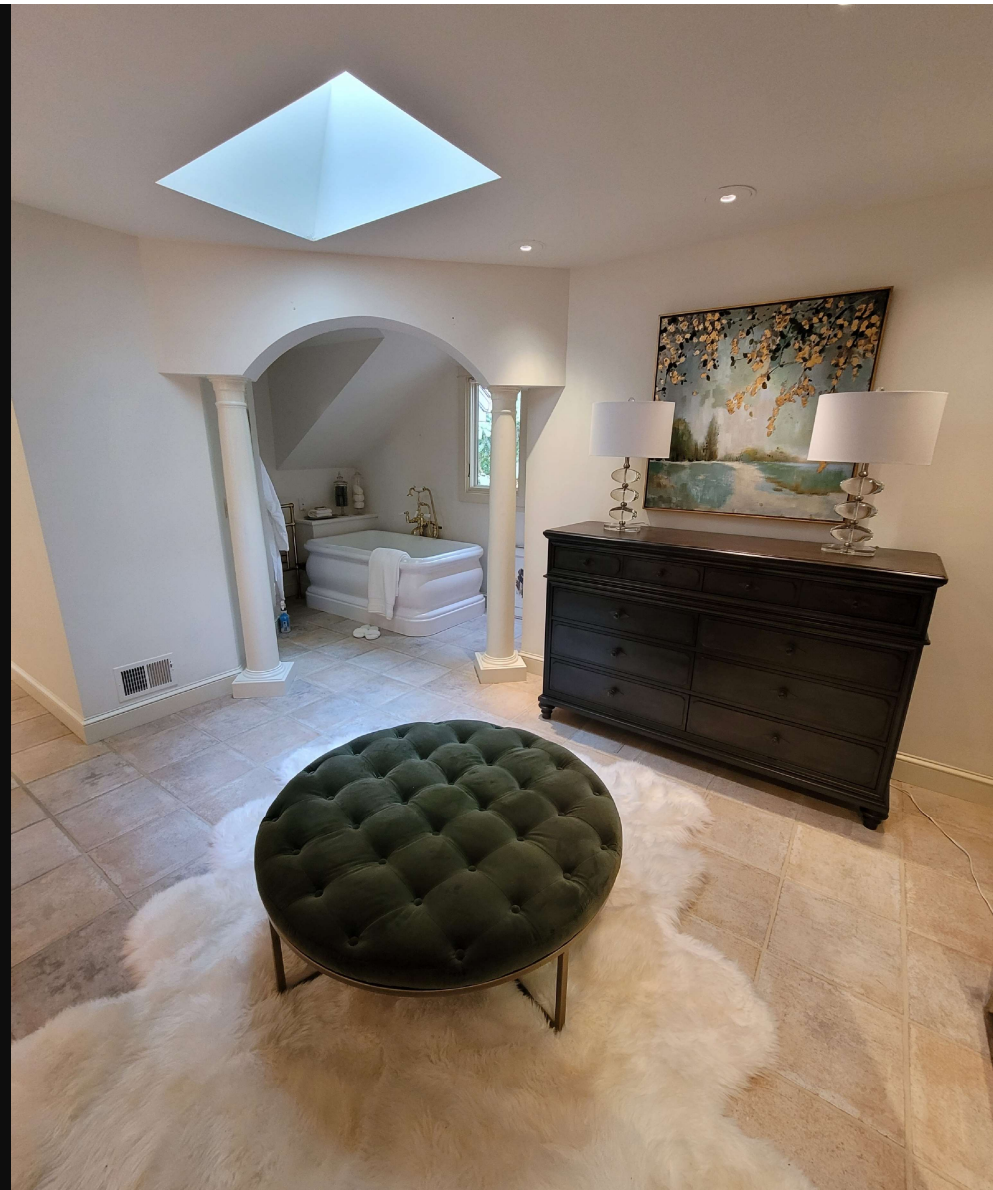
Before – customers concerns

- The bathroom felt cramped and oddly laid out
 - The shower felt and looked like something out of a dungeon
 - The space was broken up, there was a his and hers vanities, but they were literally at opposite ends of the bathroom
 - The existing tile was broken and coming up
 - The central lighting control system was not working properly, the system was about 20 years old and needed help
-

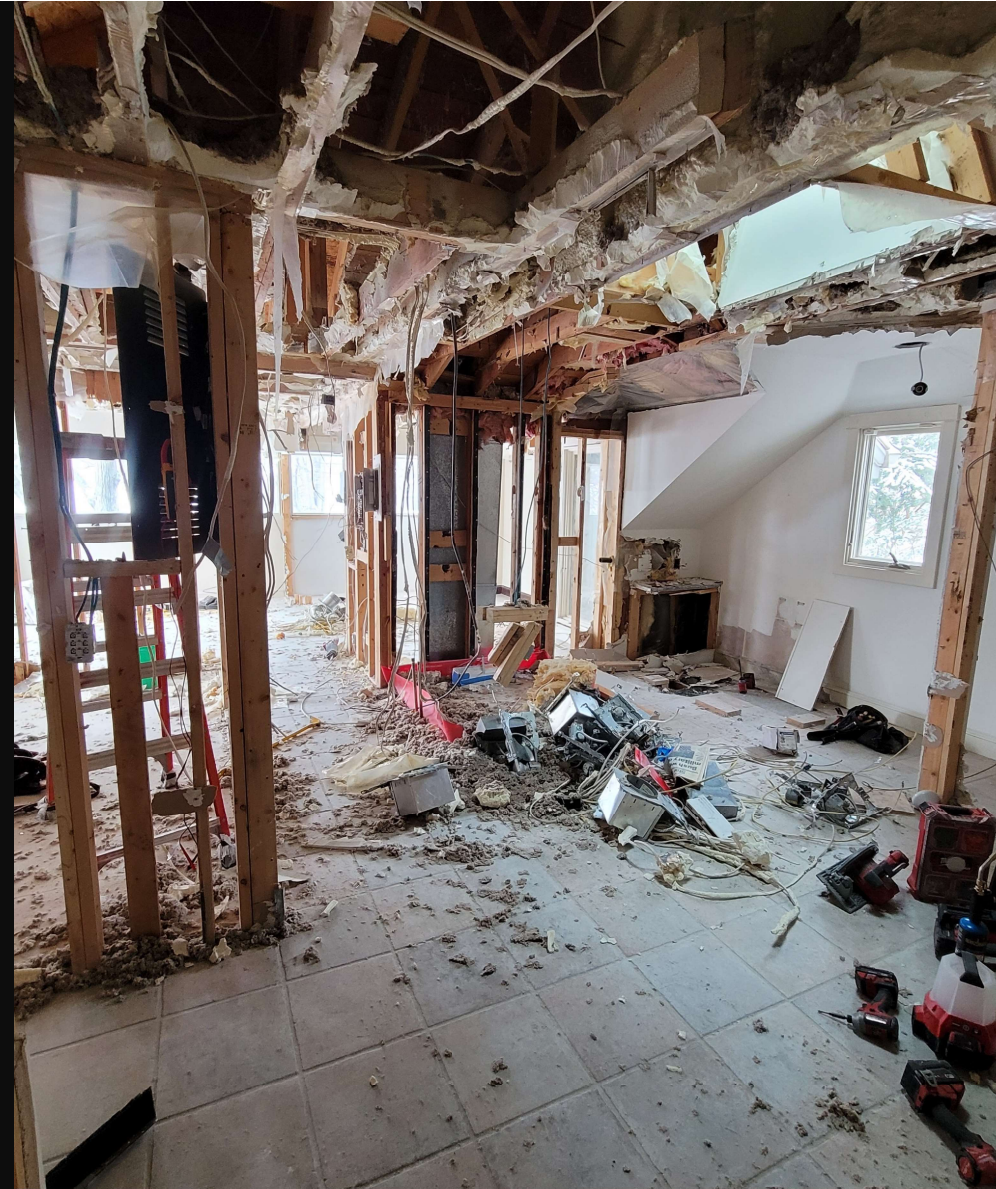
There is always a problem to deal with

- The space had been remodeled before and had two different HVAC units servicing the area. This created a unique situation to balance the two systems
 - Due to the prior remodeling, there was a difference in floor heights from the original space to the remodeled space. This required new sub floors throughout to level the space
-

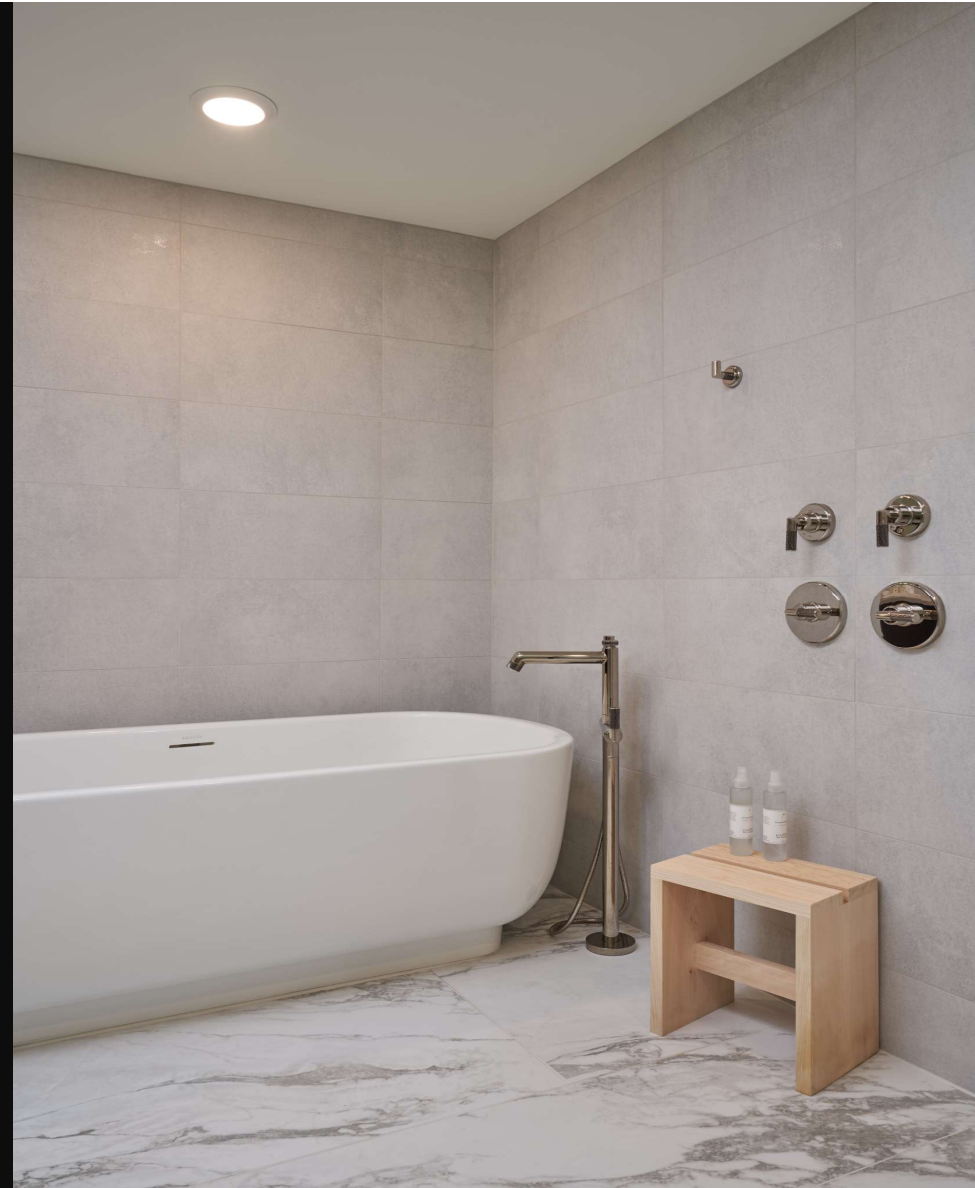
After:

The in-floor heat was carried through the bathroom and into the tub and shower area. The customer loves the warm feel under their feet

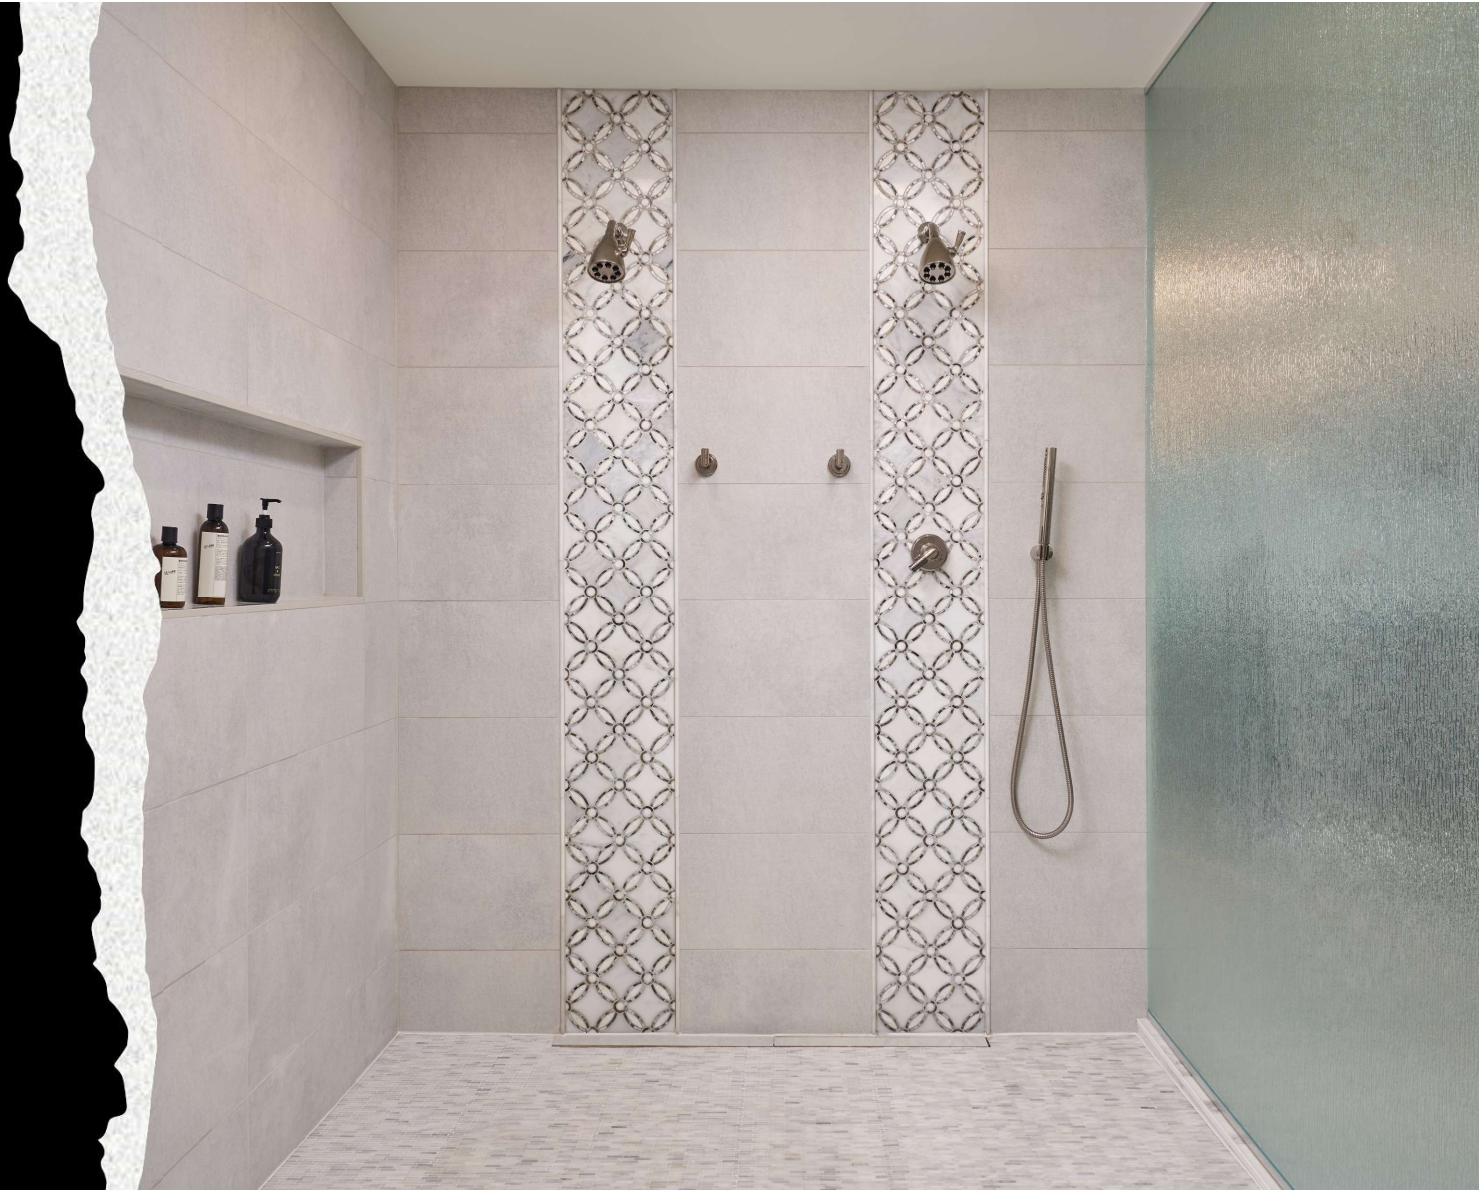
After:

The his and hers showers create a great place to get ready each day. Each shower is independently controlled both for temperature and for volume. The shower on the right also has a separate control for the handheld as well. The vertical marble tile accent has a mother of pearl inlay that adds a touch of elegance to the shower. The large niche on the side is a perfect spot for the shower essentials.

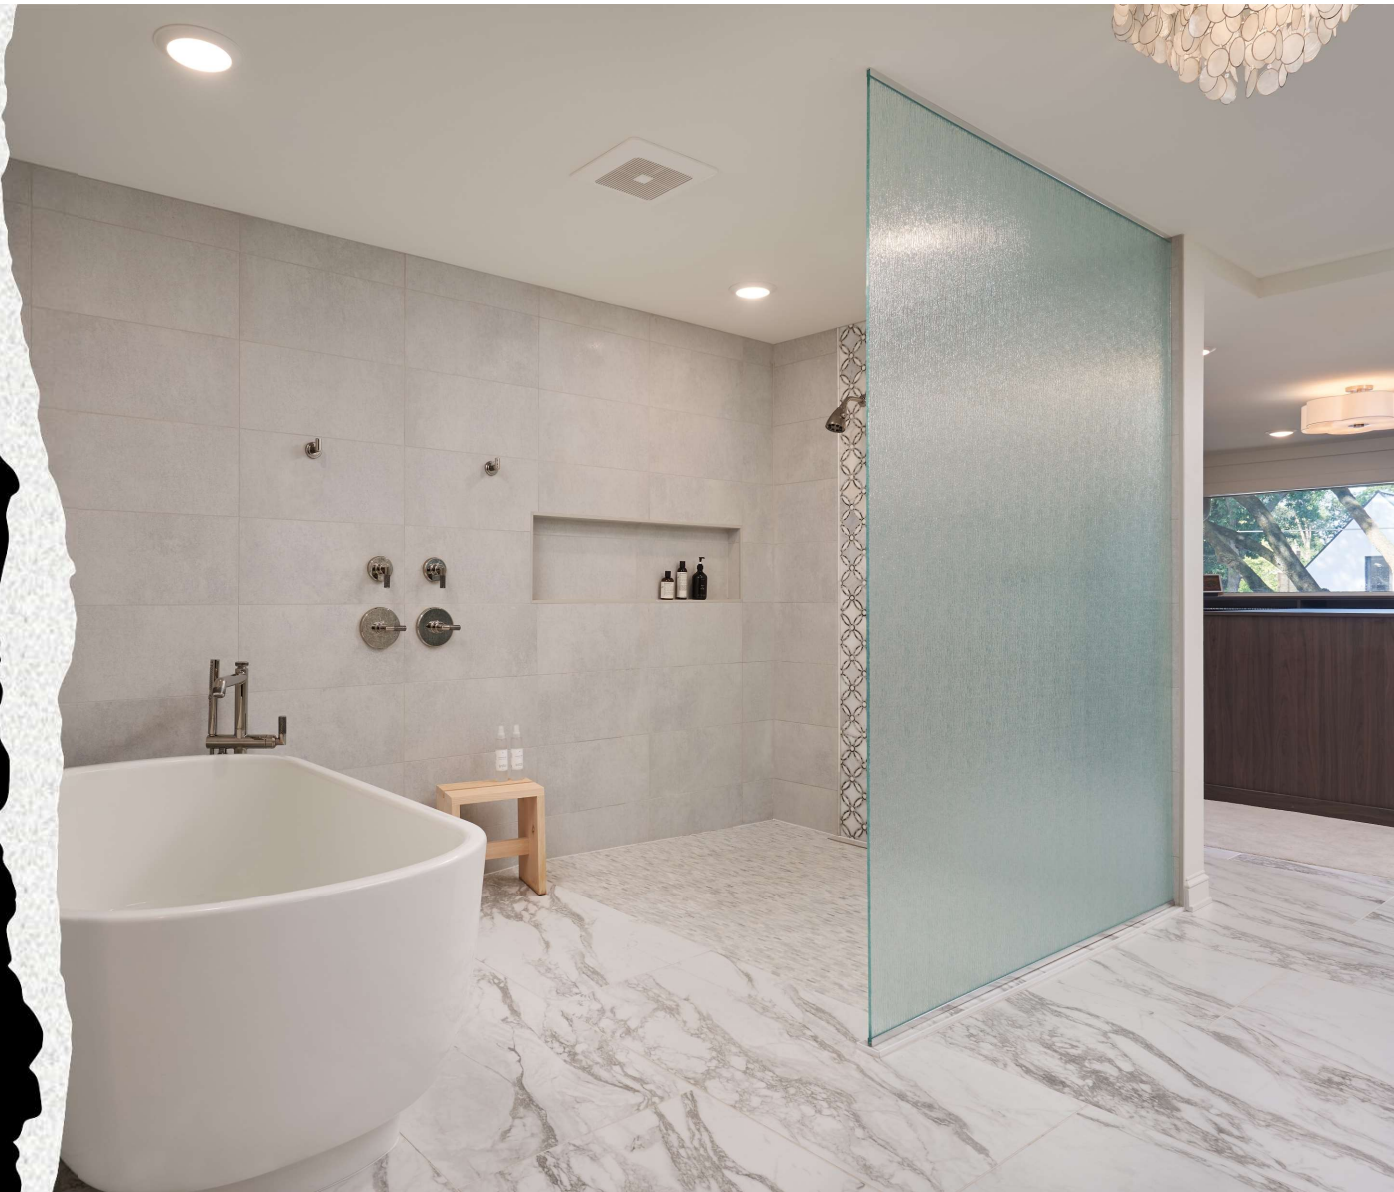
After:

The shower and tub are all situated in one large wet room space. The large soaking tub is perfect for relaxing after a long day and when done it's just a few steps to the shower to rinse off. The shower controls are positioned to allow for ease of control. The shower glass has a rain glass texture to it and is one large piece. It was the largest single piece that would fit into the home.

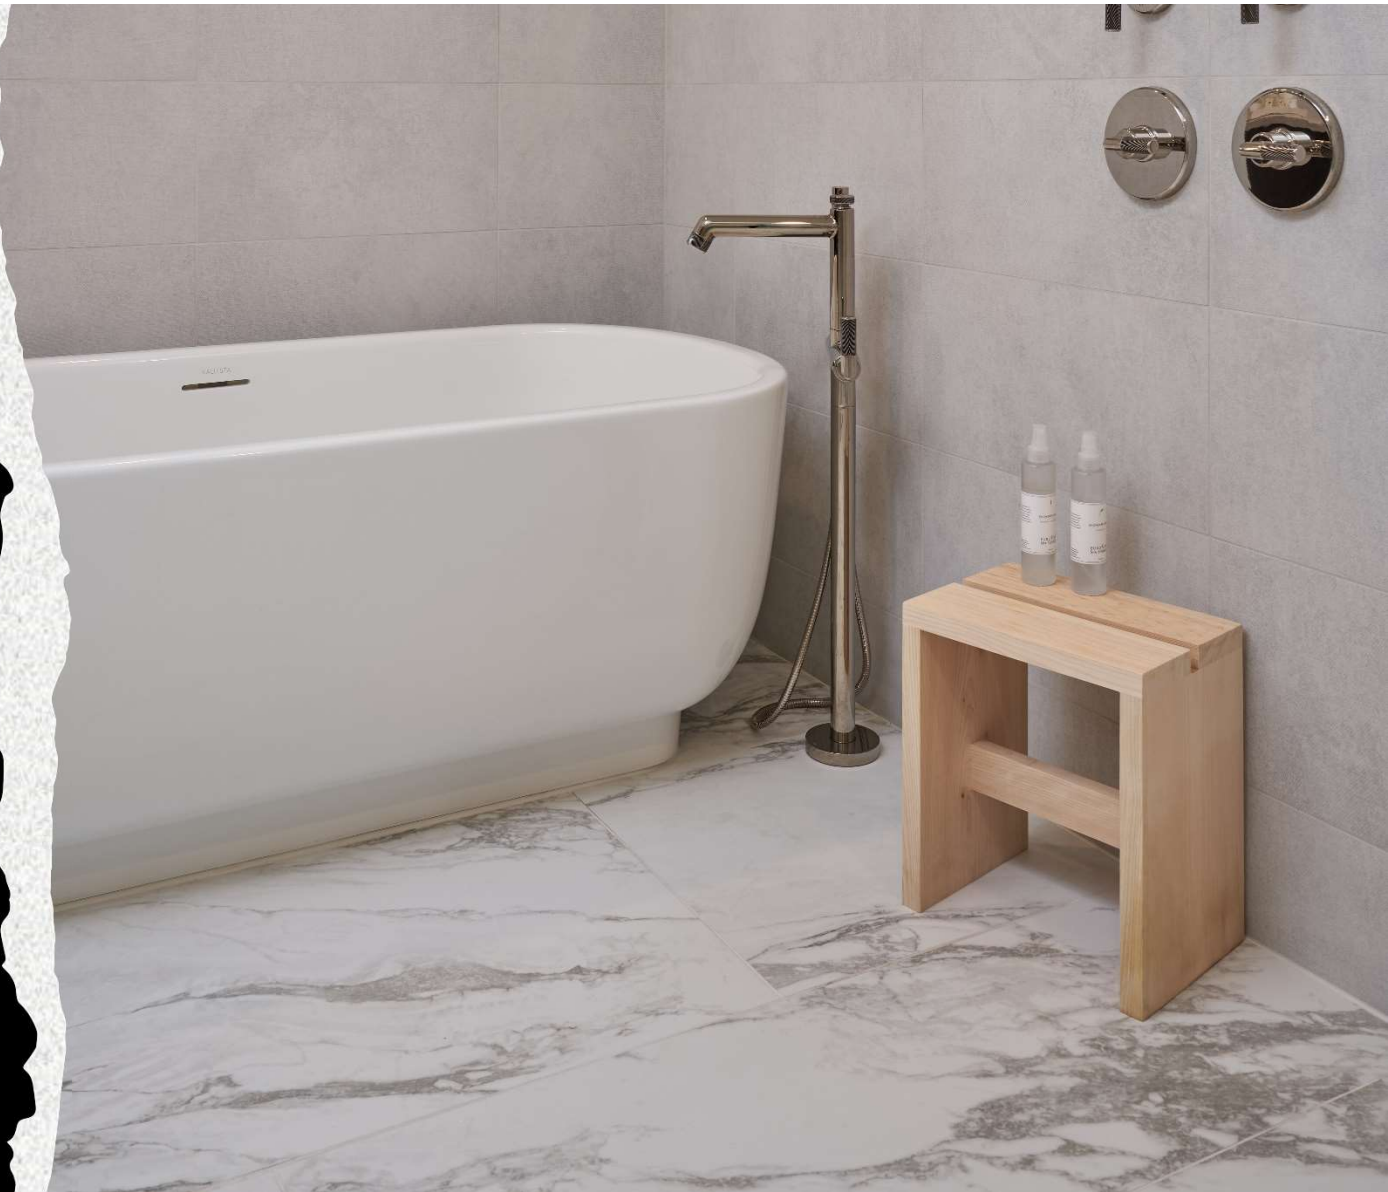
After:

The floor mounted filler is plumbed directly to the water heater to ensure that this tub fills quickly and with hot water. It also features a handheld sprayer as well.

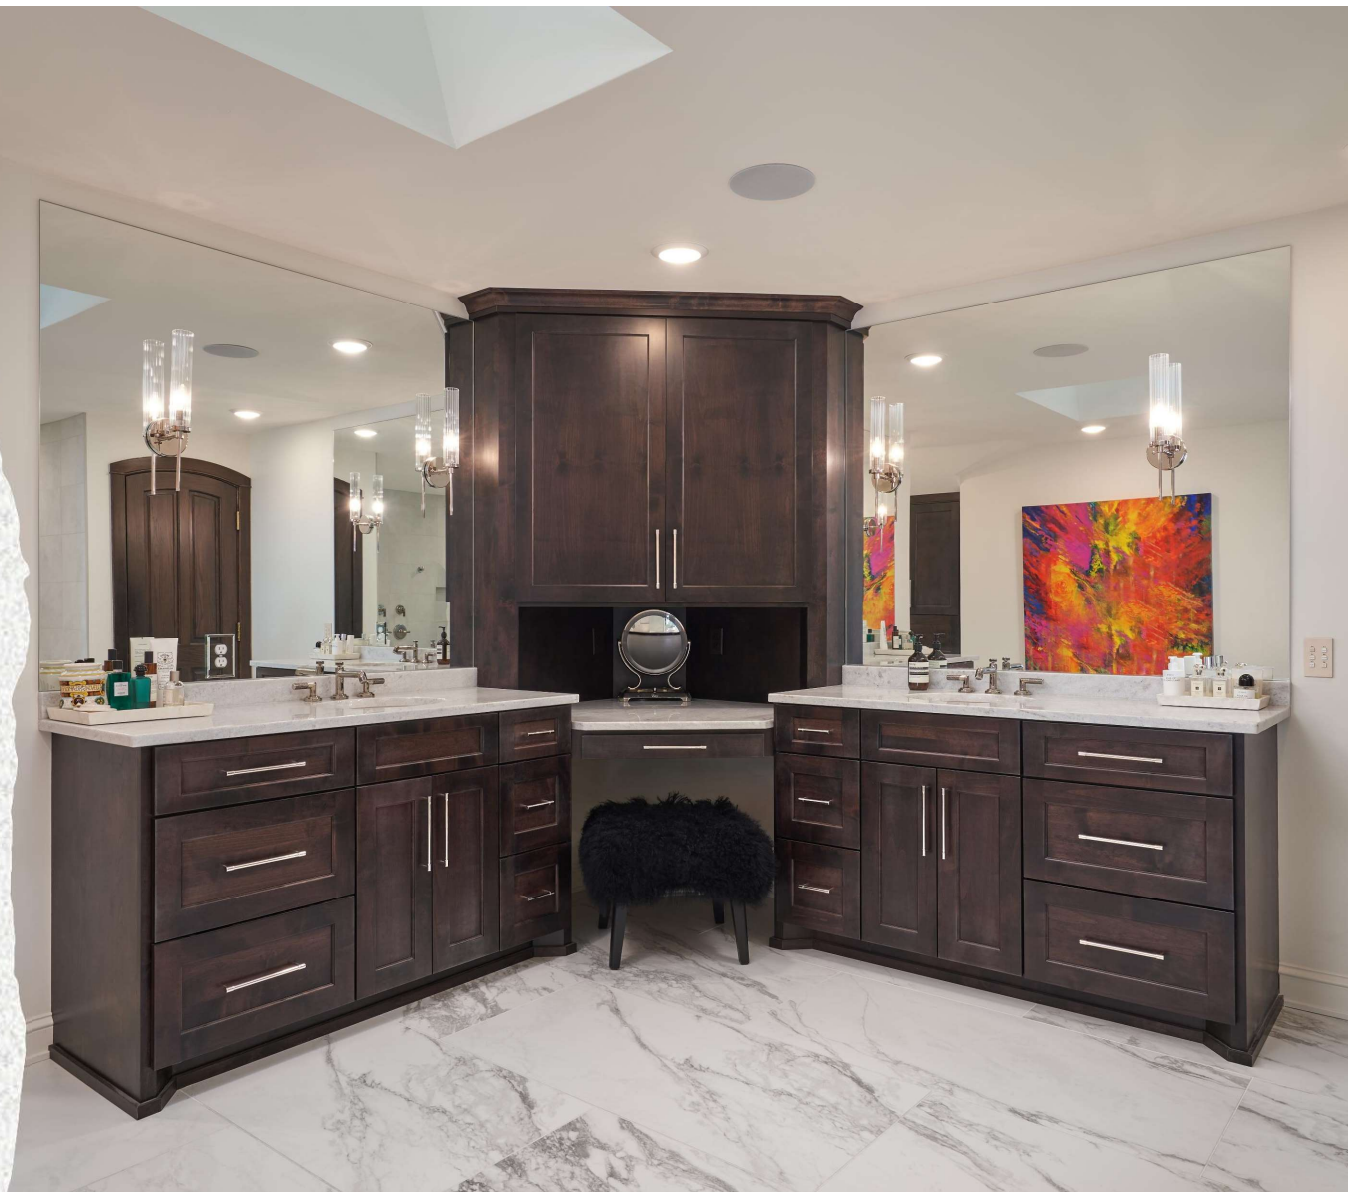
After:

The his and hers vanities provide great storage and with the sinks offset to one side there is plenty of “work-space” to get ready each day. The large center dressing area was just what the homeowner was looking for and is excited to put it to use.

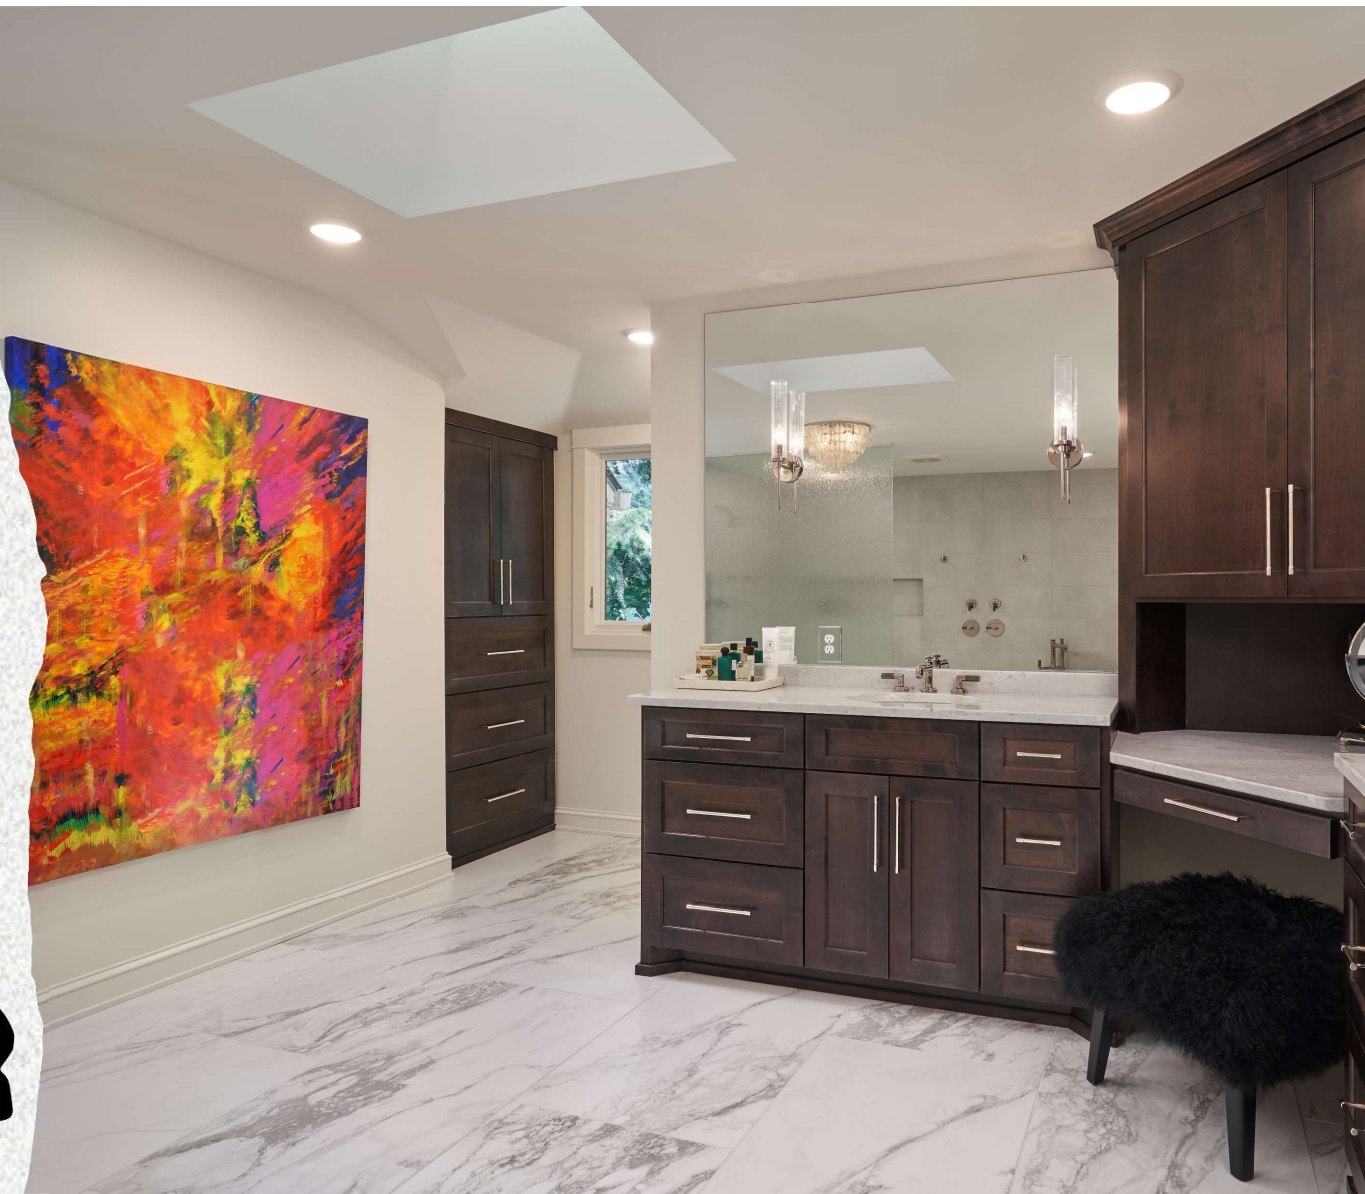
After:

There was an odd nook in the corner where the roof lines came together. The homeowner wanted as much storage as possible, so a custom cabinet was created to fit the space and follows the roof line closely to utilize as much space as possible.
