# Residential Historical Renovation/Restoration

# Project Overview

- 118-year-old historic home, known for being the longest avenue of Victorian homes in the country. This particular avenue is notable for having preserved its historic character and mix of buildings.
- Historian Ernest R. Sandeen described it as “the best-preserved example of the Victorian monumental residential boulevard.”
- Aluminum siding and roof damaged in storm, covered by insurance
- New siding meant opportunity to be more historically accurate with exterior renovation
- James Hardie lap with a 4-inch reveal
- Due to the complexity of the project, we were able to replace old aluminum siding with premium James Hardie siding.

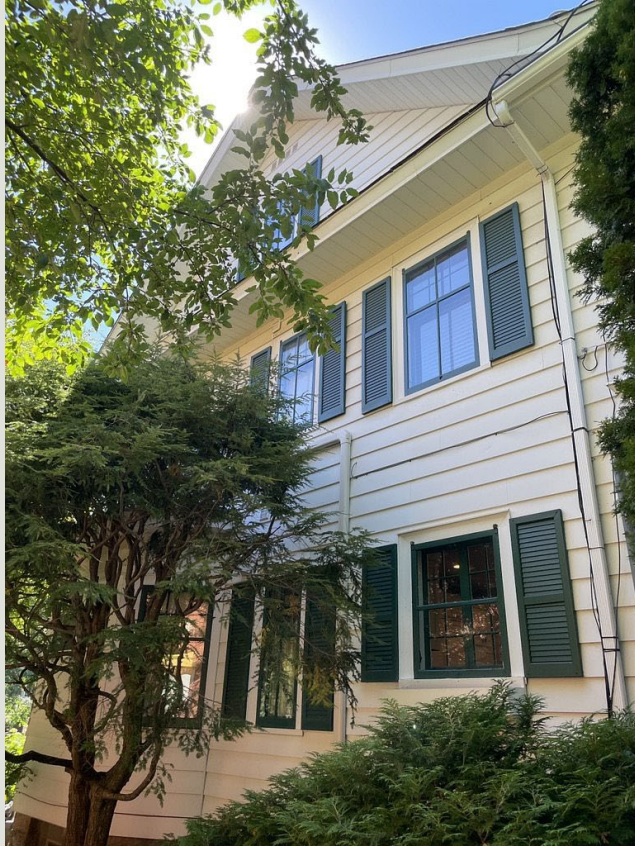
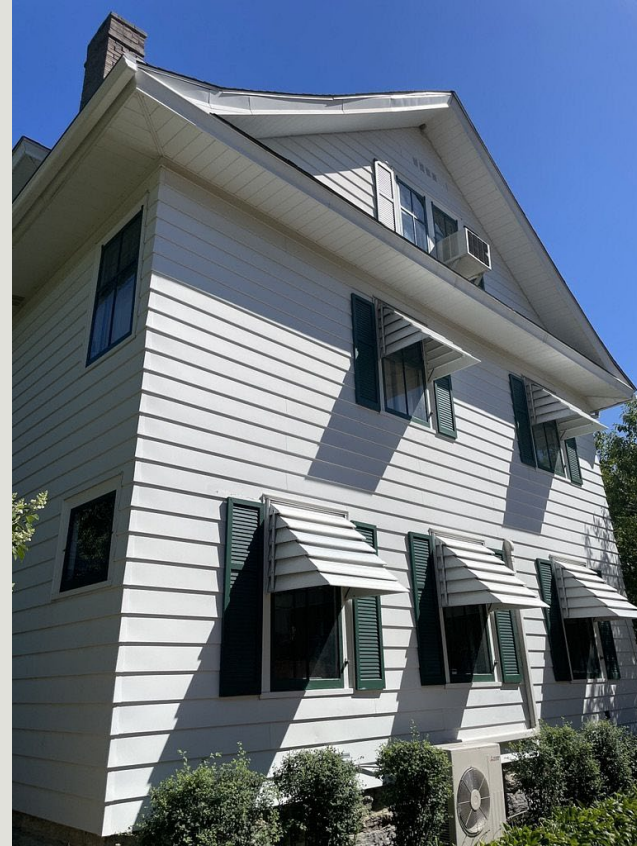
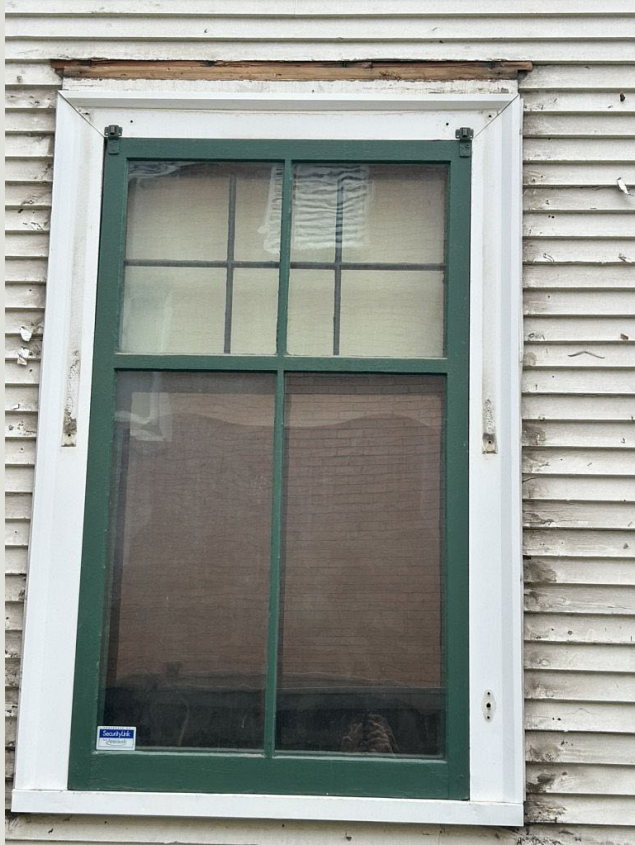
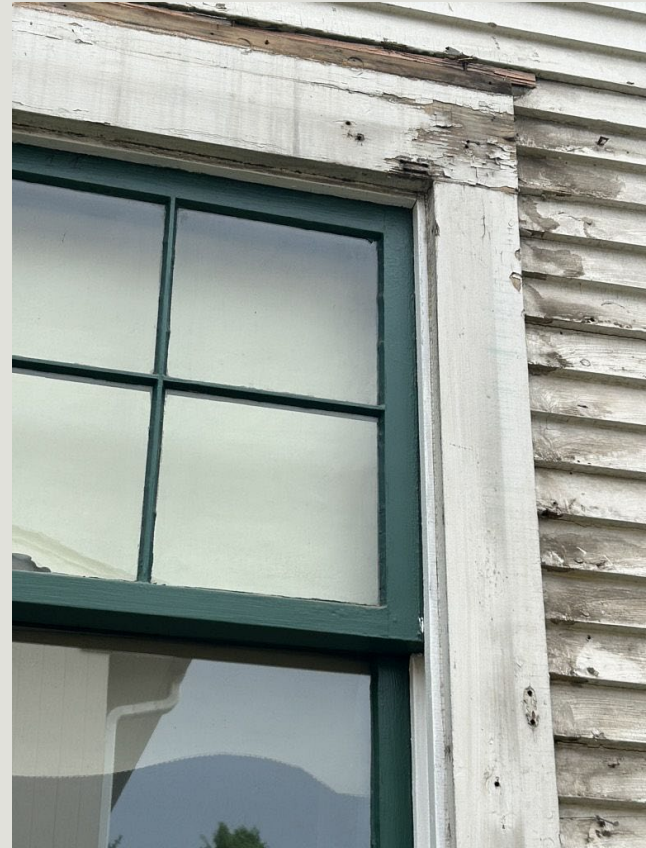
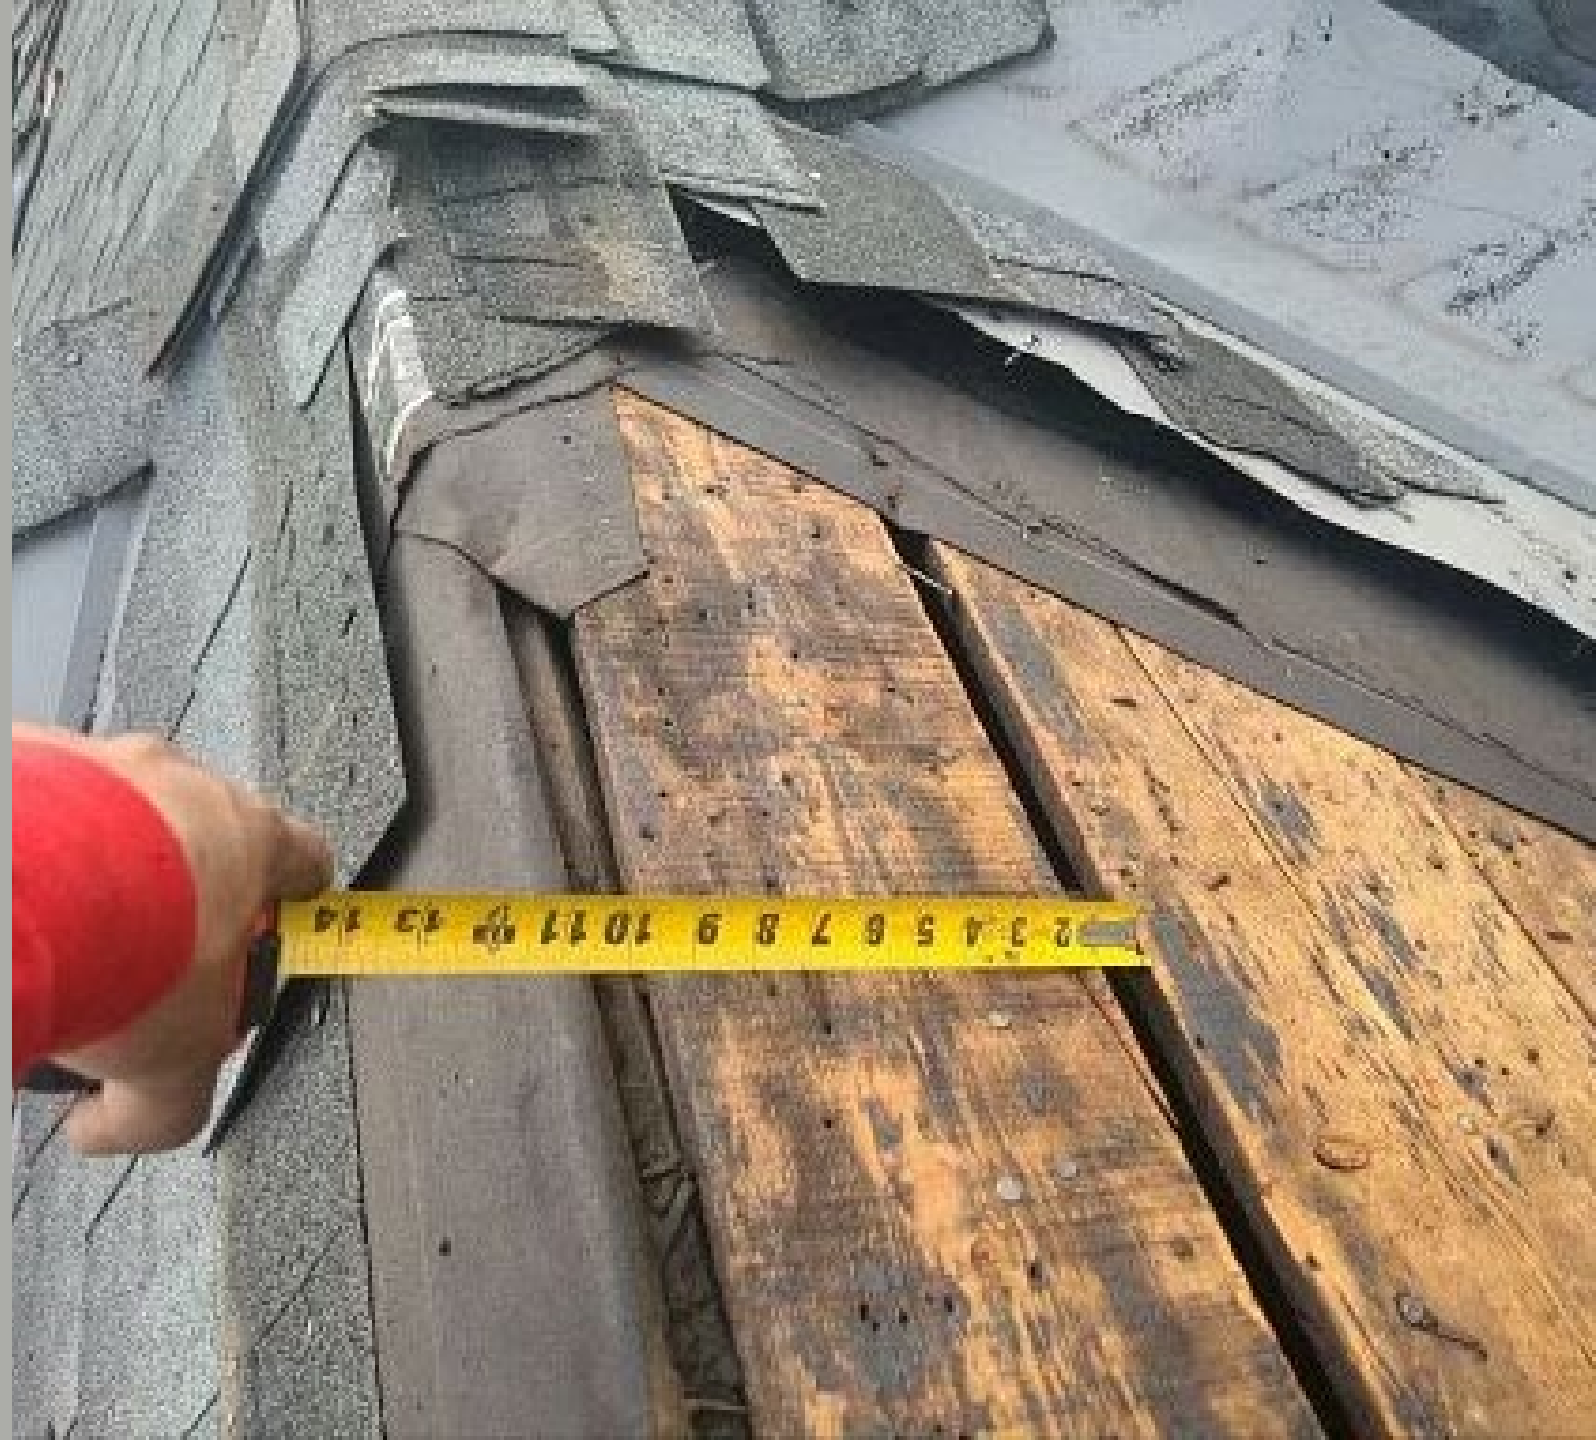
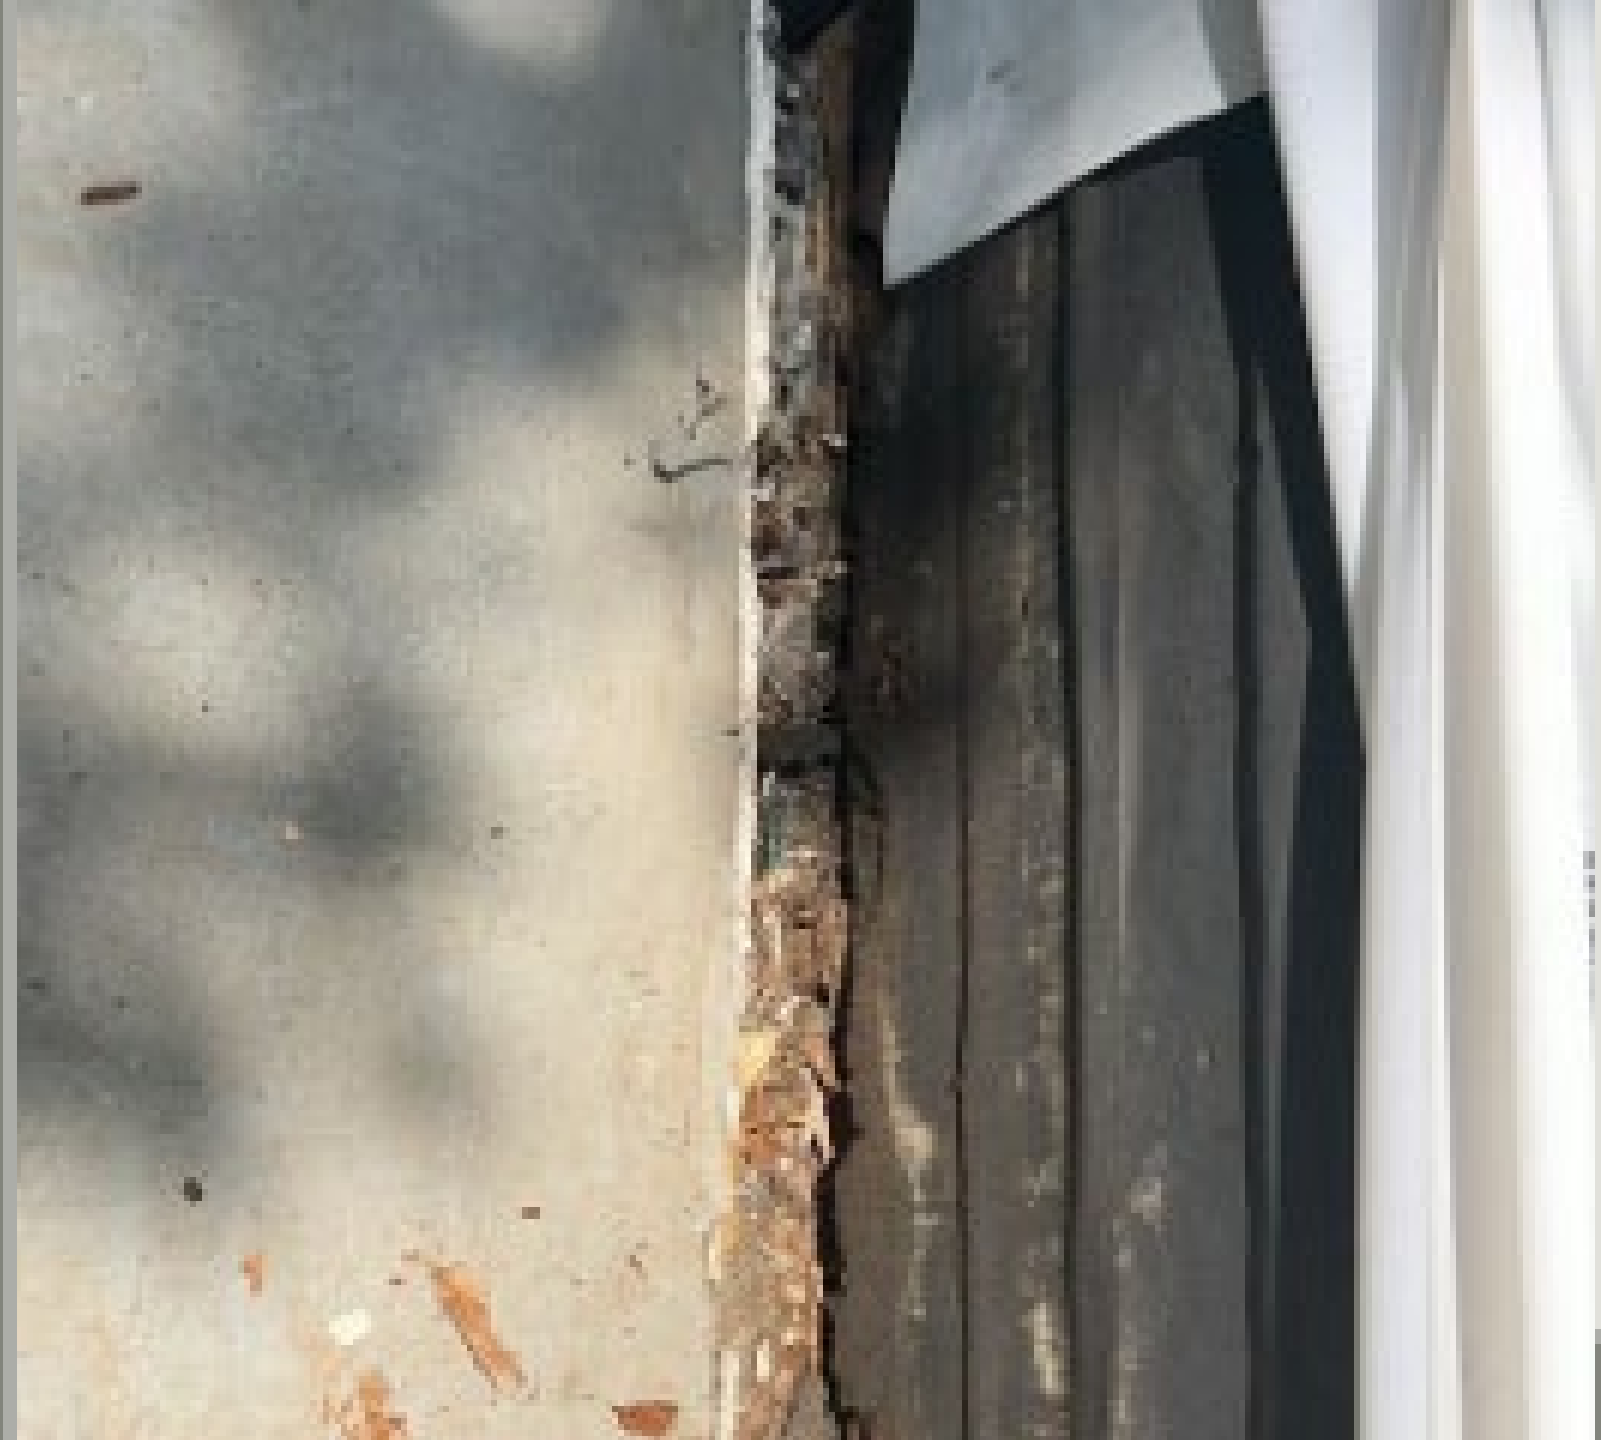
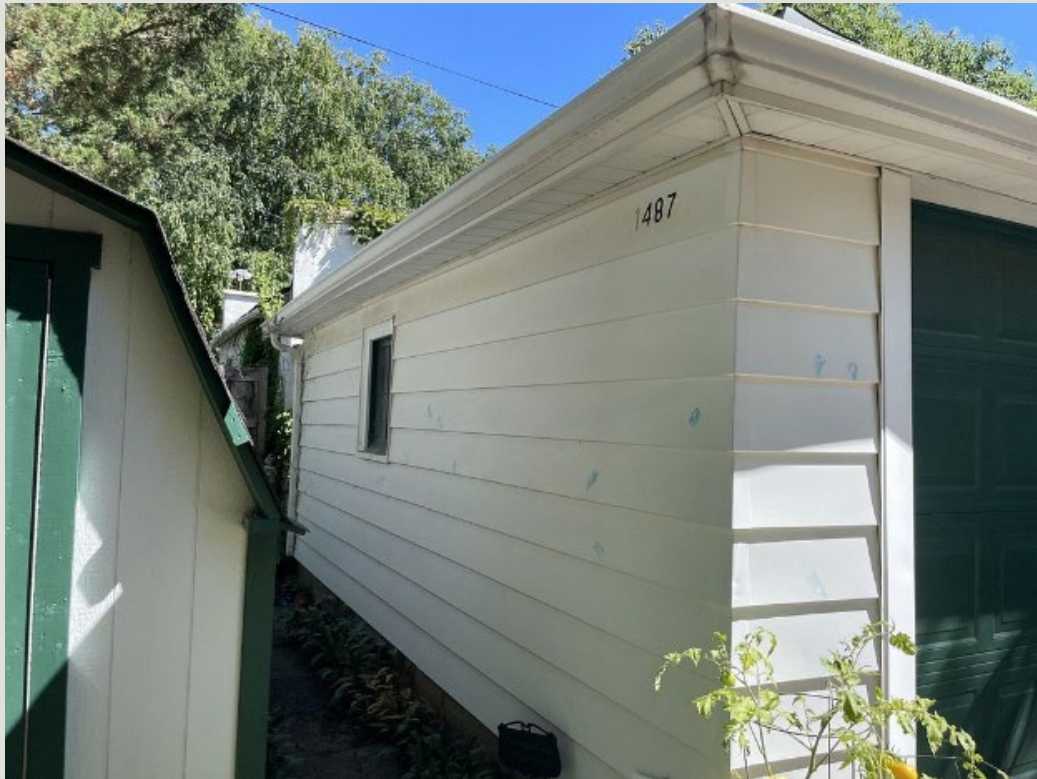
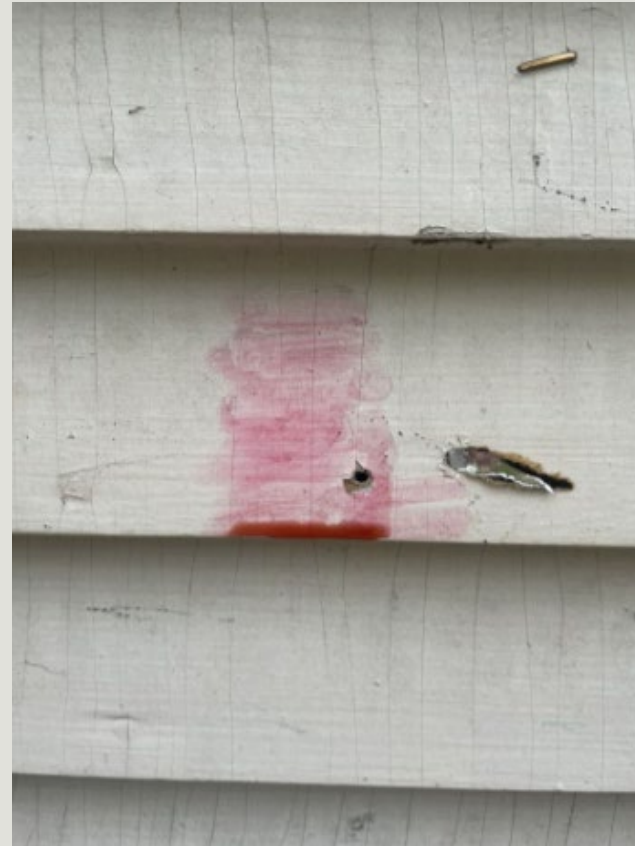
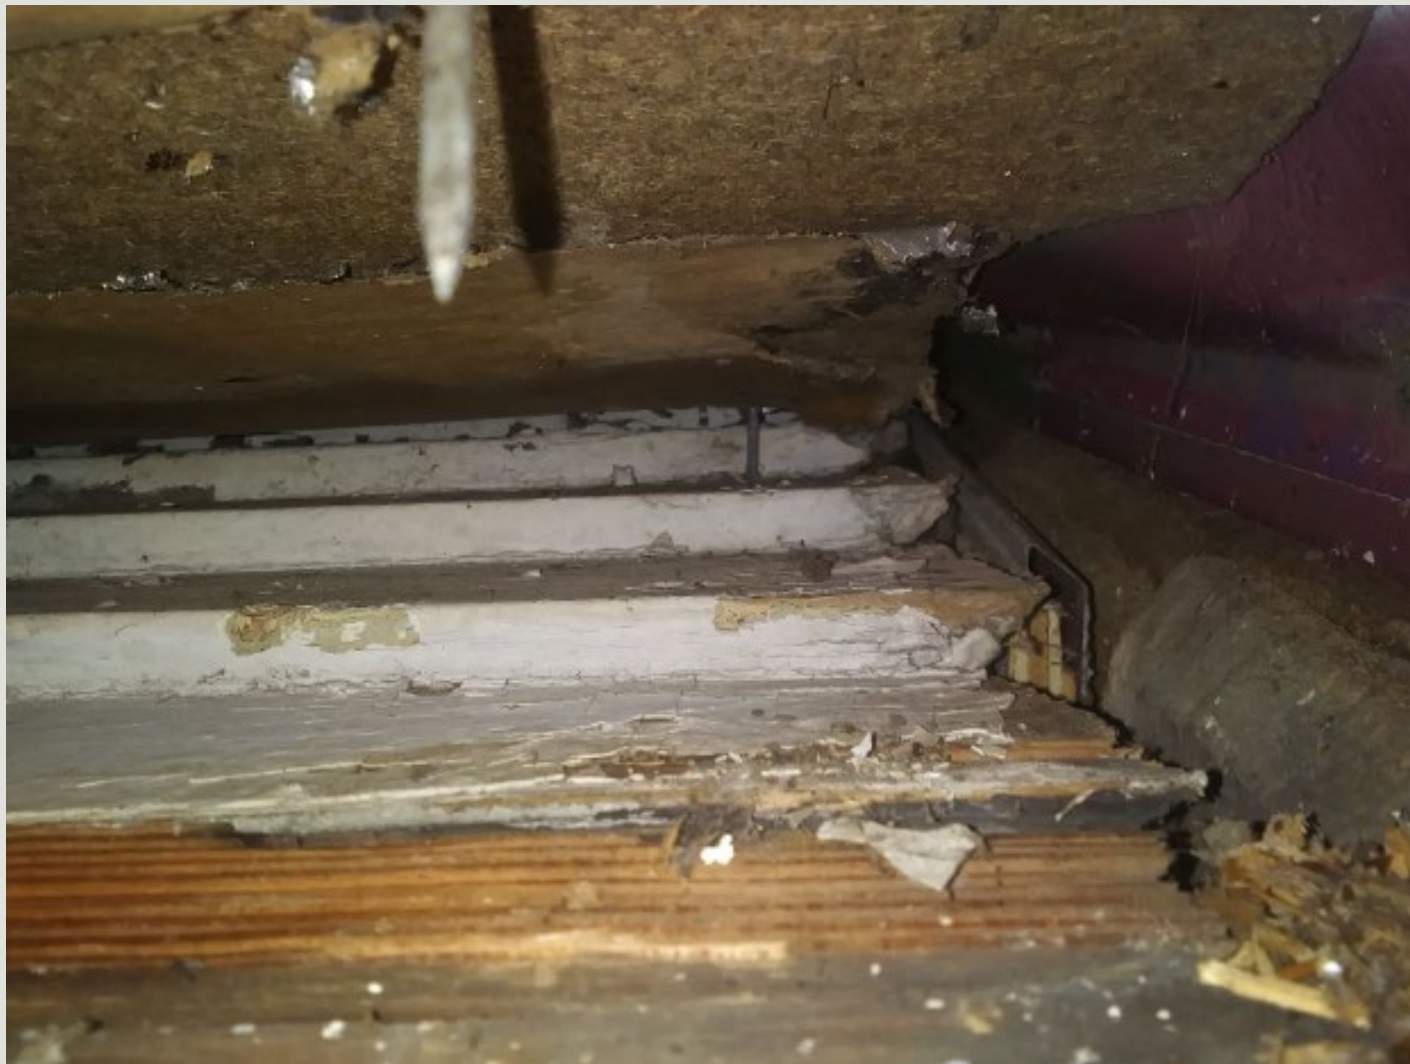
# Before

This customer reached out after storm damage to the aluminum siding and roof of their 118-year-old historic home.

When the aluminum siding was removed, another layer of aluminum siding was found underneath. This layer had a reveal that more closely matched the new siding selected, but the presence of lead required abatement and time to address.

For this particular project, James Hardie lap siding with a 4-inch reveal was selected in a white finish, similar to the previous color of the home. White lap siding is a classic and timeless aesthetic, especially when working on a historical home.

The storm also caused damage to the roof, and as a part of reroofing the home, all decking was overlaid with oriented strand board to meet current code and manufacturer specification requirements.
