Honoring the Architect

The primary objective for these homeowners was to restore and update this architect-designed, mid-century modern gem, while staying faithful to its timeless character. Originally designed in 1969 and built by the architect as a personal residence at the edge of the Mississippi, the home was now in disrepair. Even so, they saw tremendous potential in making it an architectural marriage of old and new.

Synopsis

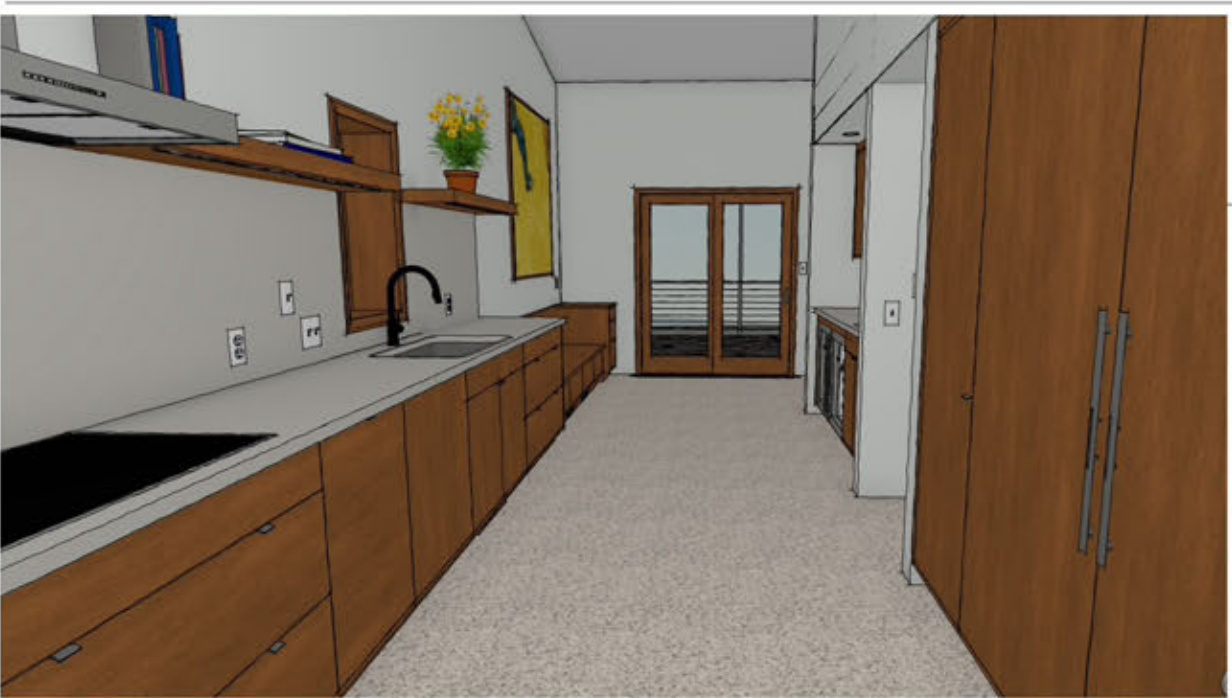
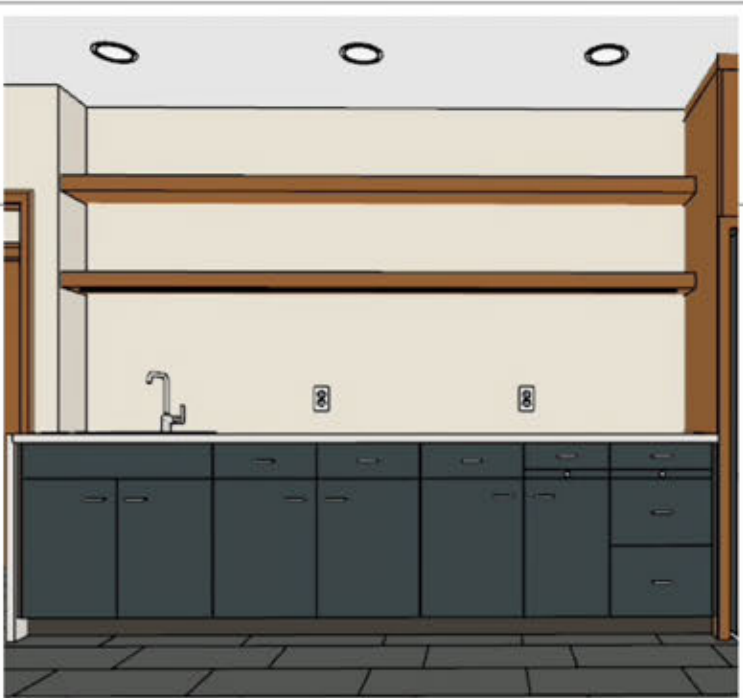
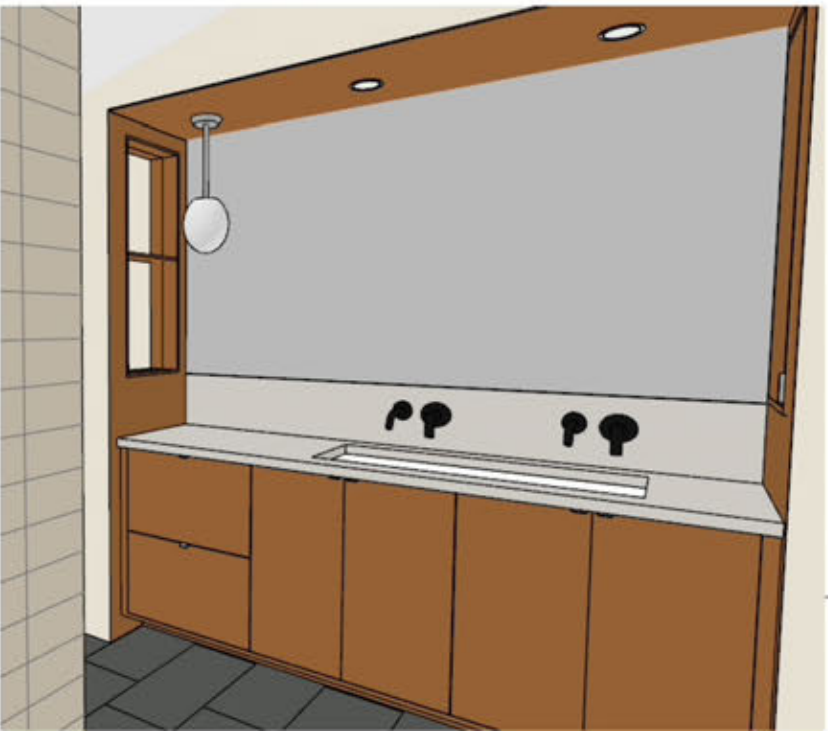
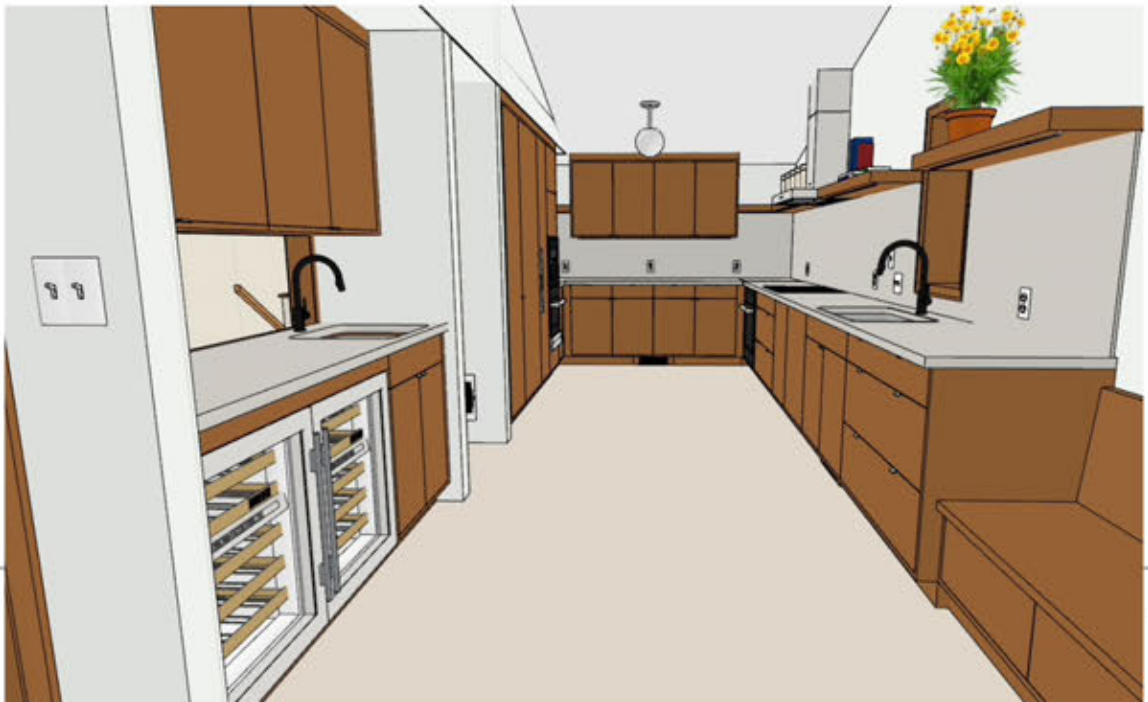
PROPOSED PLAN

PROJECT NOTES	
1	REMOVING EXISTING GAS LINE FOR HXK & RANGE
2	EXISTING WINDOW NOT MOVING
3	REMOVING EXISTING HOOD VENT FOR HXK & VENTING
4	REMOVING WALL BETWEEN HXK/PANTRY & KITCHEN
5	REMOVING EXISTING CHASE
6	AFFLIANCES IN FULL CABINET MICROWAVE CAPPUCINO MAKER STEAM OVEN HOT PLATE / WARMING DRAWER
7	REUSE ALL EXISTING DOORS & FRAMES, OR REUSE DOOR SLABS FOR NEW SOCKET DOORS. EXISTING DOORS ARE 34" TALL AND 1-3/4" THICK. DOORS OVER CARPETED AREAS ARE TRIMMED TO CLEAR.
8	EXISTING CABINETRY AT DINING ROOM BUFFET - NEW COUNTER TOP & BACK SPLASH
9	NEW COUNTER TOP MATERIAL ON FIRE PLACE HEARTH
10	REMOVE HALL TO BATHBED ROOM. REMOVE DROP CEILING AND MATCH SLOPE OF CEILING IN BATH ROOM AREAS.
11	EXISTING REGISTER BEING RELOCATED UNDER THE VANITY
12	REMOVING SUBFLOOR & SETTING BETWEEN JOIST FOR ZERO CURB WITH A LINEAR DRAIN
13	CONTINUE THICKNESS OF MET WALL BEHIND VANITIES (FR. CUT EXISTING WALL)
14	HARDWARE ELEC. TOWEL RACK OVER TOILET

15	RELOCATE DOOR INTO OWNERS BATH
16	REMOVE WALLS FOR EXISTING CLOSET
17	HEATED FLOOR IN OWNERS BATH
18	TUB ACCESS PANEL 30" W X 15" H
19	NEW PLUMBING DRAINS FOR BATHROOMS ABOVE TO STAY ABOVE EXISTING DUCT WORK AND THEN RUN ALONG WALL TO MAIN STACK
20	NEW DIRECT VENT WATER HEATER (IN ORDER TO REMOVE CHASE IN KITCHEN)
21	RE-USE EXISTING DRIER VENT FOR NEW DRIER
22	LOWER BATHROOM FLOOR REGISTER TO BE ELIMINATED. SUPPLY FOR SHOWER / SAUNA AREA TO BE RELOCATED TO WALL REGISTER. REGISTER TO BE HIGH ON WALL NEAR CEILING.
23	RECESSED DRIER VENT RUN INTO UTILITY ROOM TO EXTERIOR
24	RELOCATING ALL EXISTING HOSE SHUT-OFFS TO IN SIDE UTILITY ROOM
25	RELOCATING THE TOILET
26	FULL CABINET SHOULD BE COVERING THE END IN-SLAB FLOOR REGISTER
27	EXISTING VENT FOR BATHROOM & BAR AREA ALONG WALL. 2X4 WALL SHOULD COVER THEM IF NOT RELOCATED

PROJECT NOTES	
28	EXISTING SINK BEING RELOCATED TO WHERE EXISTING WASHER & DRIER WERE
29	EXISTING HVAC DUCT WORK ROUGHLY IS 3" DEEP X 30" WIDE & IS 64" OFF SLAB & GOES TO CEILING
30	EXISTING HVAC CHASE 2X WALL REPLACED WITH A 2X4 WALL
31	DISASTER PAN UNDER WASHER RUN INTO UTILITY ROOM
32	BENCH IN LOWER VANITY
33	ACCESS PANEL TO 4" PLUMBING MAIN STACK
34	ACCESS PANEL FOR HOSE SHUT OFF
35	WATER HOOK-UP FOR WASHER

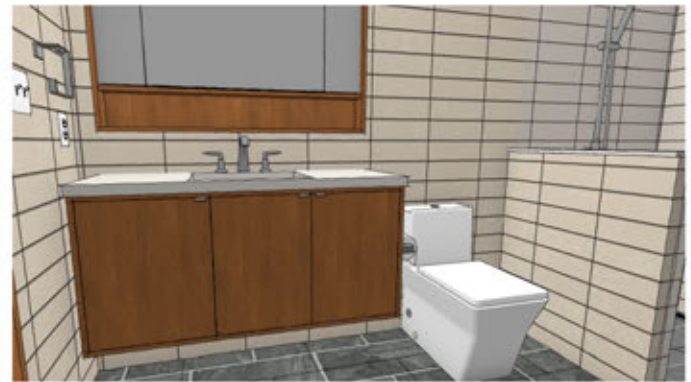
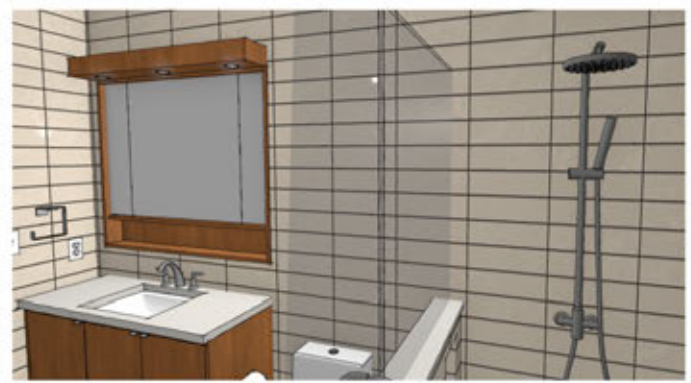
FULL BATH MAIN LEVEL

FULL MAIN BATH

MAIN LEVEL BATHS. The owners' bathroom had been poorly updated with a low-quality vanity and epoxy countertop, which resembled partially digested seafood on a sea of Pepto-Bismol. Ice dams had caused significant water damage to the ceiling and exterior walls. The hall bathroom had a tiny shower and tradition-style, freestanding vanity.

MAIN LEVEL BATHS. In the owners' bathroom, we eliminated the door dividing the toilet and shower and relocated/converted the swing door to a pocket door, gaining significant usable space. A custom vanity, hidden medicine cabinet and passthrough shelving, heated soaking tub, in-floor heat, and smart toilet turned this space a private spa. By reconfiguring the entryways to the hall bathroom and bedroom, we added enough space to create a luxurious $\frac{3}{4}$ bath with curbless shower and floating vanity. The custom medicine cabinet added lighting, storage, and the timeless character specified by the homeowners.

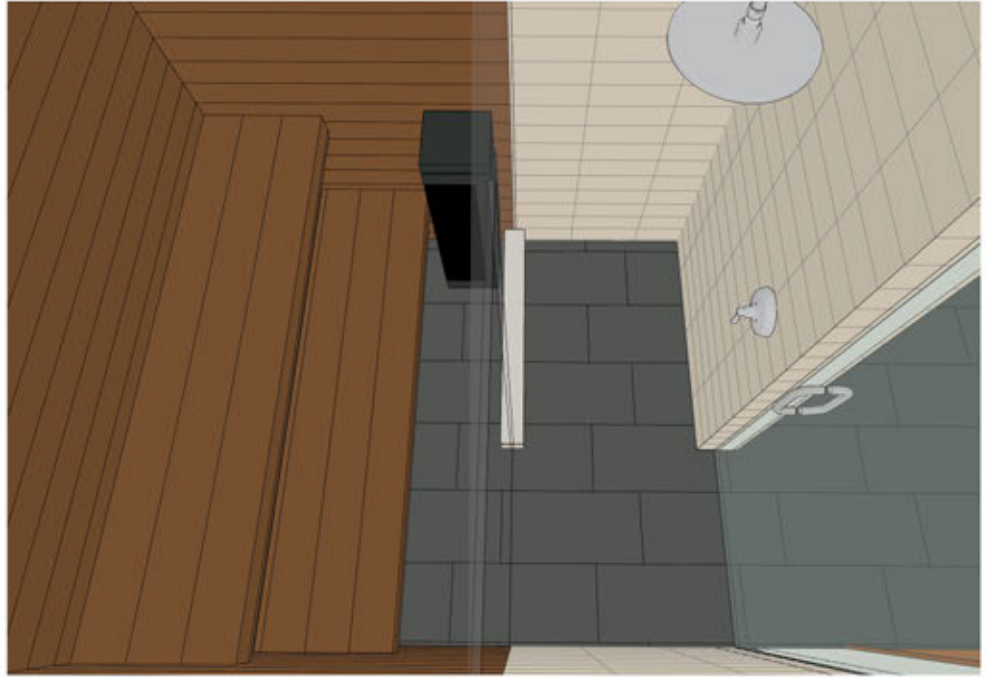
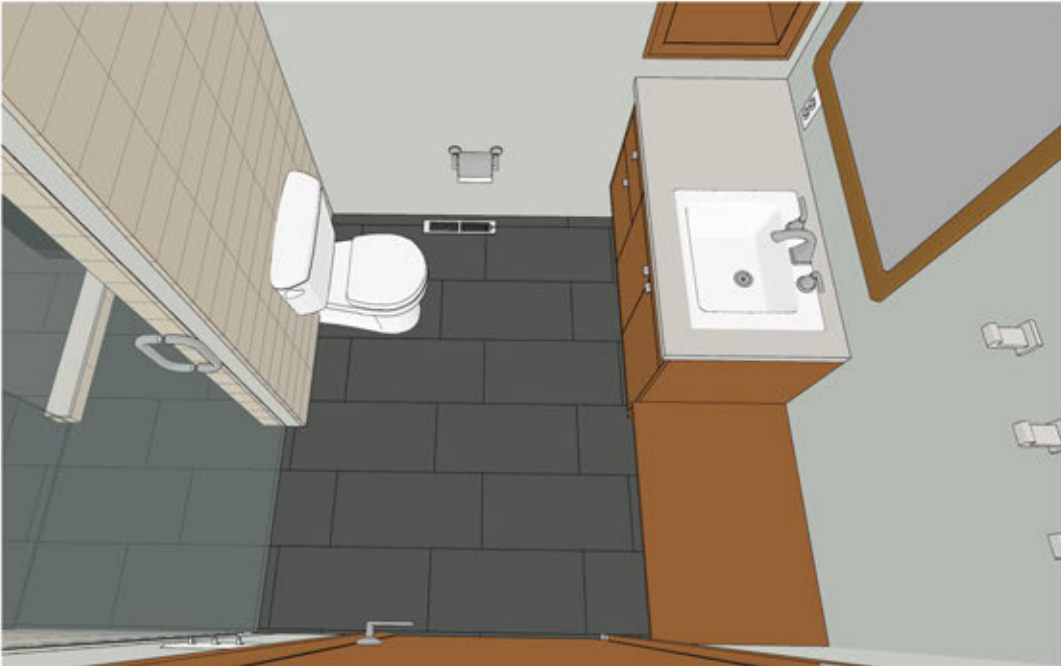
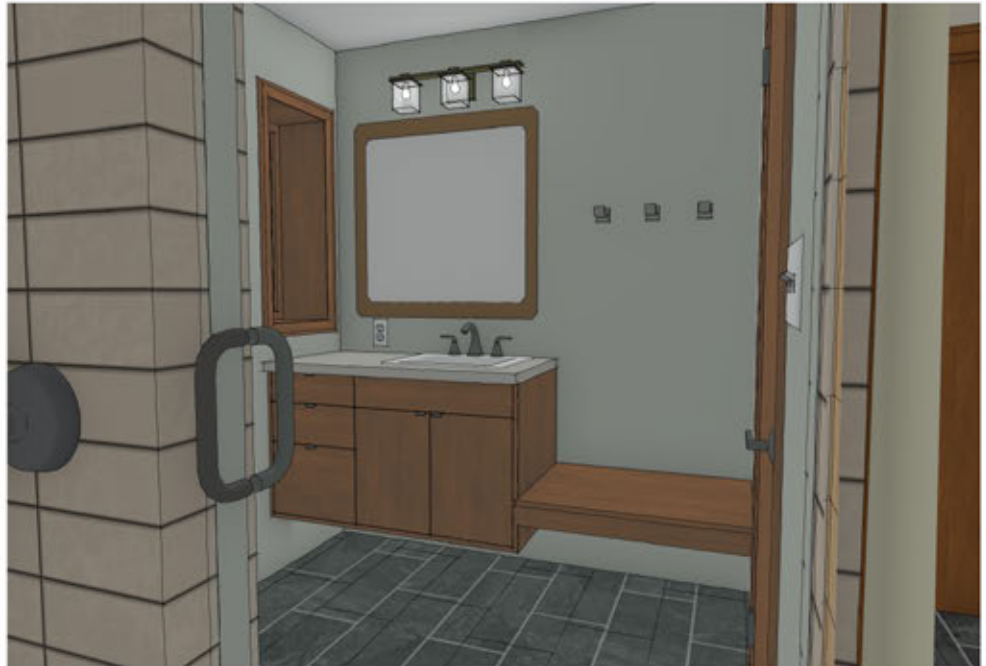
LOWER-LEVEL BATH & SAUNA

LB1 - LOWER BATHRM - SAUNA
SCALE: 3/8" = 1'-0"

LB2 - LOWER BATHROOM
SCALE: 3/8" = 1'-0"

Lower-level—Re-design bathroom and create sauna, which was imagined but never built by the owner/architect; create wet bar/kitchenette and laundry closet.

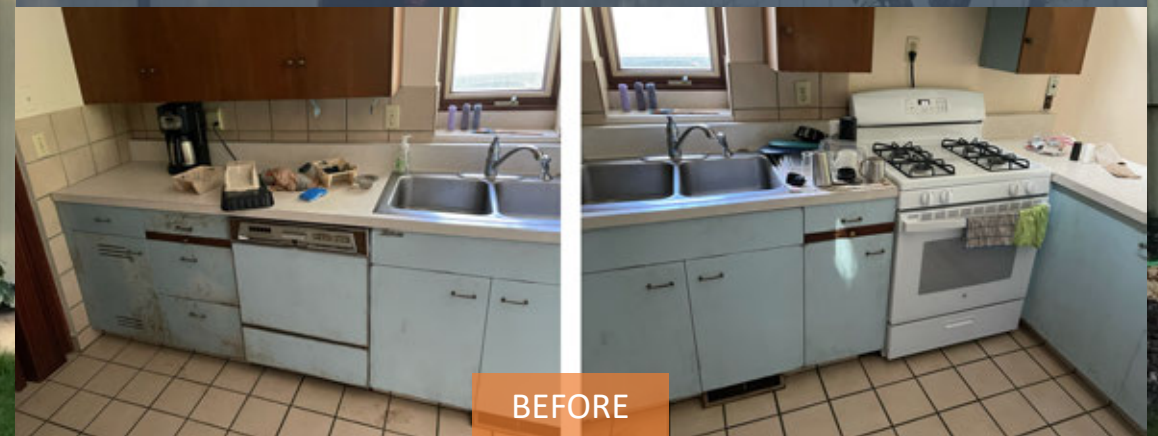
STRUCTURAL. During demo, we found a 30-foot section of load bearing, exterior wall/floor system had been built without adequate support to the foundation. Urgent redesign and city approval was needed to minimize delays. The existing hot roof provided only R-25 insulation value and had caused significant ice damming & water infiltration.

KITCHEN. Cabinetry was in poor condition, layout was dysfunctional, and appliances had been “updated” with low quality units. A sink leak had rusted through the bottom of the steel cabinet and damaged the ceiling and walls of the bathroom below. A giant 300 lbs. 8-foot commercial wok, range hood and roof vent from the kitchen had to be carefully removed.

TERRAZZO FLOORING. Creating/Installing terrazzo floor in the entryway and kitchen encountered design and structural problems with the floor support system.

STRUCTURAL. Working with building officials, we built an exterior wall, bearing on the existing brick ledge, to support the existing exterior wall and framed for new window openings. Spray foam was installed in problem areas of the roof system.

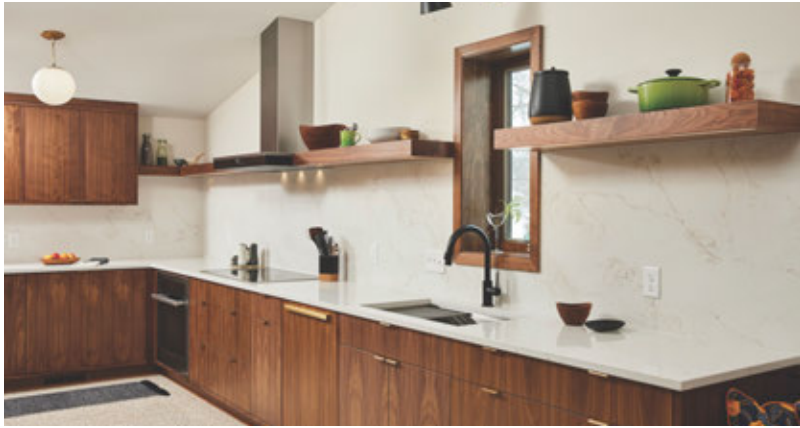
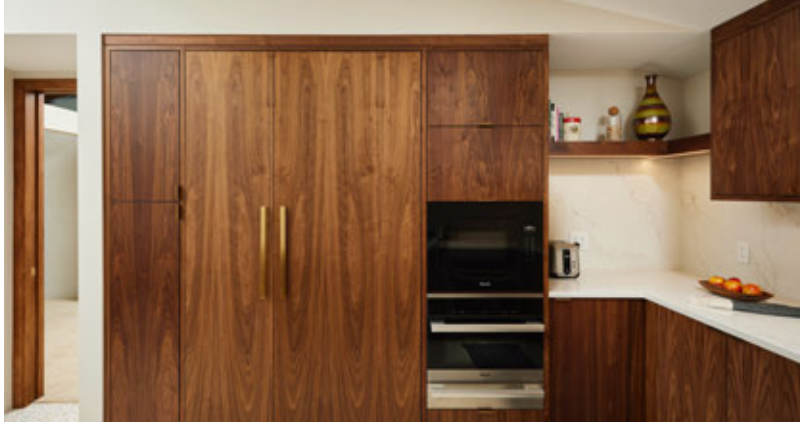
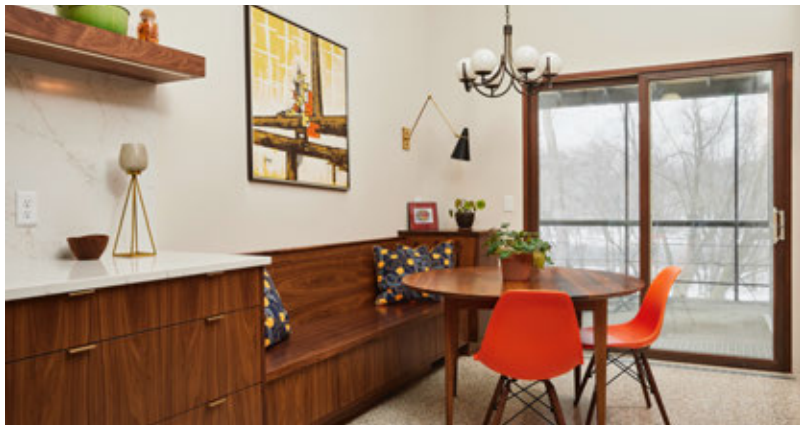
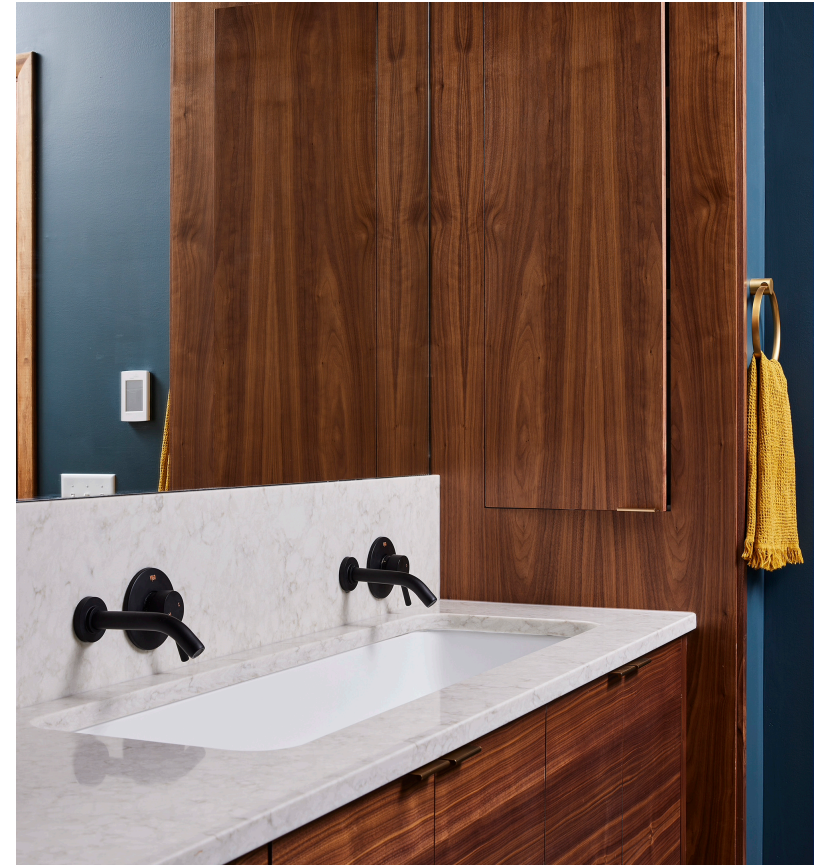
WET BAR. Like the sauna, the wet bar/kitchenette had been imagined by the architect, but never realized, and needed to utilize recovered cabinetry from the kitchen.

LOWER-LEVEL BATH & SAUNA. Planned but never realized, the bathroom space needed reconfiguring to accommodate the sauna, and maintain functionality and code-compliance.

LAUNDRY. The laundry had been relocated into the utility room with a 54" ceiling height under the split-entry floor system. It was dark and claustrophobic.

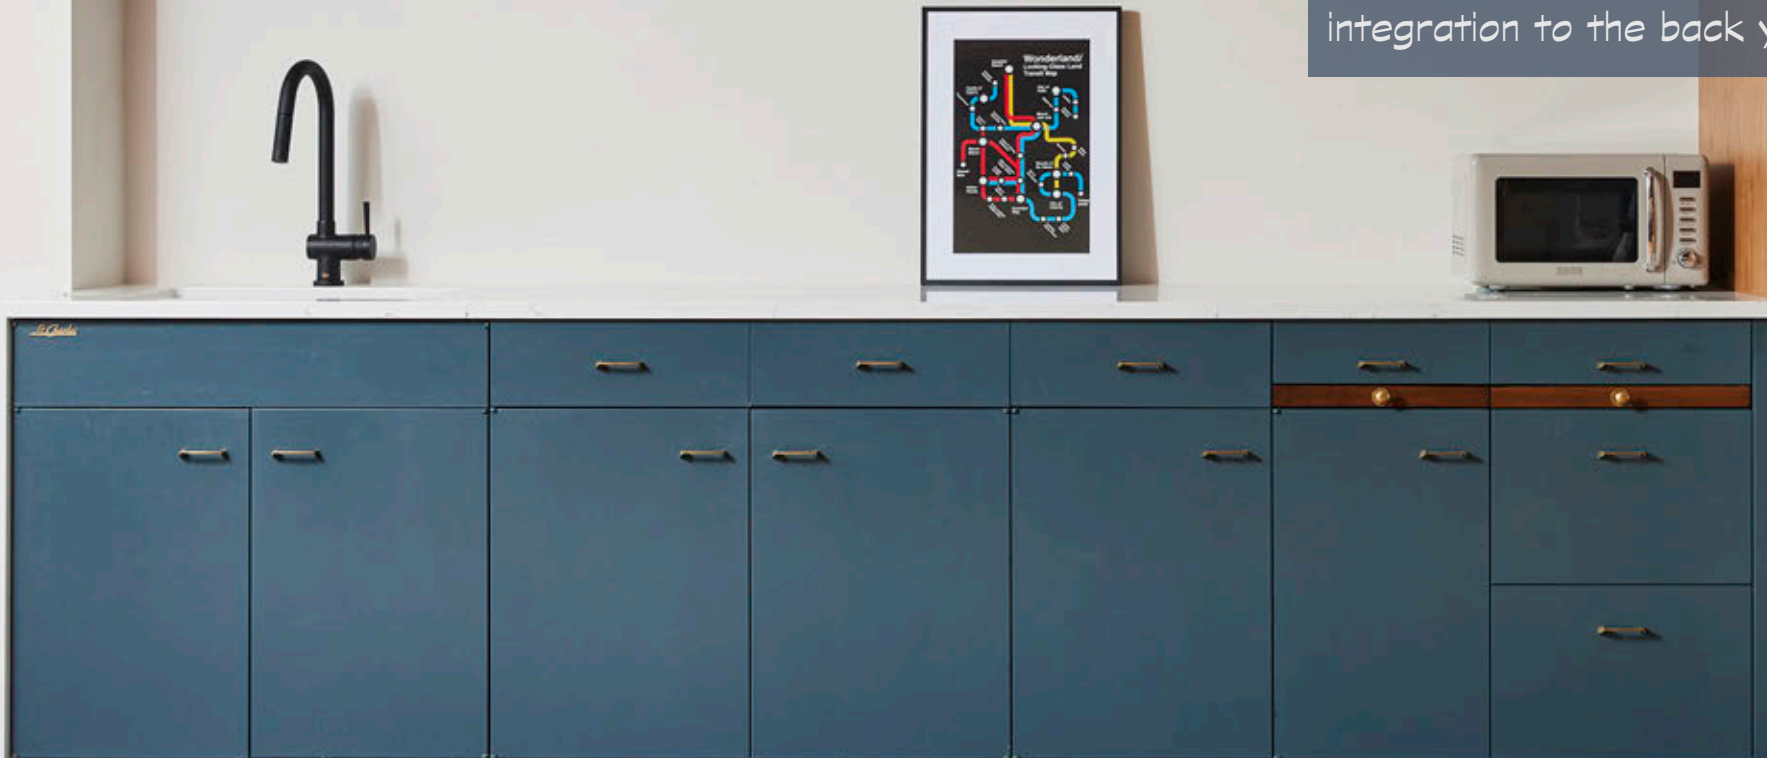
SALVAGED ITEMS. We carefully removed doors, cabinets, and the owners' bathroom sink. We painstakingly disassembled, stripped, and restored each item to like-new condition AND repurposed them in the lower-level wet bar.

WET BAR / KITCHENETTE. A mix of restored kitchen cabinetry and new custom cabinetry, floating shelves with integrated lighting, and waterfalled countertops fulfills the original vision of the architect. Tile flooring was chosen throughout the new lower-level spaces to provide durable integration to the back yard and patio spaces.

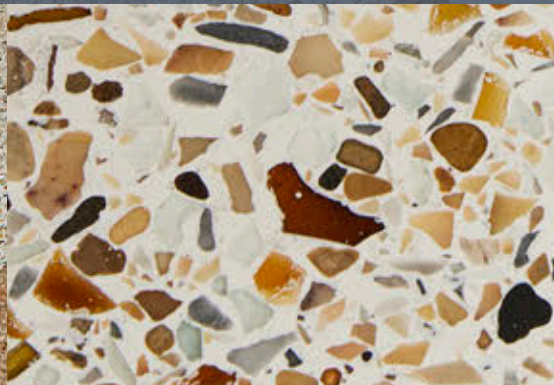
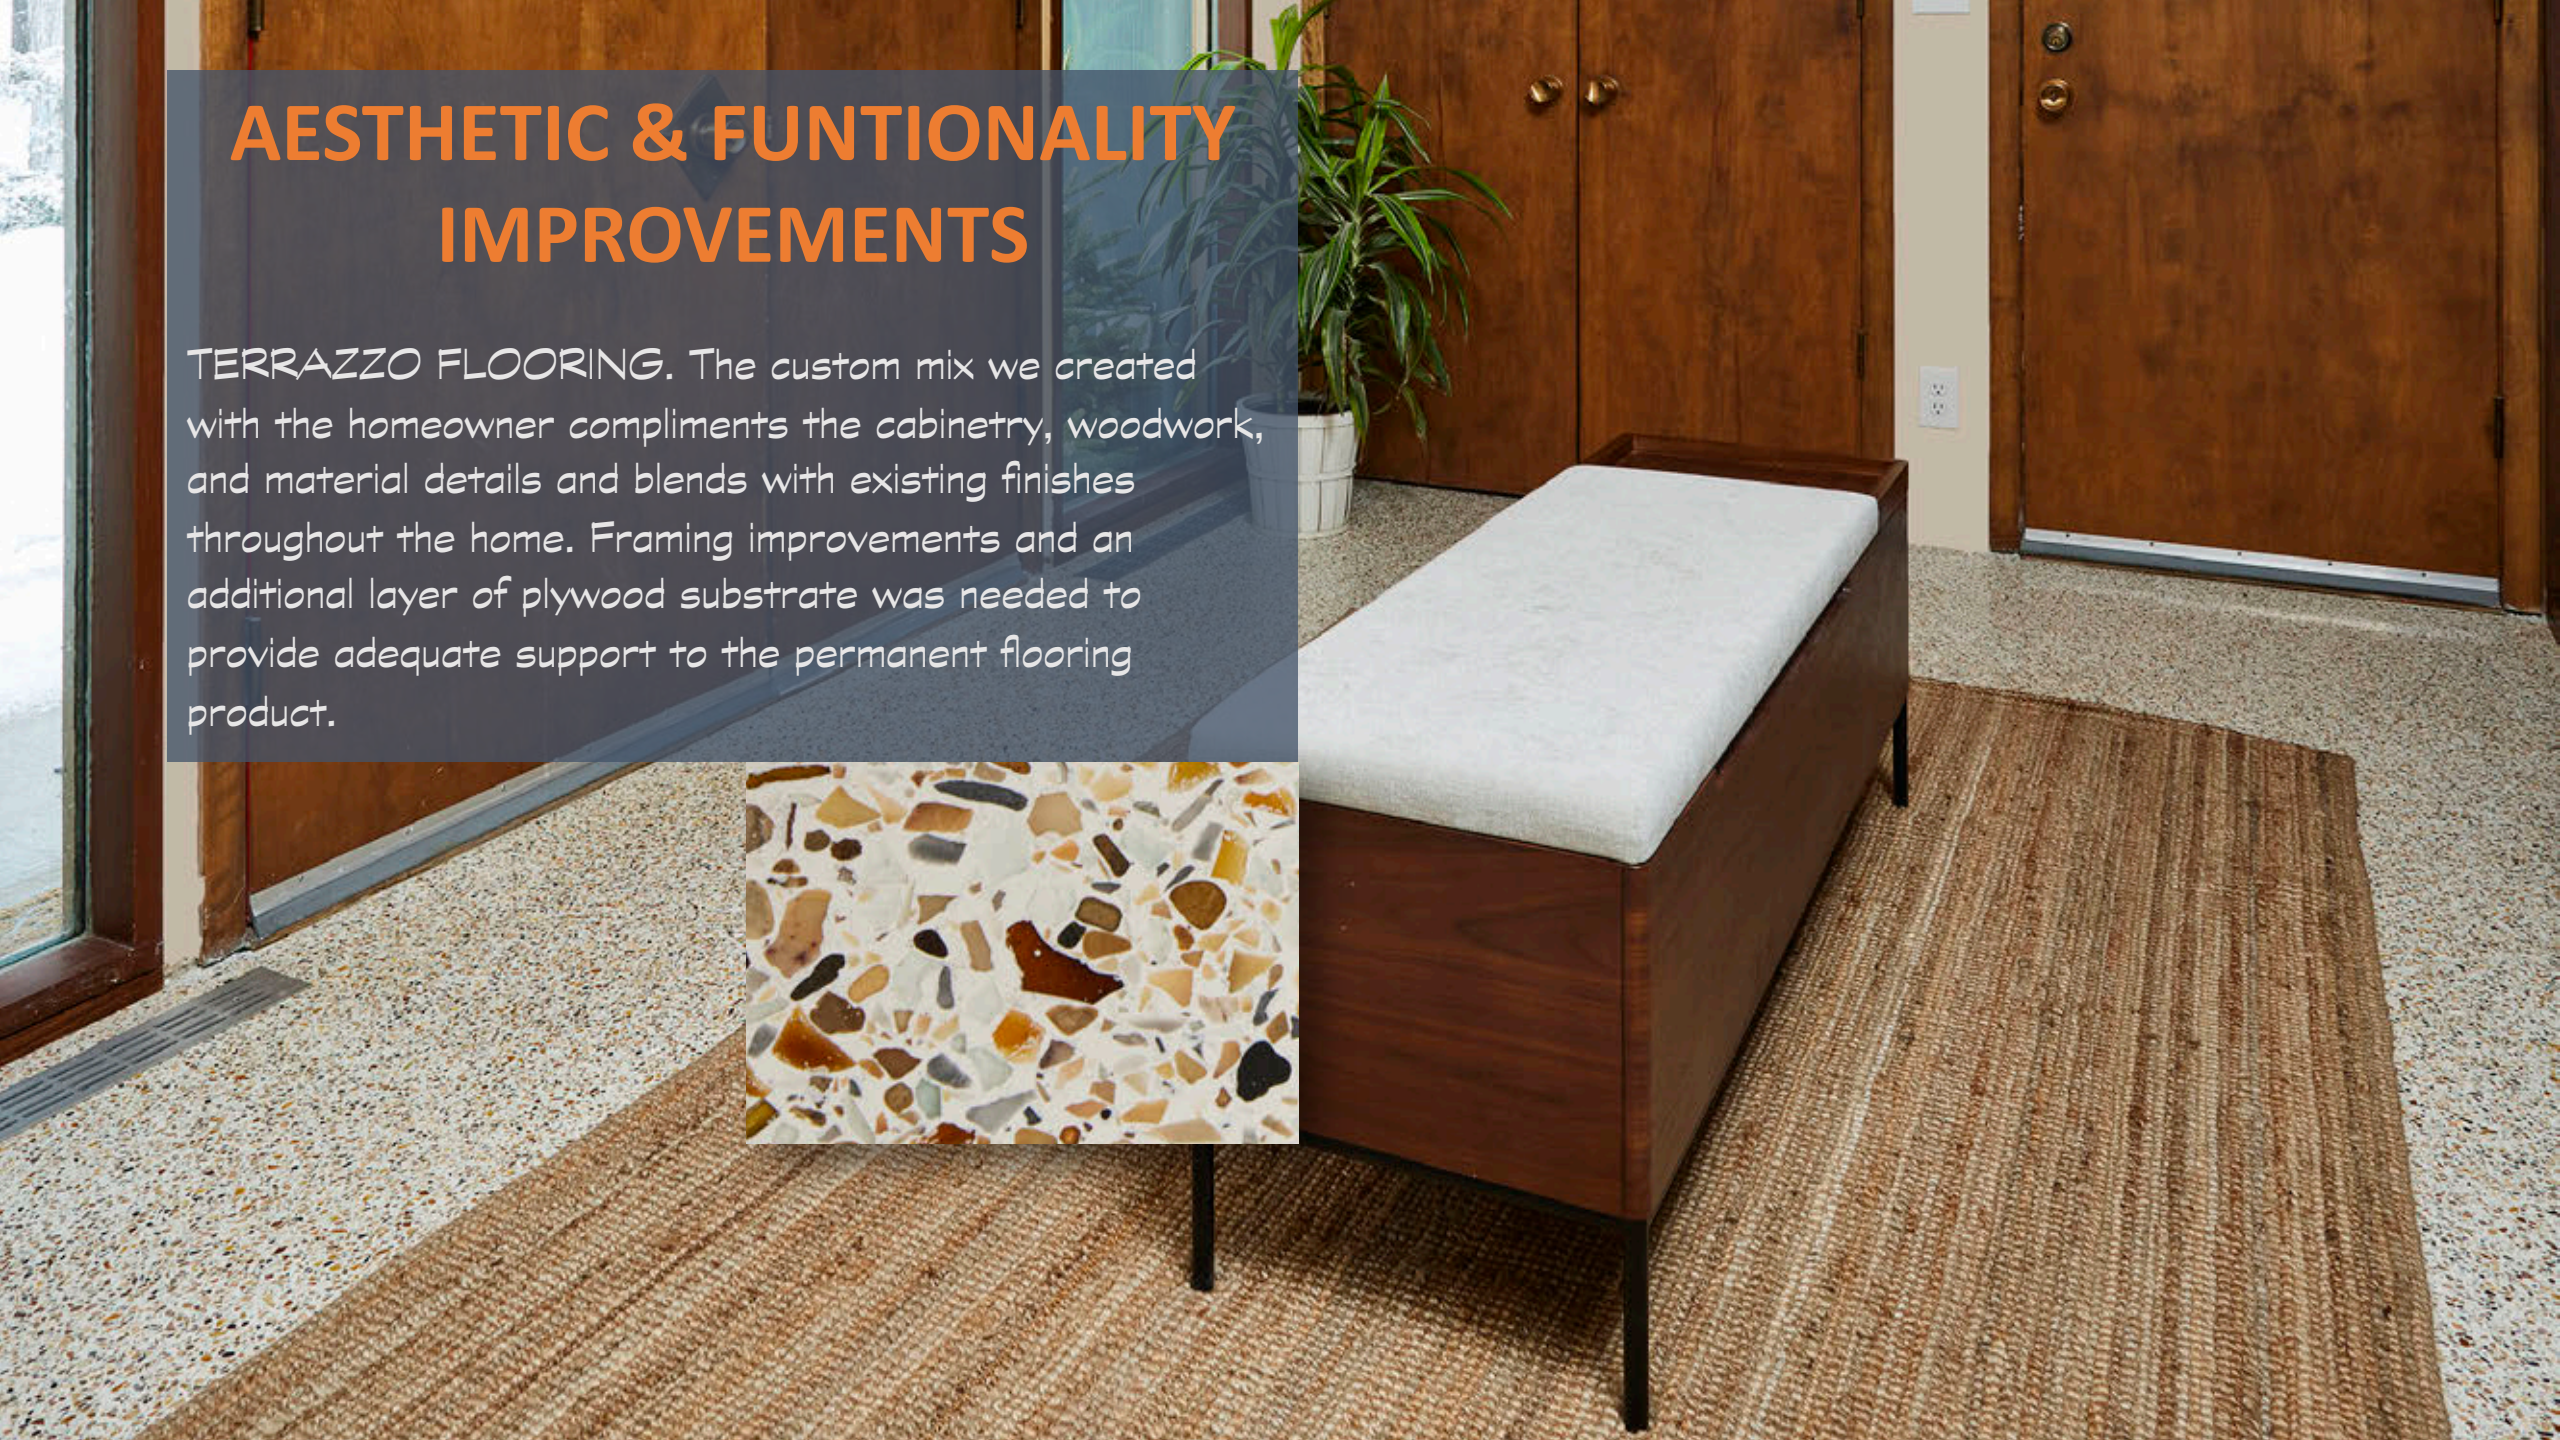
TERRAZZO FLOORING. The custom mix we created with the homeowner compliments the cabinetry, woodwork, and material details and blends with existing finishes throughout the home. Framing improvements and an additional layer of plywood substrate was needed to provide adequate support to the permanent flooring product.

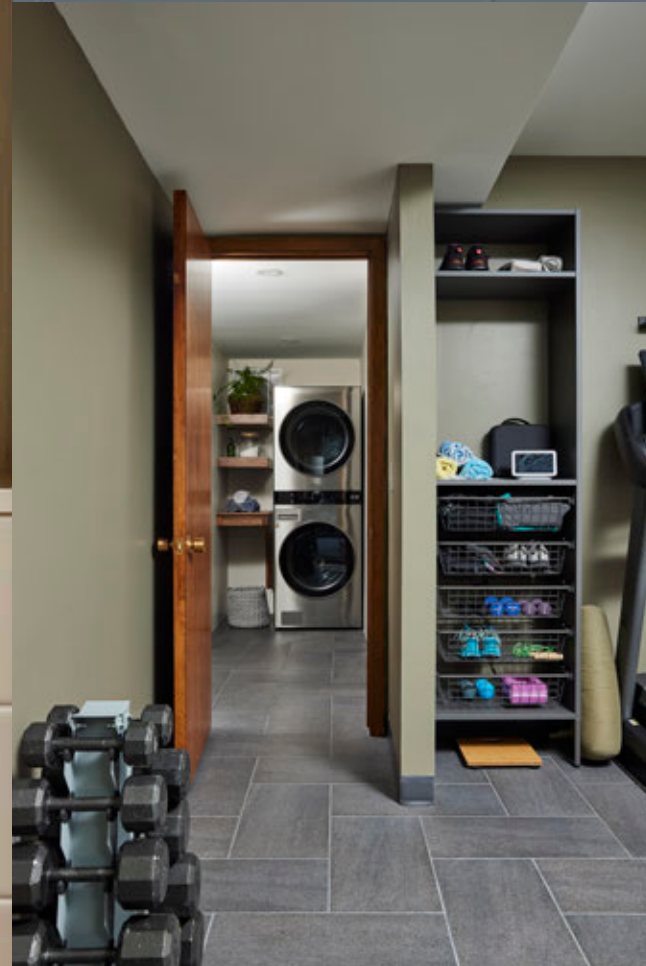
LAUNDRY. An unused niche between the workout room and sauna perfectly houses the new laundry closet.
