## Flat Rock Dam Betterment Project: Reconnecting the Manayunk Canal

PA AWWA Southeast District Fall 2024 Joint Technical Conference

# Project Background and History

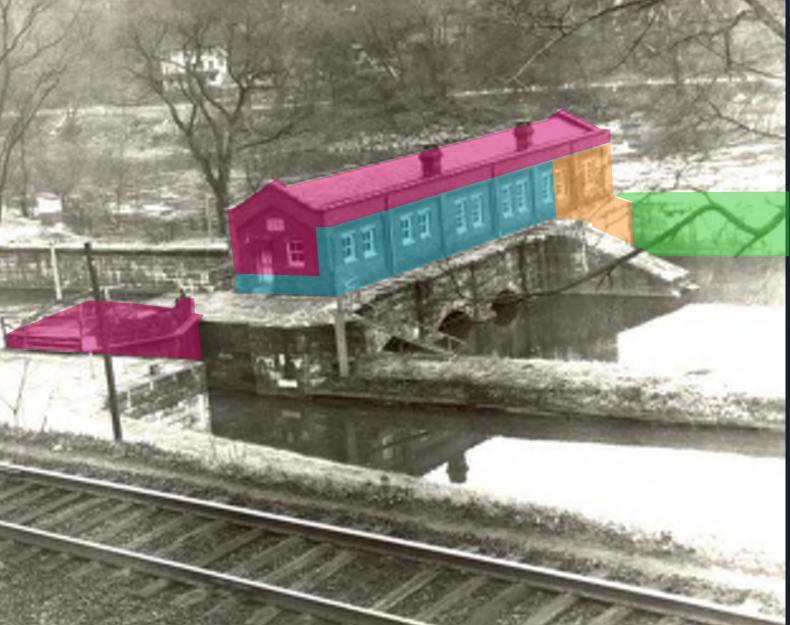
No Longer Exists

Extremely Deteriorated

Conflicts With New Configuration

**Requires Stability** Improvements

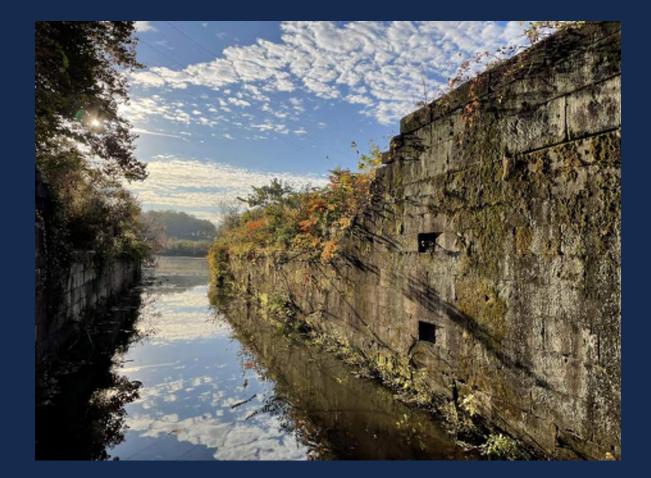
- Spring flow ranges from 3 5 cfs
- Summer flow ranges from 1 3 cfs
- Average velocity of 0.03 ft/s
- **Post-construction conditions:** 
  - Flow ranges between 50 110 cfs
  - Average velocity between 0.3 0.5 ft/s

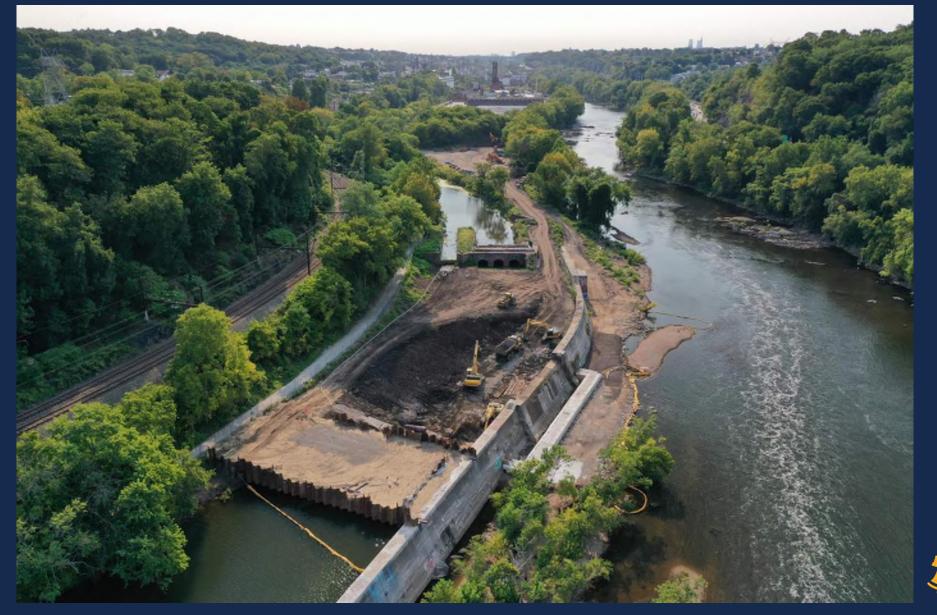
# September 2022 - Excavation of Site

- contractor raised concerns when beginning excavation of accumulated sediment on site
- Characterized soil following PADEP Management of Fill Policy
  - 3 ft. layer of accumulated sediment upstream of Lock 68
  - Clean Fill Concentration Limit exceeded for Arsenic and Cyanide
  - Mass Removed: Approx. 3000 tons
- This discovery resulted in additional costs for disposal of Regulated Fill

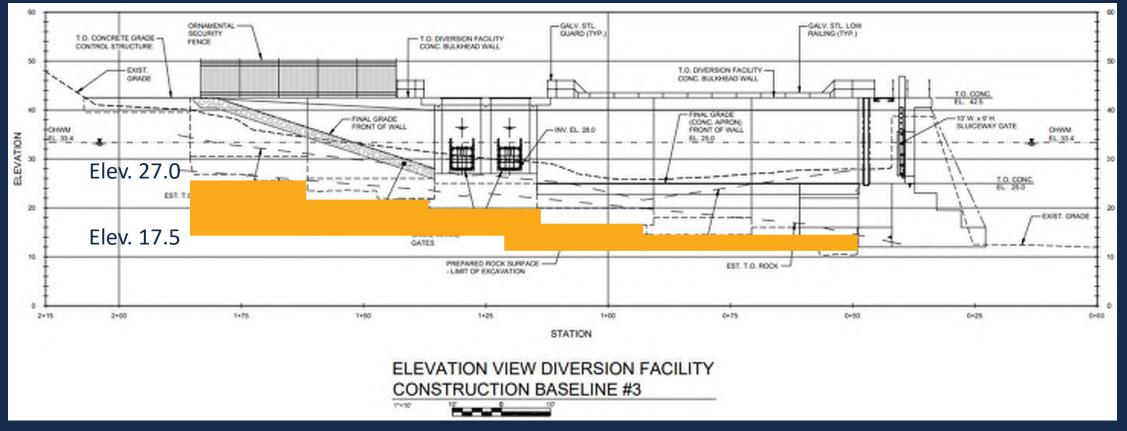
• Resulting in as much as a 10 ft. change in Bulkhead Wall Foundations and Shoring needs for excavation

• To combat the lack of rise in Bedrock Elevation sections of the wall were redesigned to be taller in height. This change resulted in cost increases for rebar, concrete, and support of excavation needs.
