BUILDING PERFORMANCE: HURRICANE ANDREW IN FLORIDA

OBSERVATIONS, RECOMMENDATIONS,
AND TECHNICAL GUIDANCE

FEDERAL EMERGENCY MANAGEMENT AGENCY
FEDERAL INSURANCE ADMINISTRATION

DECEMBER 21, 1992

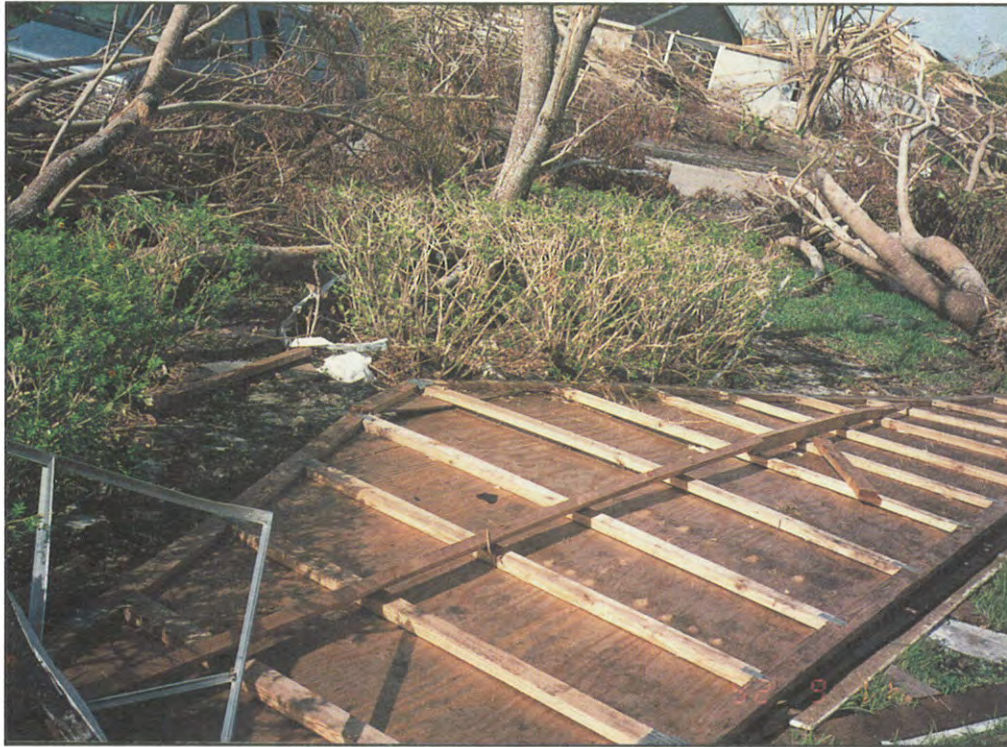
The wood-frame gable ends of roof structures were found to be especially failure-prone. Wood-frame gable ends are effectively a vertical continuation of windward/leeward wall systems and require bracing from within the roof structure for lateral force resistance. A lack of an adequately defined load transfer path for the gable ends was evident. Bracing of the wood-frame gable ends was not performed with the consistency and completeness required to effectively resist and transfer the wind loads in the absence of roof sheathing. This indicates a lack of a clear understanding of the gable sections’ importance to the integrity of the overall structural system during a wind storm by those responsible for the design and construction of such systems. (SEE FIGURES 6 AND 7). The reliance on plywood sheathing to act as the sole stiffener of the roof diaphragm left buildings susceptible to structural damage from roof truss collapse when sheathing separated from the roof trusses.

FIGURE 6. *Entire wood gable separation. Bracing connection, if completed, may have prevented this from occurring.*

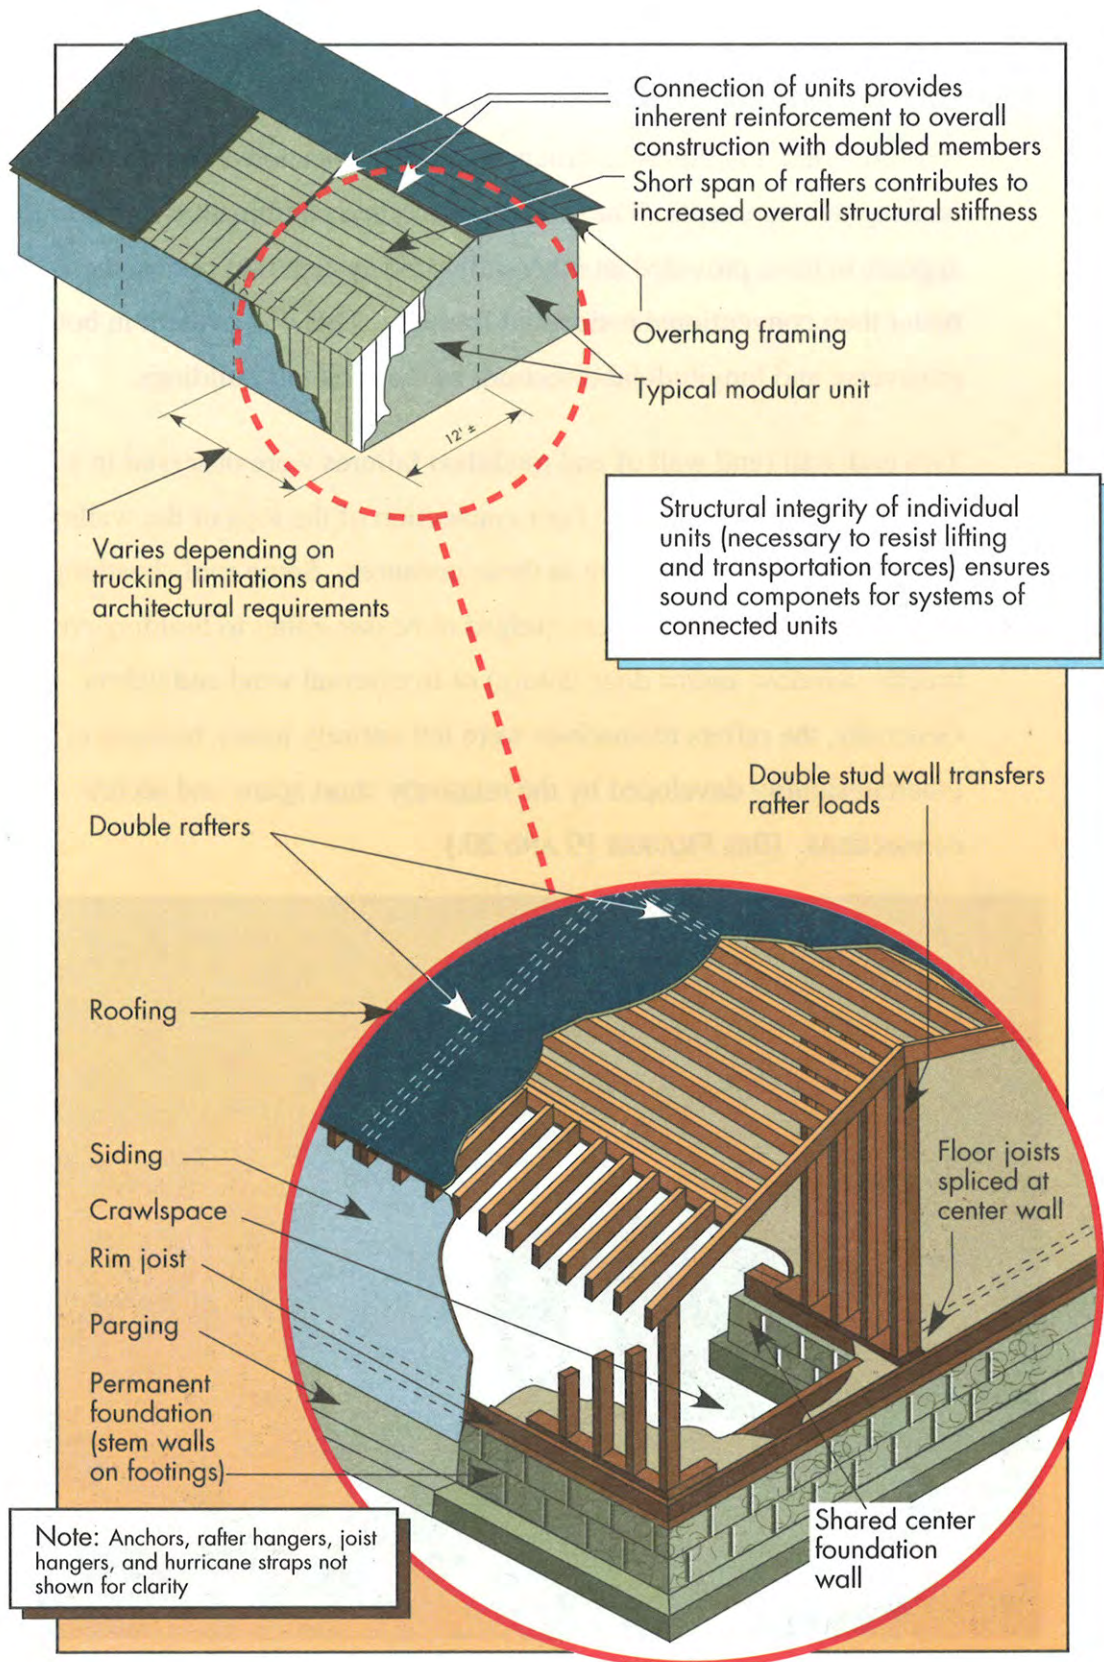
Two end-wall (end wall of end modules) failures were observed in a modular home subdivision. Poor connection of the tops of the walls to the roof diaphragms was evident in these instances. Some roof sheathing was observed missing from rafters, judged to be due either to building envelope breach (window and/or door failure) or to external wind and debris. Generally, the rafters themselves were left entirely intact, because of the inherent rigidity developed by the relatively short spans and secure connections. (SEE FIGURES 19 AND 20.)

FIGURE 20. *Inherent structural strength of modular construction.*

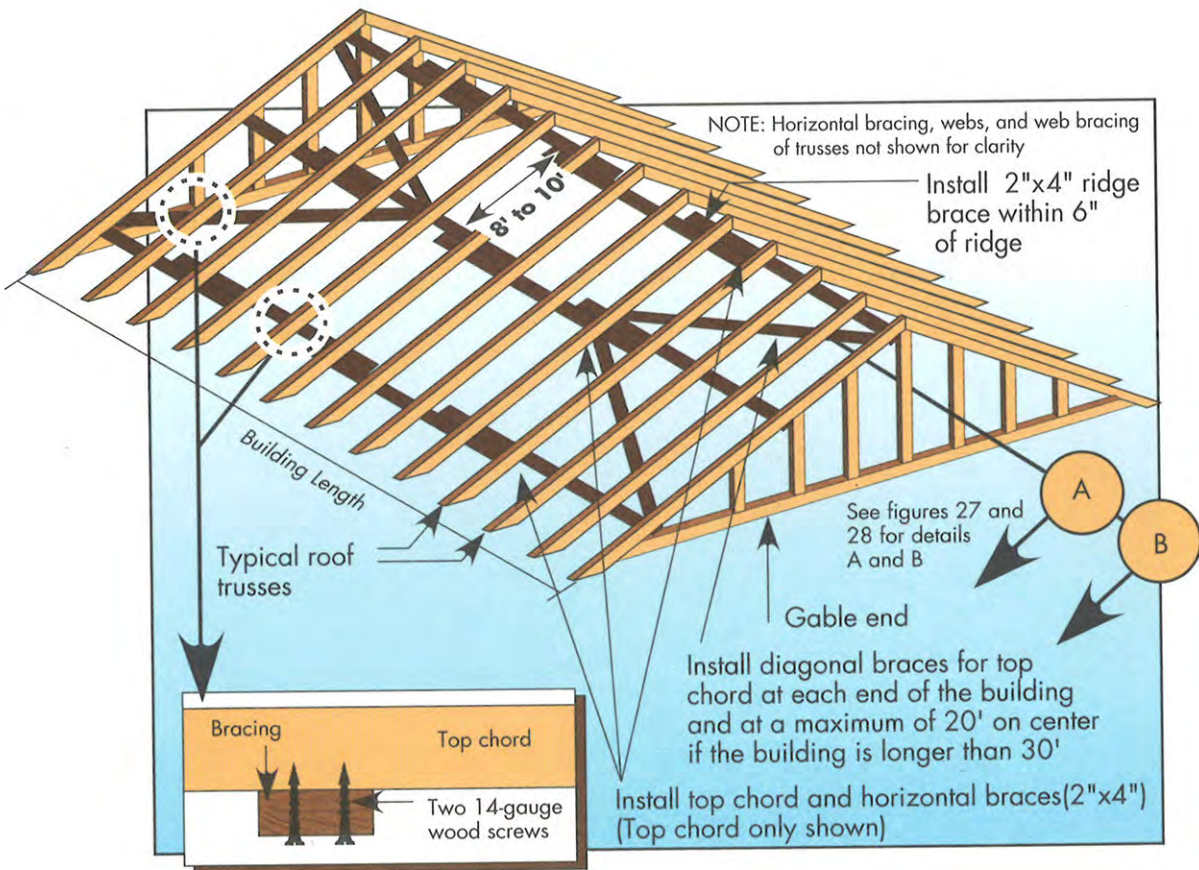
FIGURE 26. Typical roof truss top chord bracing.

1. In addition to the existing program of systematic framing inspections, a specific roof bracing and sheathing inspection should be required prior to installation of roof underlayment (SEE FIGURES 26-29). Note the extra bracing recommended for gable ends in particular.

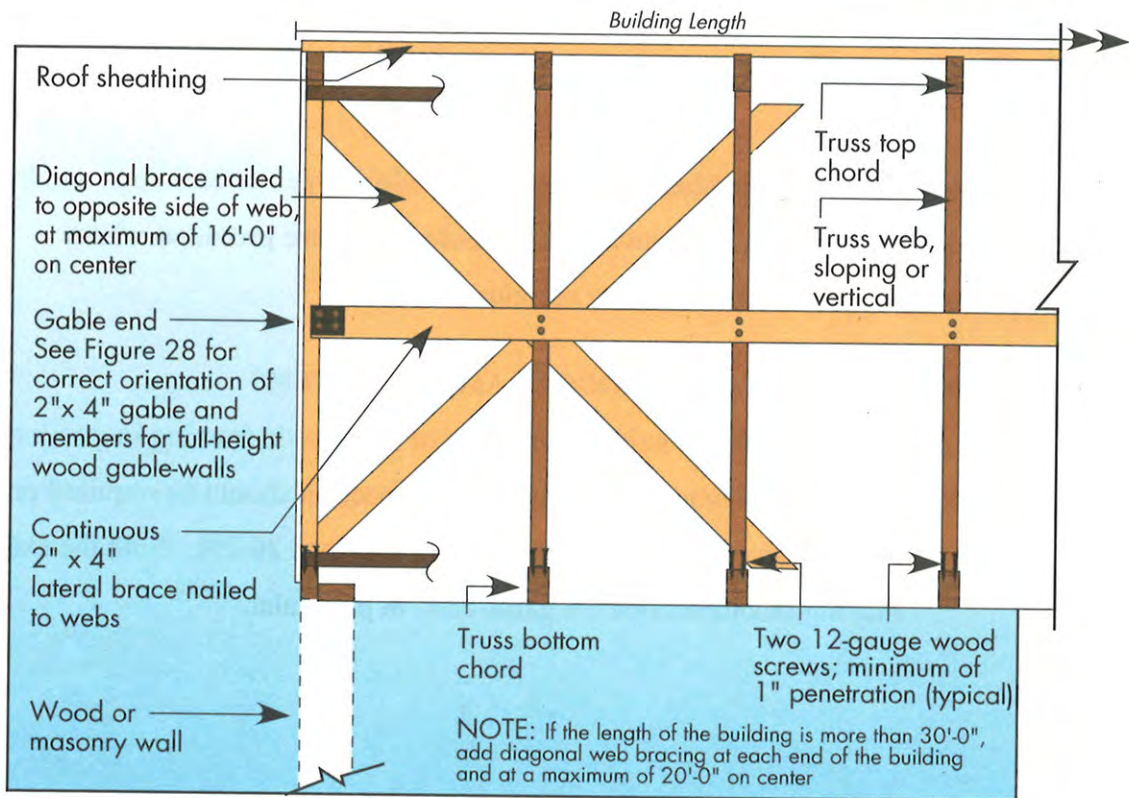
FIGURE 27. Detail A — Typical truss web bracing. Diagonal web bracing as shown, at each gable end of building.

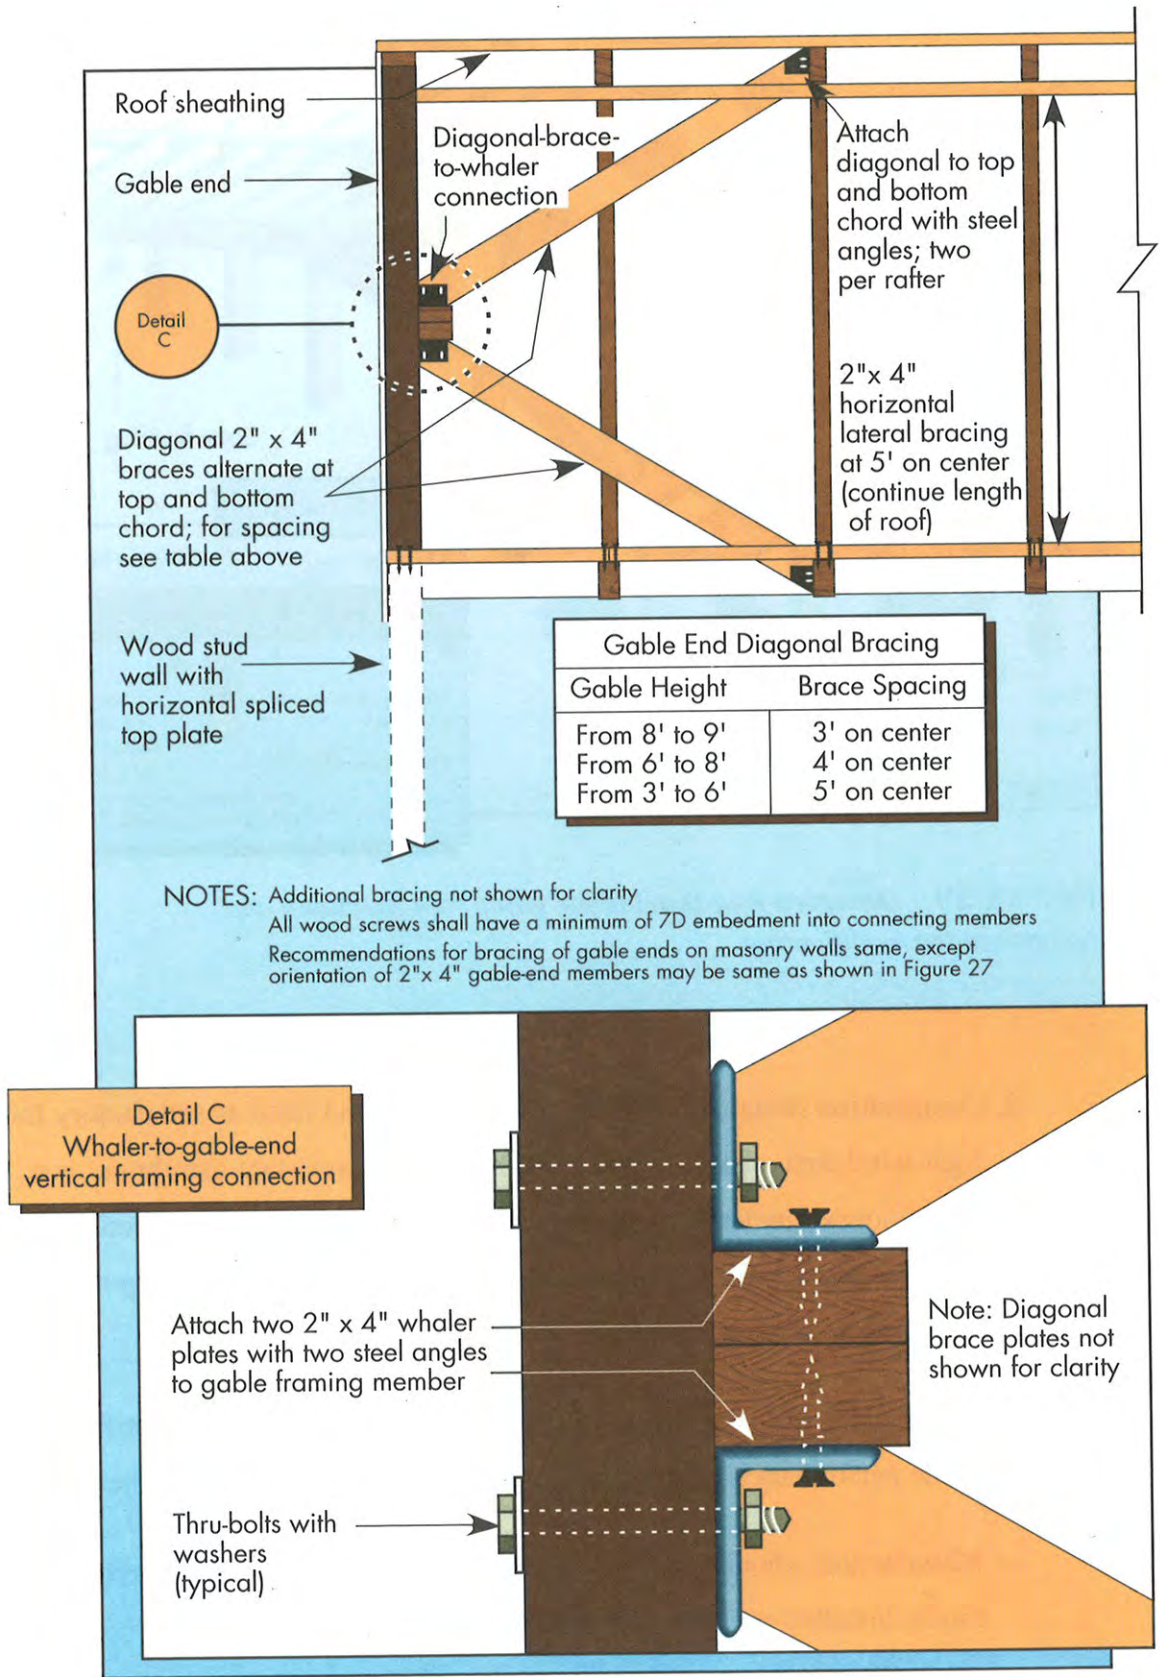
FIGURE 28. Detail B — Typical wood gable-wall bracing.

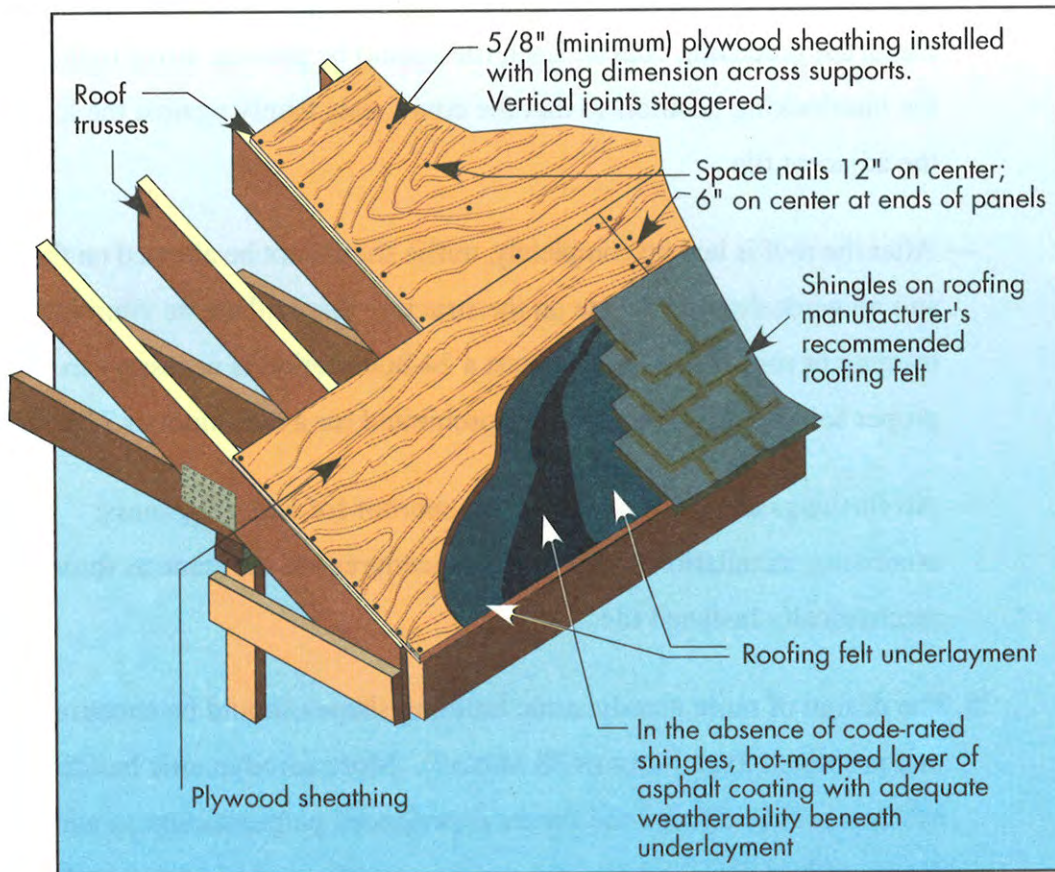
FIGURE 31. *Composition shingle roofing system showing sheathing and hot-mopped underlayment.*

2. Composition shingles should be manufactured and rated as satisfactory for high-wind areas. In the absence of this, a water-resistant membrane, e.g., a hot-mopped underlayment, should be installed to provide protection from the water infiltration that may result from the loss of roofing material during high-wind storms (SEE FIGURES 30 AND 31).
3. Manufacturers of roof tile products should provide testing and verification of tile performances under realistic conditions (as addressed by the Code).
 - Manufactures should verify that mortar used with extruded concrete tiles can be installed to Code requirements.

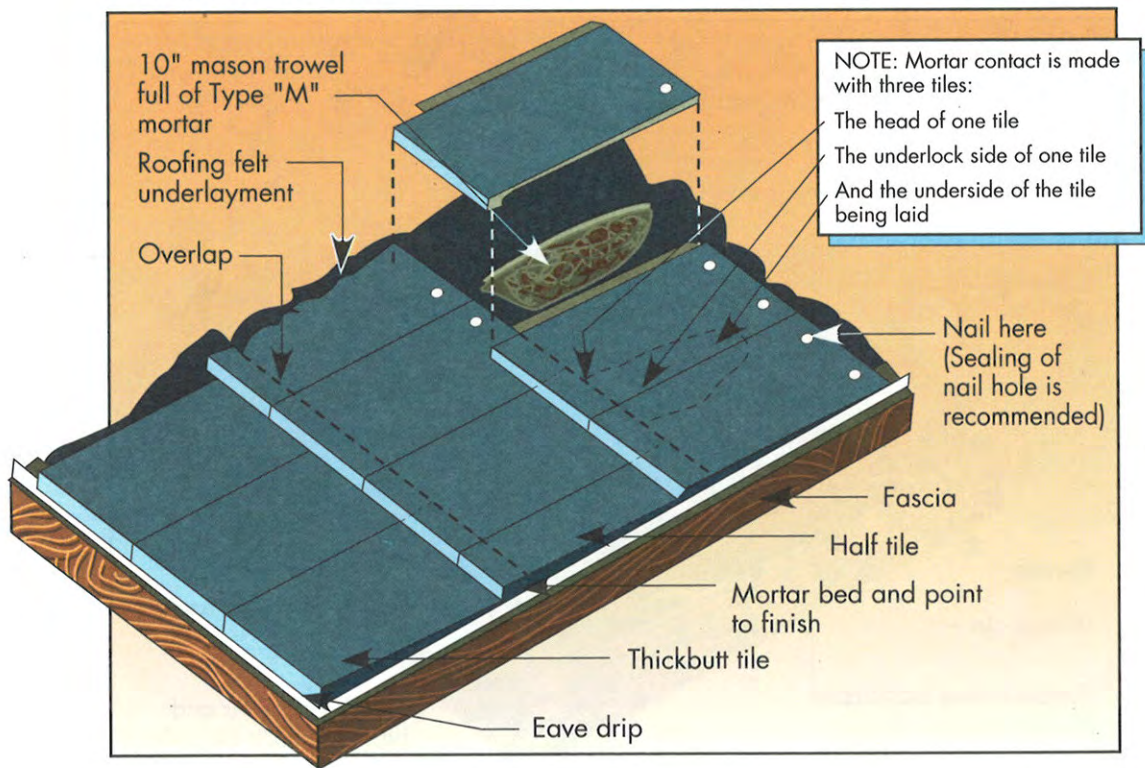
FIGURE 33. *Recommended tile and mortar placement for extruded concrete flat tile roofing system.*

4. Quality control of roof tile installation should be improved by ensuring both consistent mortar pad placements and installation in accordance with manufacturers' requirements, as specified by the Code. (SEE FIGURES 32-37). Though this would improve the survivability of roof tile systems, continued debris impact will result in damage occurring from future wind storms.

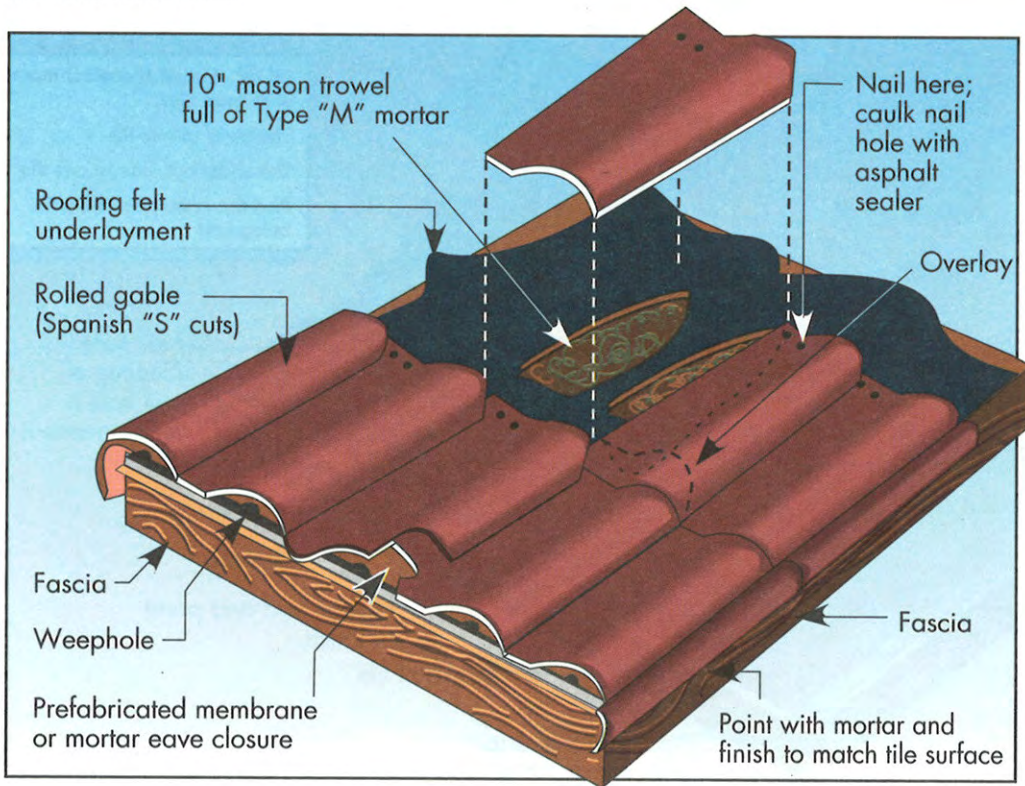
FIGURE 35. Recommended tile and mortar placement for "S" tile roofing system.

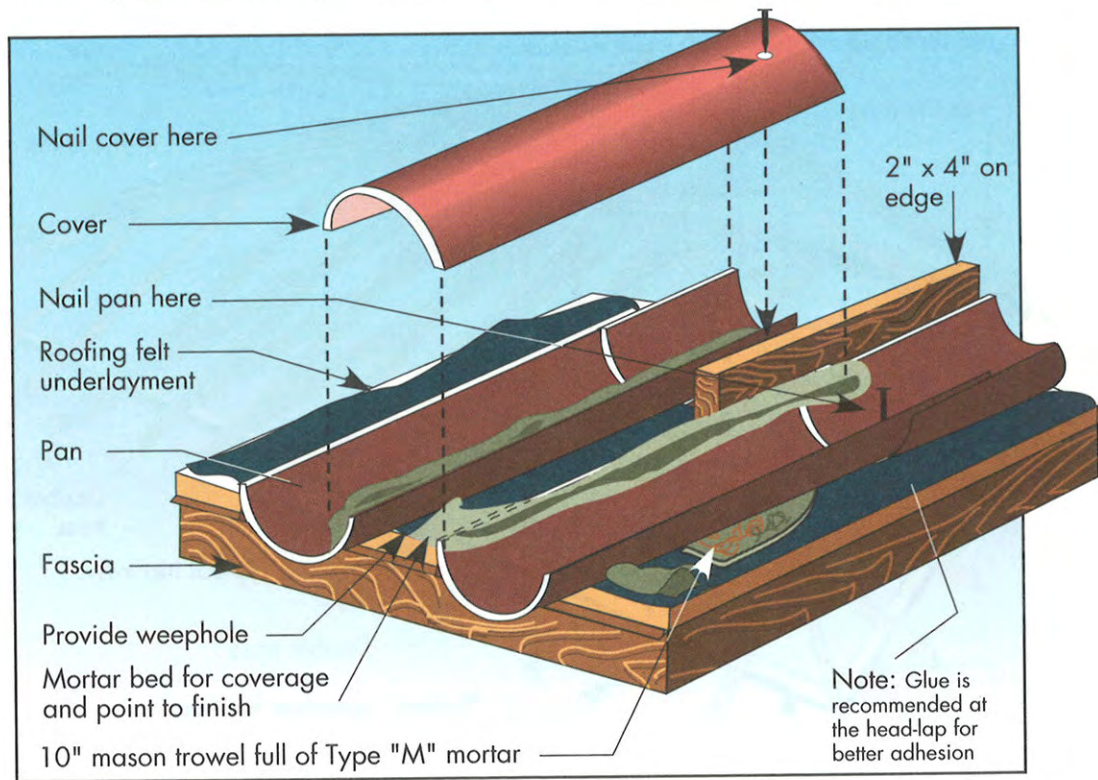
FIGURE 37. *Recommended tile and mortar placement for barrel tile roofing system.*

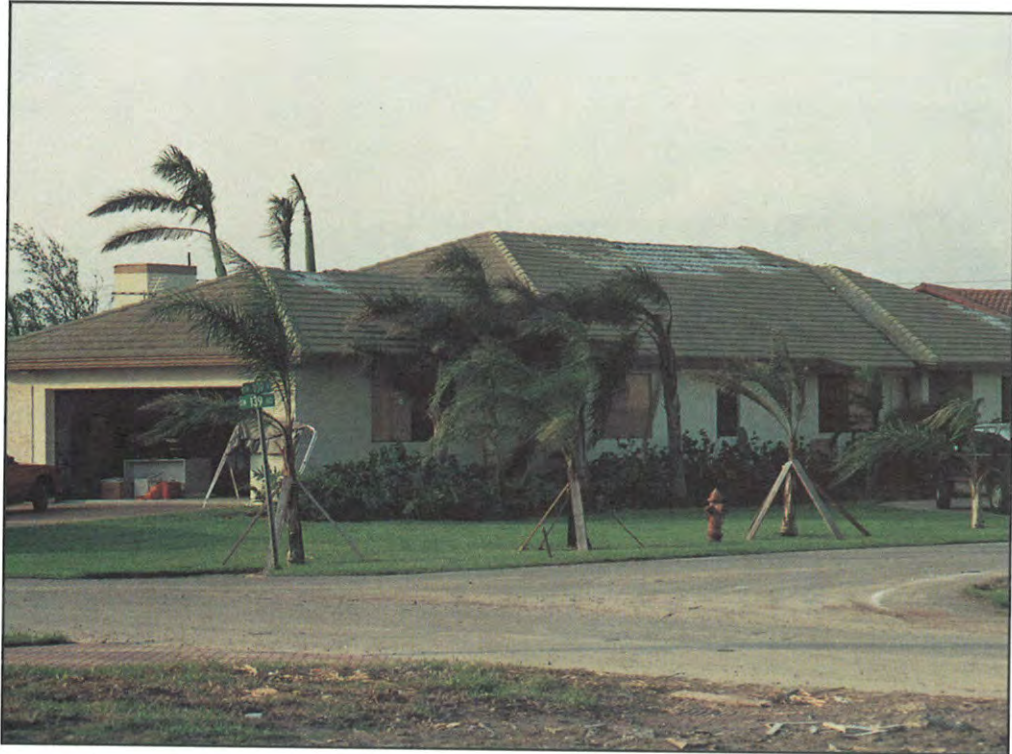
FIGURE 38. *Hip roof.*

5. The design of more aerodynamic building shapes should be encouraged and promoted (SEE FIGURES 38 AND 39). More aerodynamic building systems reduce direct wind forces experienced perpendicular to windward planes of buildings and also the consequent effect of whirling air flows, called vortices, that accumulate at the corners and edges of the planes. The

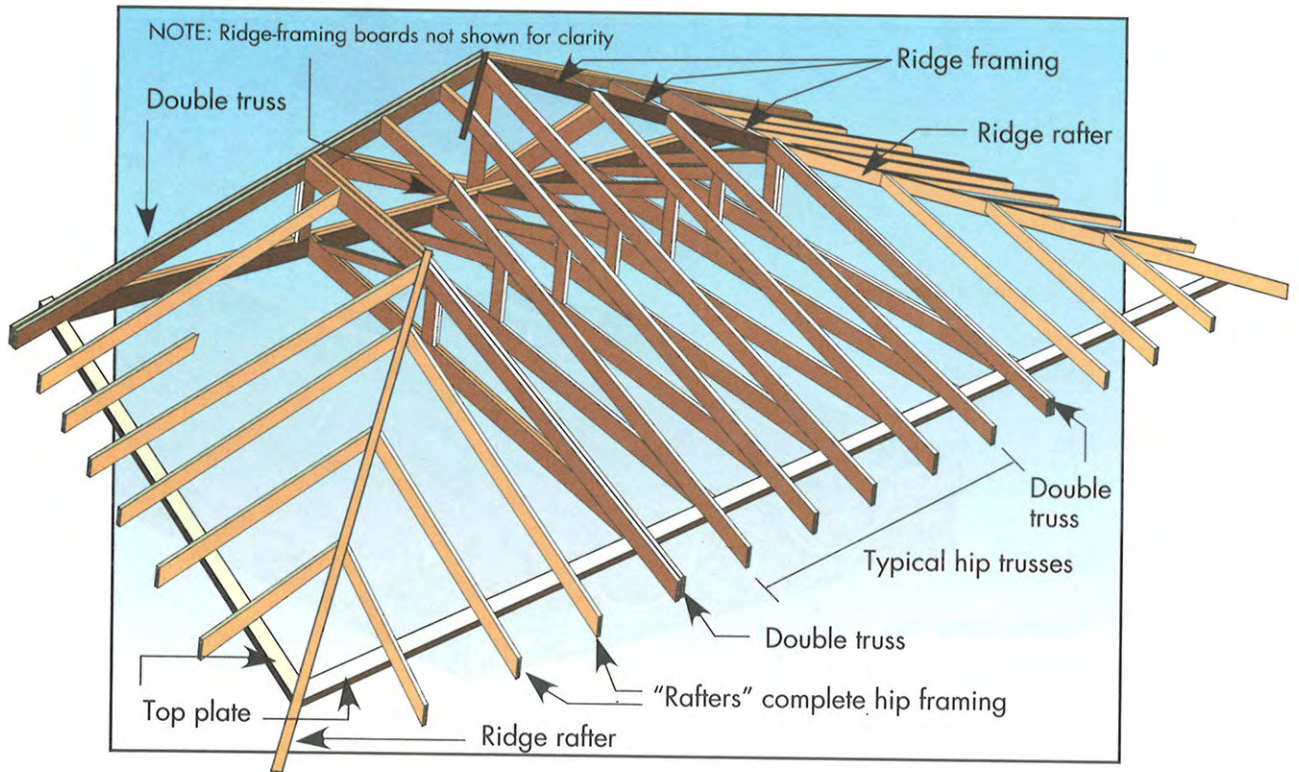
FIGURE 39. *Recommended hip roof framing.*

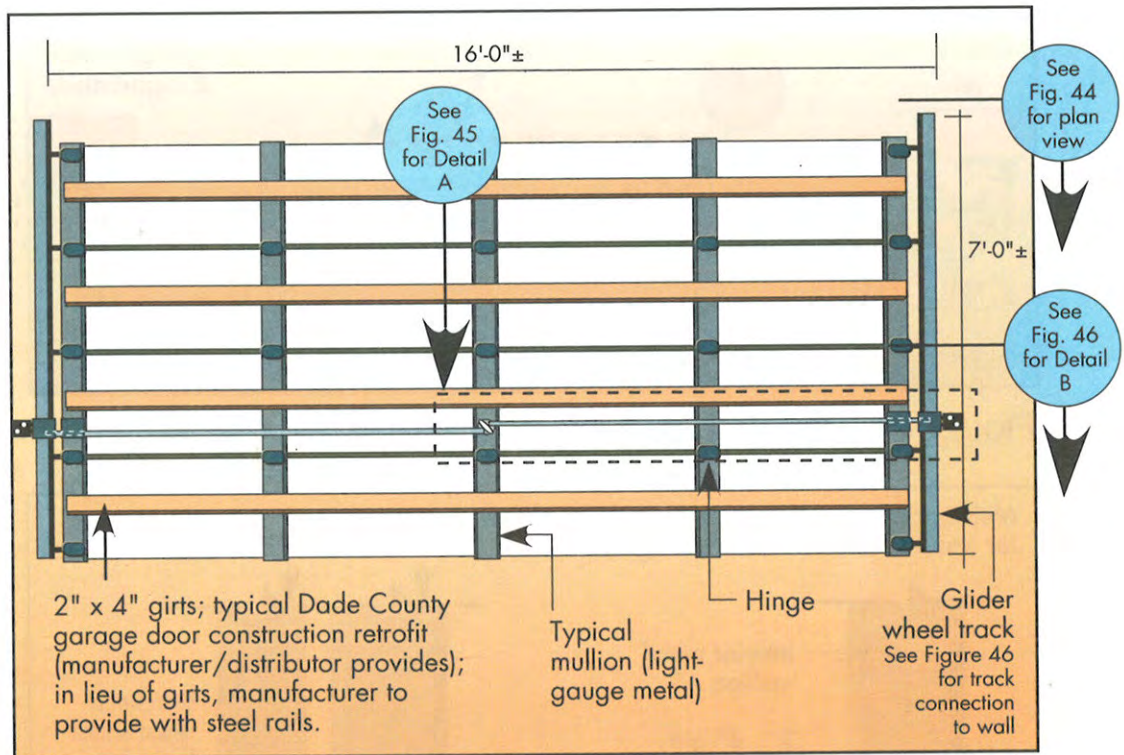
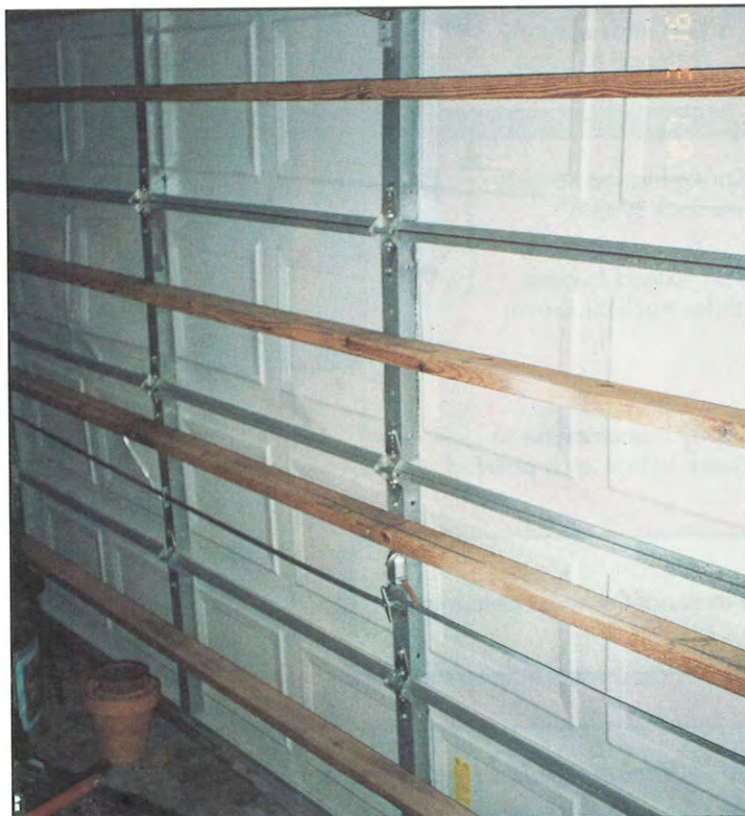
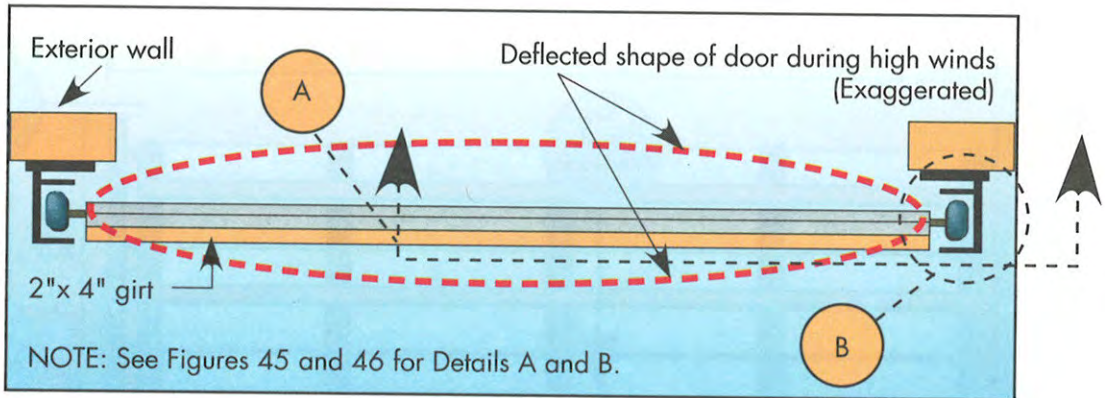
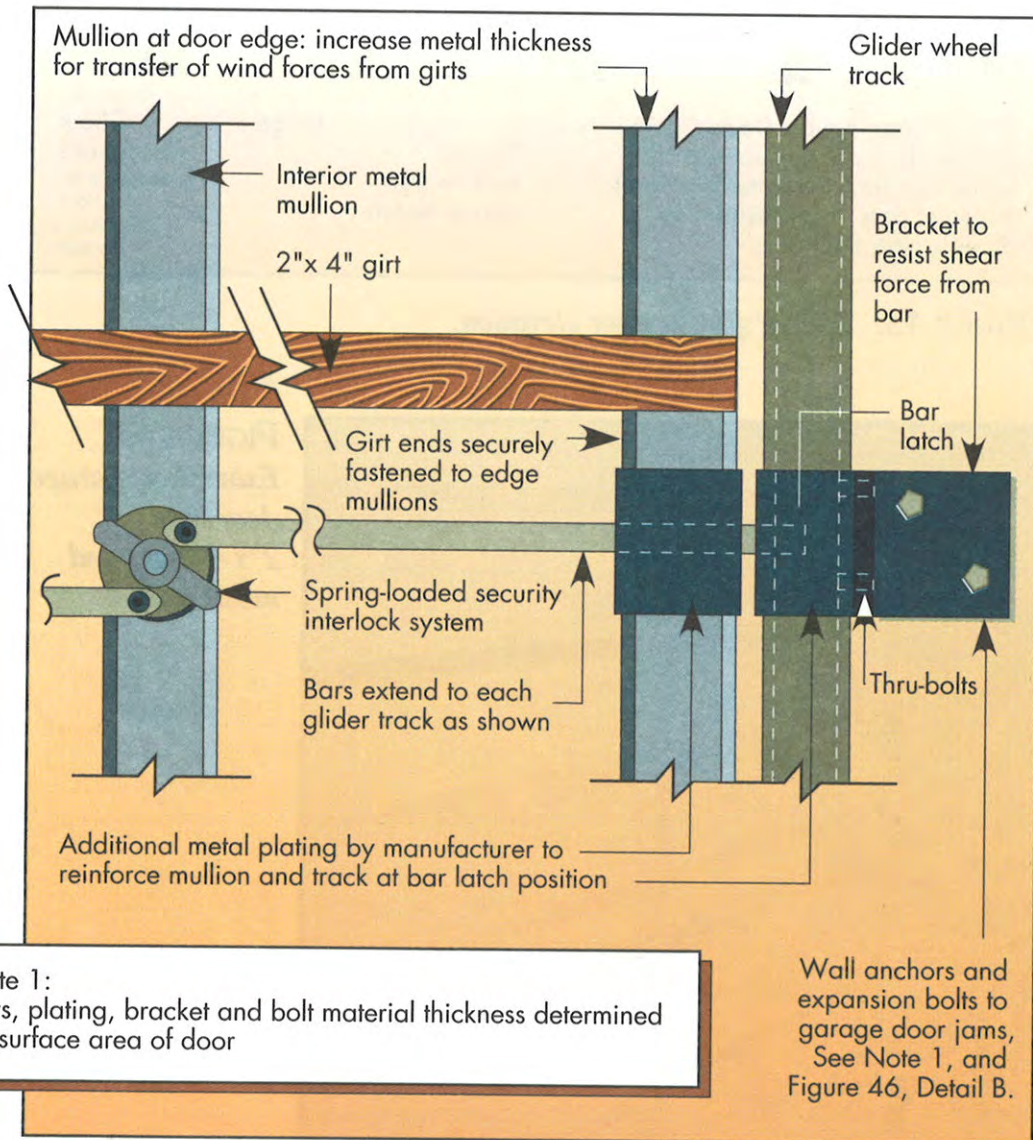
FIGURE 42. Typical garage door elevation.

FIGURE 43. Example of garage door with 2" x 4" girts and metal mullions.

FIGURE 44. Plan view of typical garage door.

FIGURE 45. Detail A—Recommended reinforced horizontal latch system for garage door.

2. The installation of entire garage door assemblies should be reevaluated for strengthening to resist wind and flood loads.
- In order to reduce the effects of the wide spans of two-car garage doors, the doors should be manufactured to include mullions and girts. Also, manufacturers should reinforce both the security locking system, to provide a wind-force-resistant latch, and the chain of the door pin to glider track connections, to reduce rotation of the door along its edges. (SEE FIGURES 42-45).

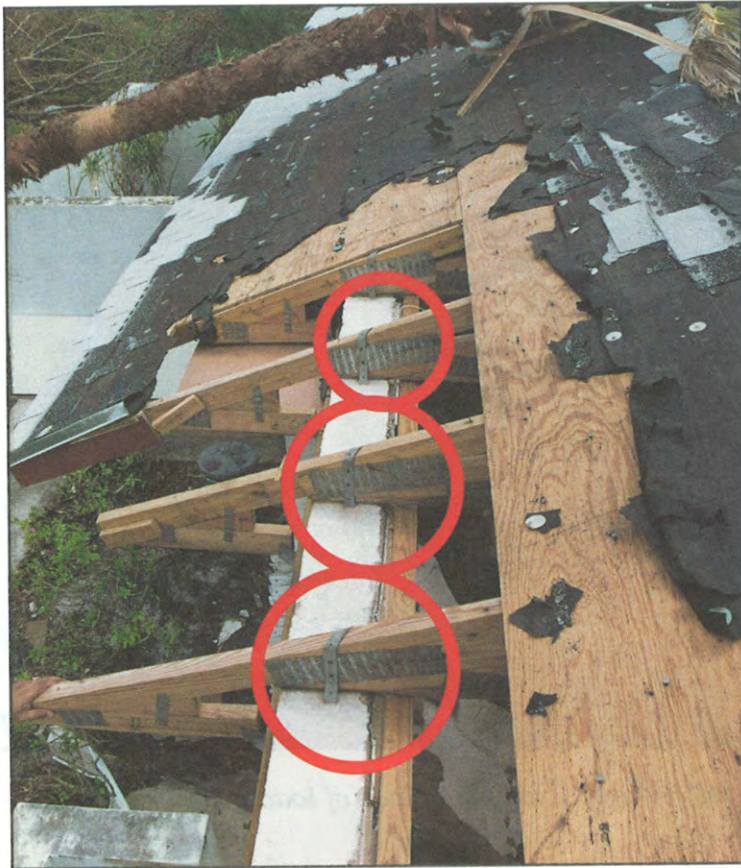
FIGURE 56.
*Properly placed
hurricane straps
from masonry
tie-beams to
roof trusses.*

1. Designers and plan reviewers should pay greater attention to lateral load transfer mechanisms because of high lateral loads generated by hurricane winds (SEE FIGURES 9, 10, AND 54-58).
 2. At the construction stage, greater attention must be paid to the proper installation of all lateral load transfer mechanisms inherent in conventional building framing, especially hurricane straps and clips (SEE FIGURES 59-62).
- Manufacturers of metal connectors for wood framing currently provide on-site demonstrations and workshops for training purposes. These workshops should be structured to provide certificates of participation to builders and should be encouraged by the home-buying community.

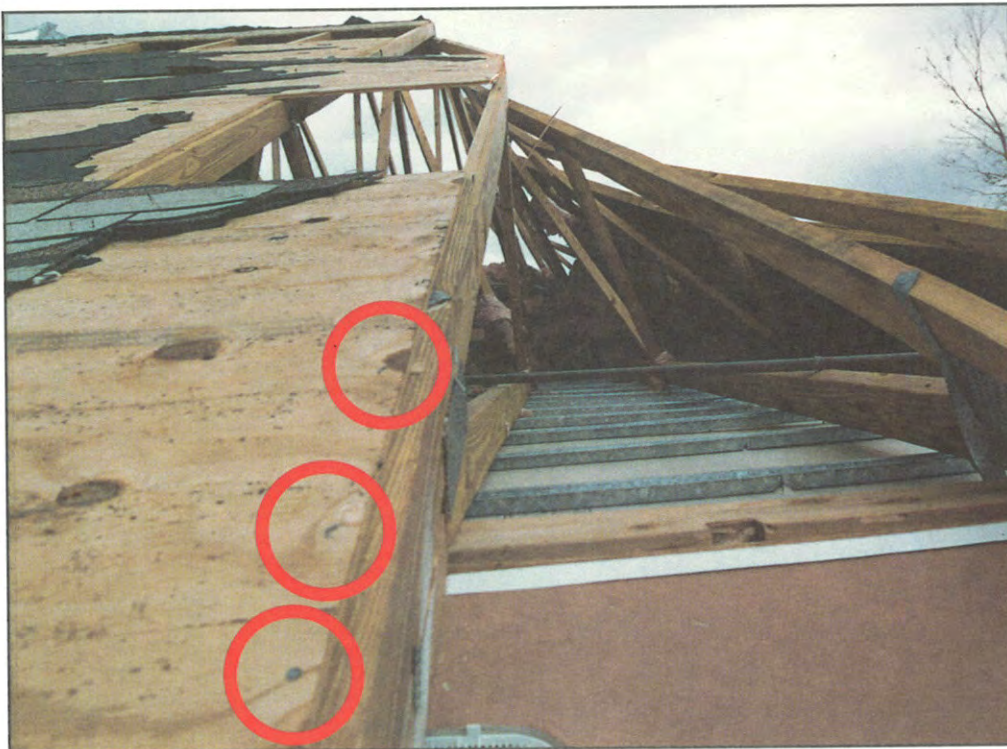
FIGURE 57. *Sheathing only tack-nailed.*

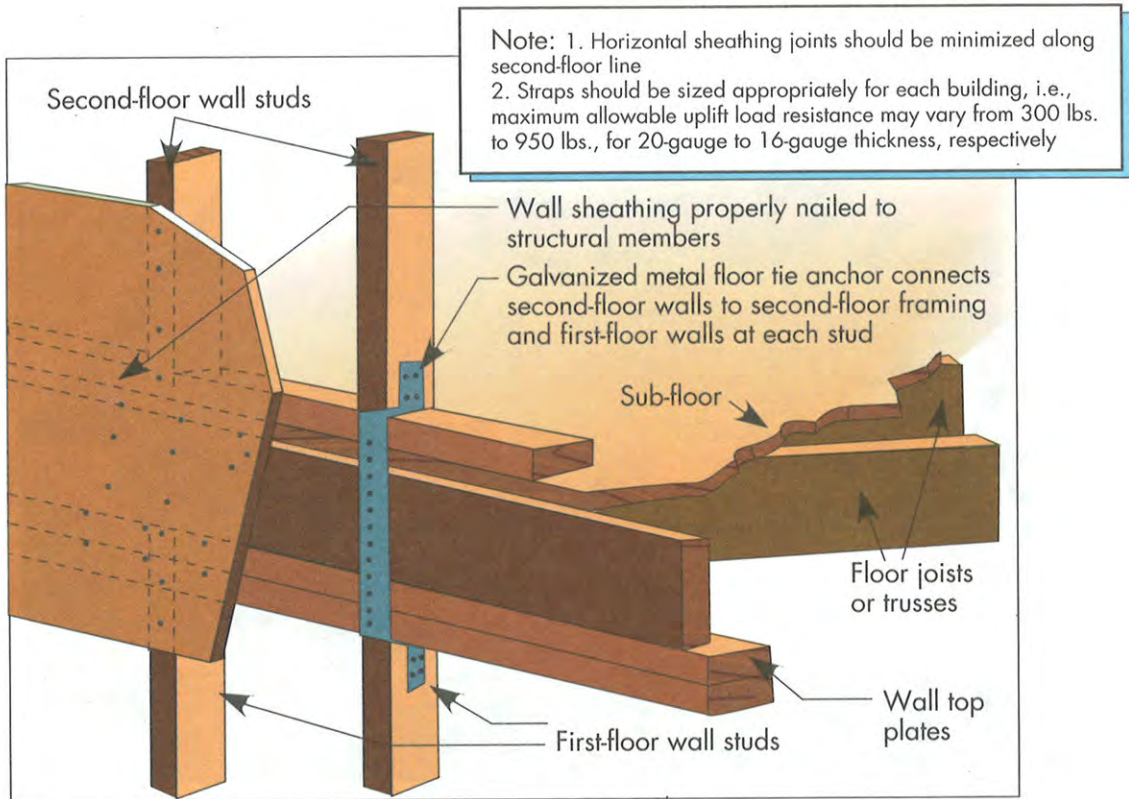
FIGURE 62. *Upper-floor tie to lower floor for two-story building. Floor tie anchor and nailed wall sheathing.*

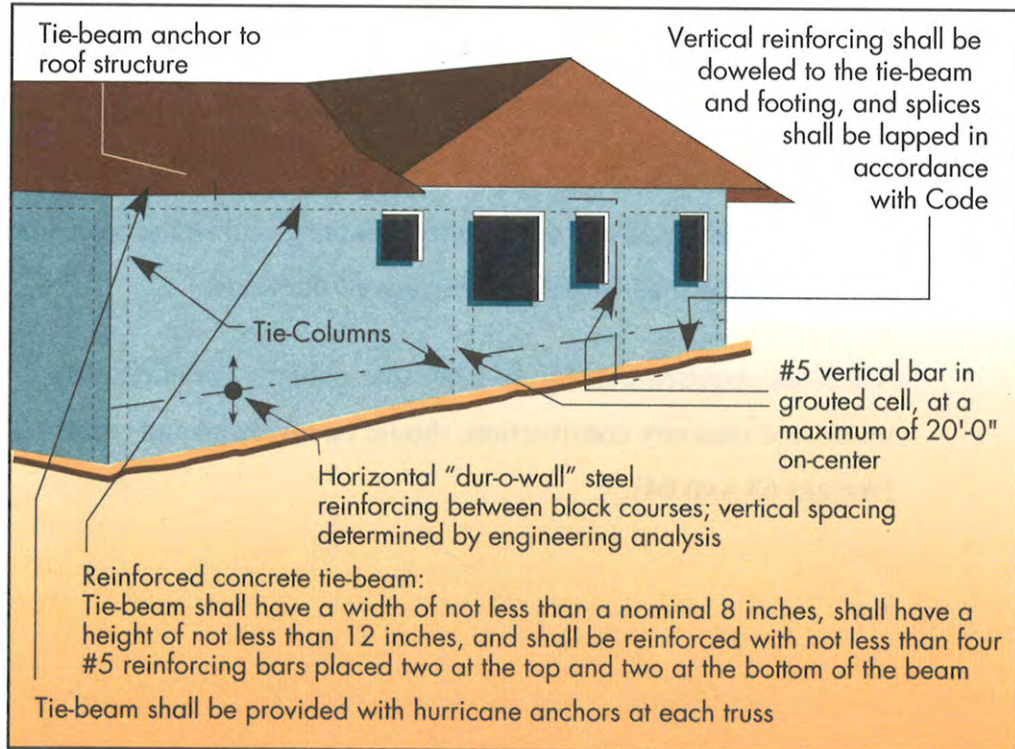
FIGURE 64. *Adequately designed and constructed tie-beam/tie-column masonry wall.*

— The Code requirements for tie-beams/tie-columns, or alternative reinforced masonry construction, should be reviewed and enforced (SEE FIGURES 63 AND 64).

- A tie-beam of reinforced concrete should be placed in all walls of unit masonry, at each floor or roof level, and at such intermediate levels as may be required to limit the vertical heights of the masonry units to 16 feet.

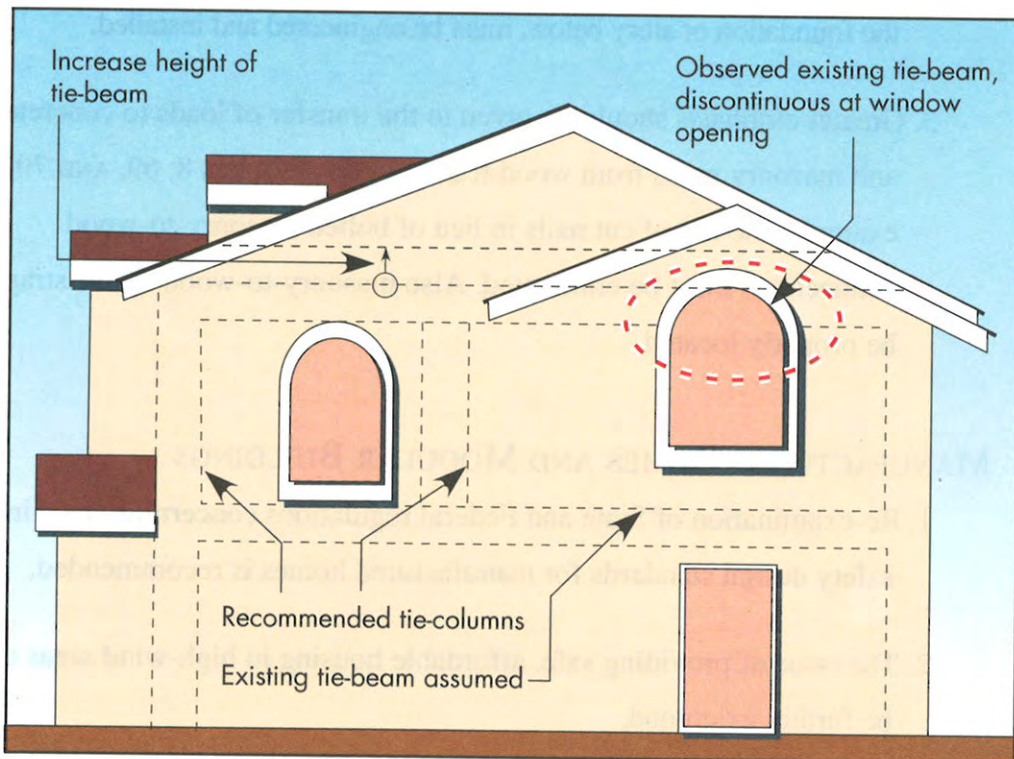
FIGURE 66. *Individualized architectural systems require designs for structural support.*

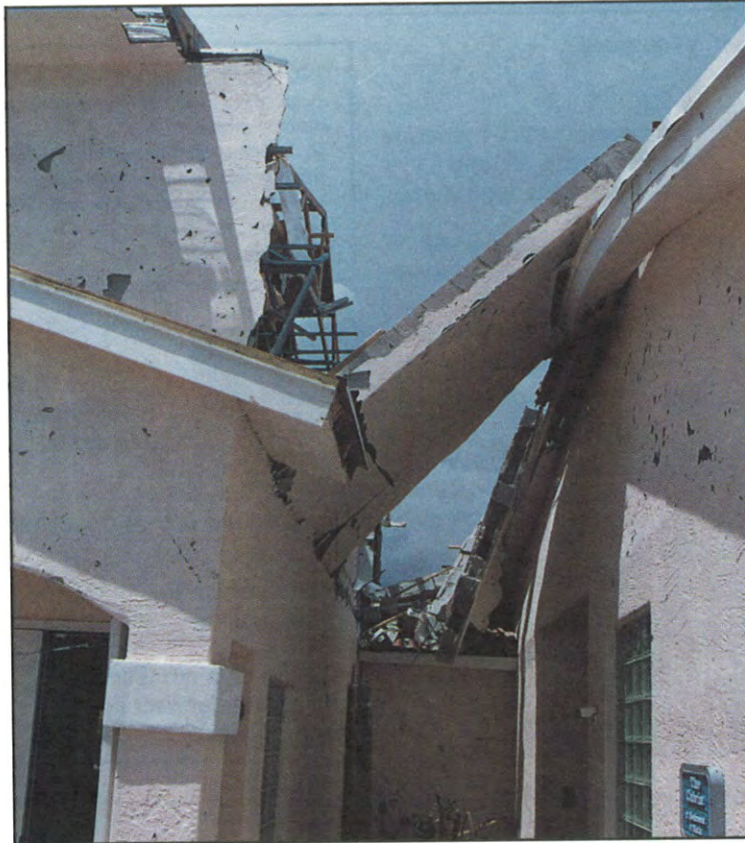
FIGURE 67.
 Firewall separation .
 Results from building
 corners being
 discontinuous with tie-
 beams. (See Figure 68
 for side view)

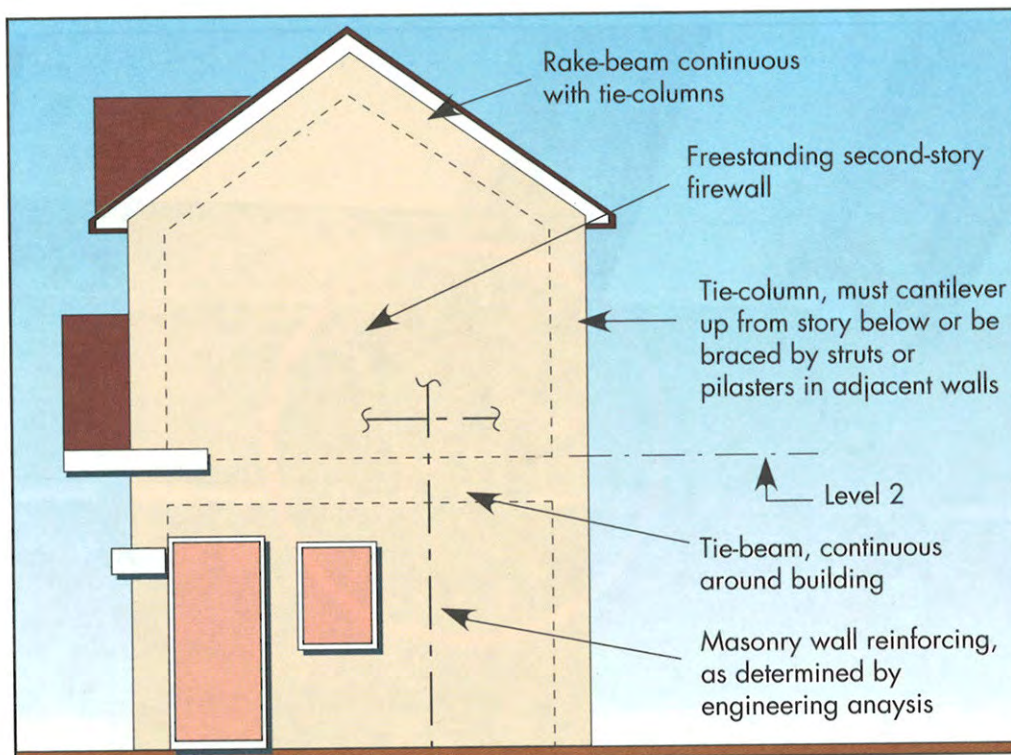
FIGURE 68. Adequately designed and constructed freestanding cantilevered wall system.

- Bracing with struts or pilaster columns in walls perpendicular to the freestanding walls, or adequate reinforcing in the walls sufficiently anchored in the foundation or story below, must be engineered and installed.

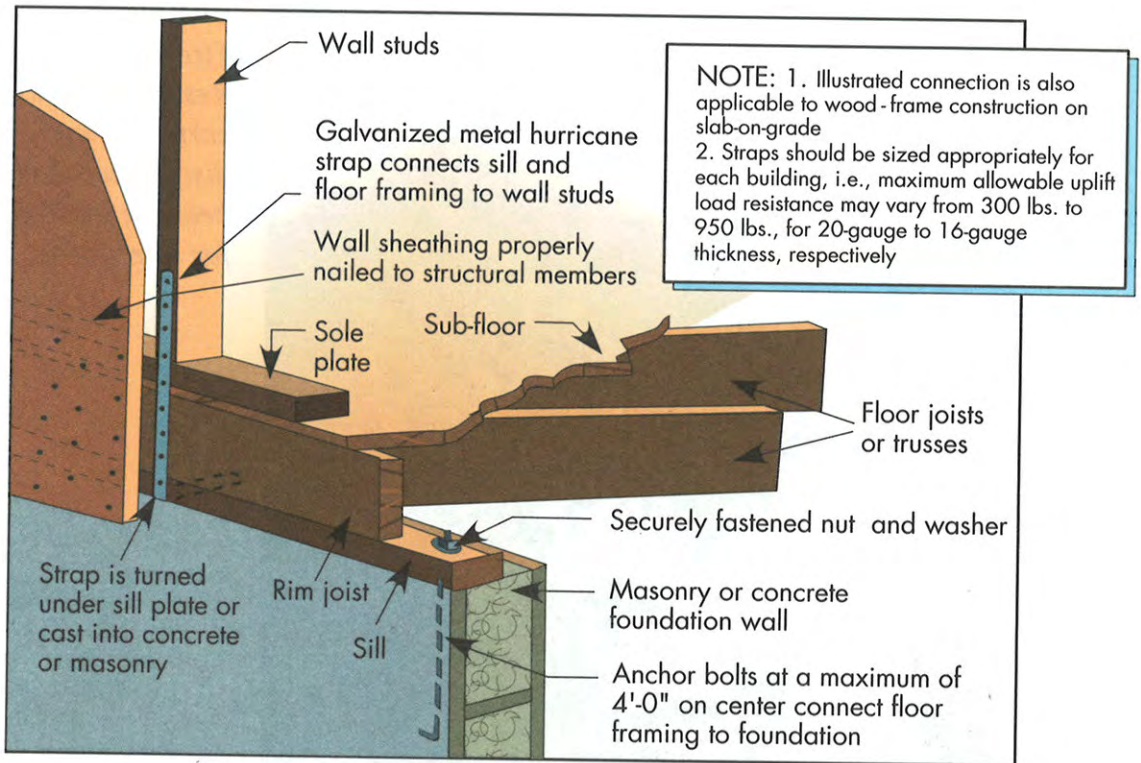
FIGURE 69. Lower-story wall anchorage to masonry (or concrete) base. Straps properly nailed at wall studs.
