# When Things Go Wrong: Post-tension Repairs

Carl L. Schneeman, PE

May 12, 2026

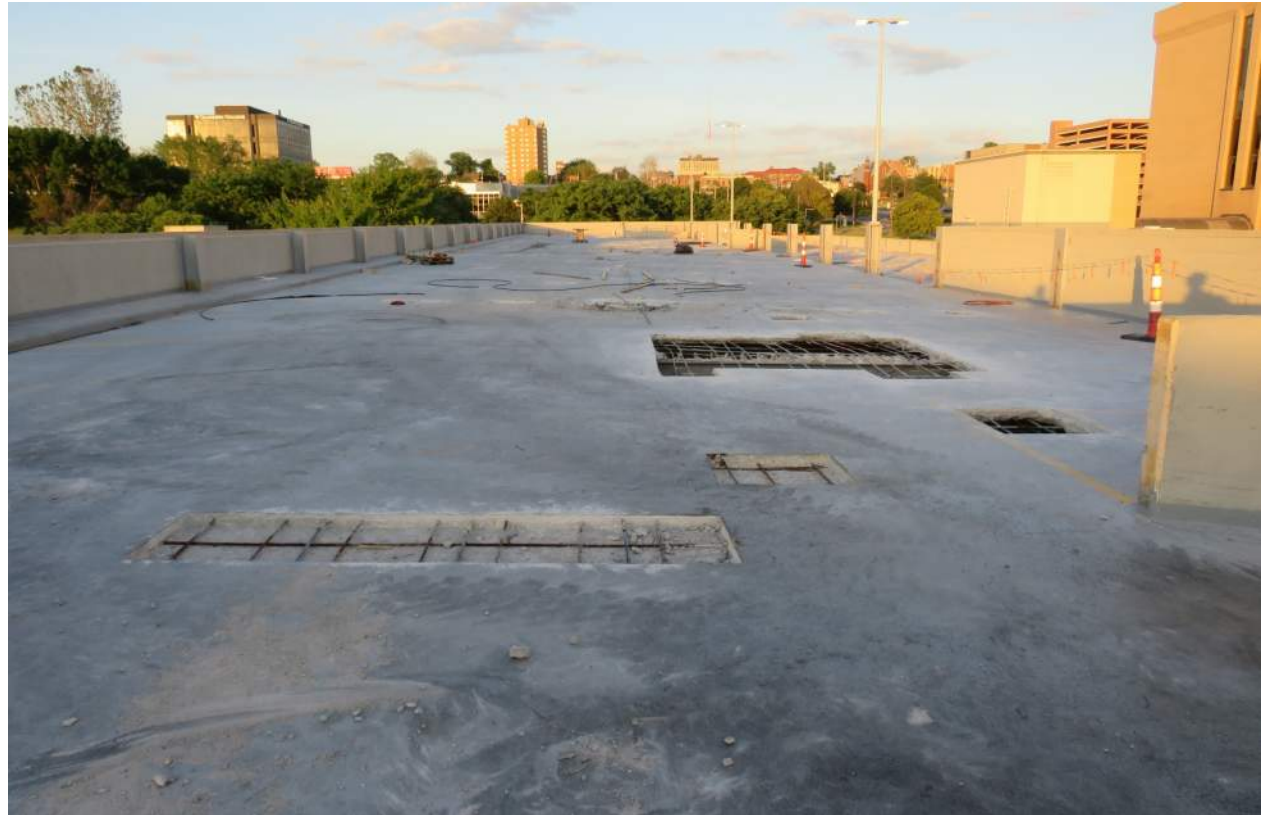
Structures built in the 1960s-1980s are particularly vulnerable

Many of the button-head and paper-wrapped systems are no longer around

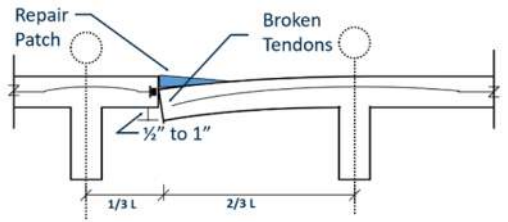
Slab deflection / offset

Tendon protruding, grease cap missing

Tendon protruding at expansion joint gap

Anchor displacement

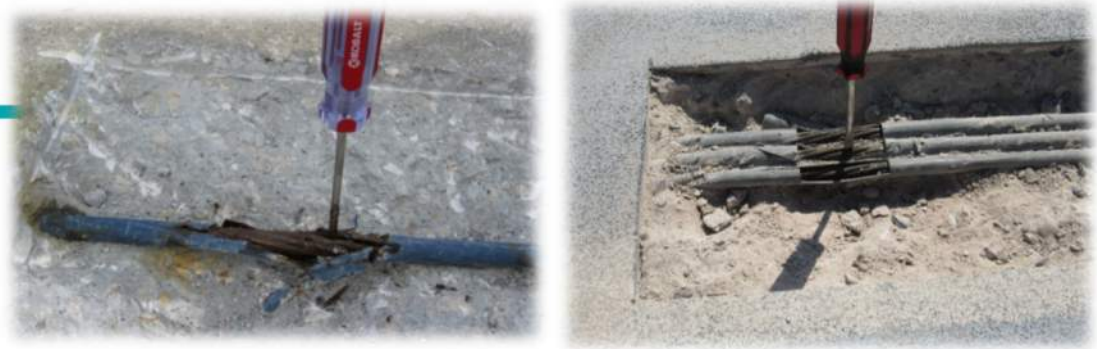
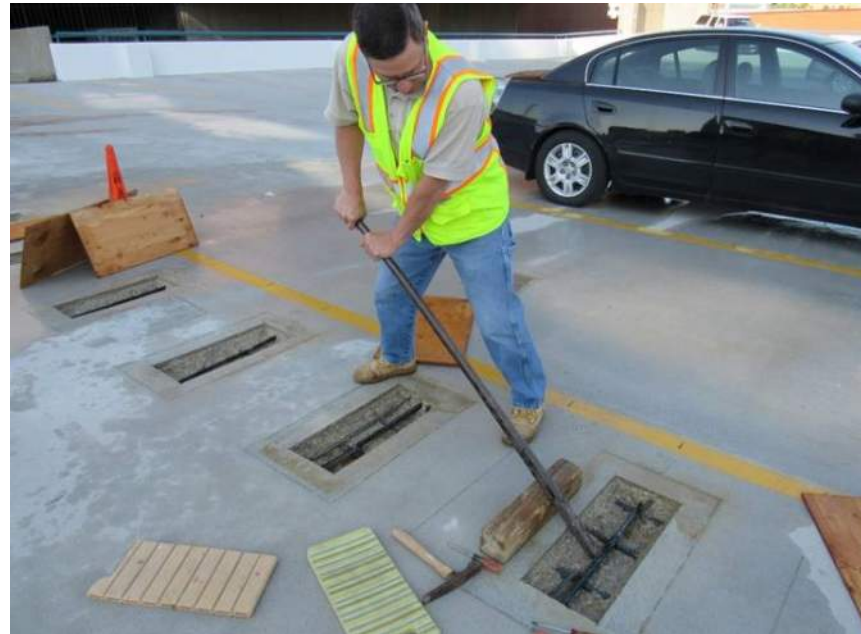
- Pry bar Test
- Screwdriver test

- ✓ Sheathing intact?
- ✓ Quality of grease?
- ✓ Corrosion?

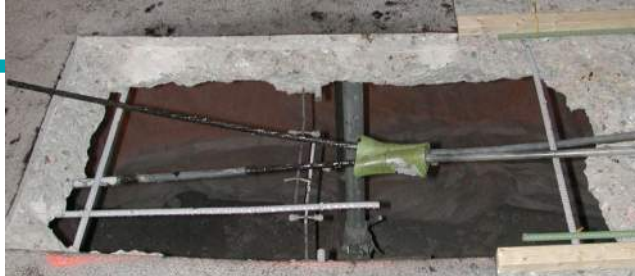
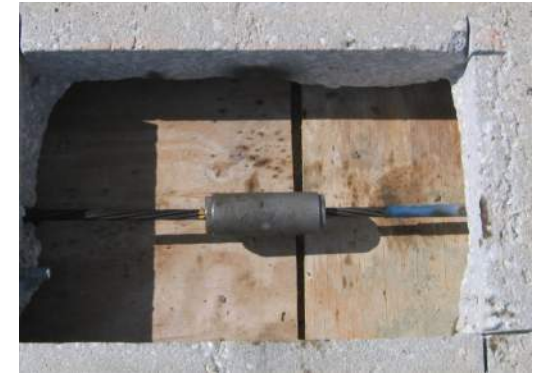
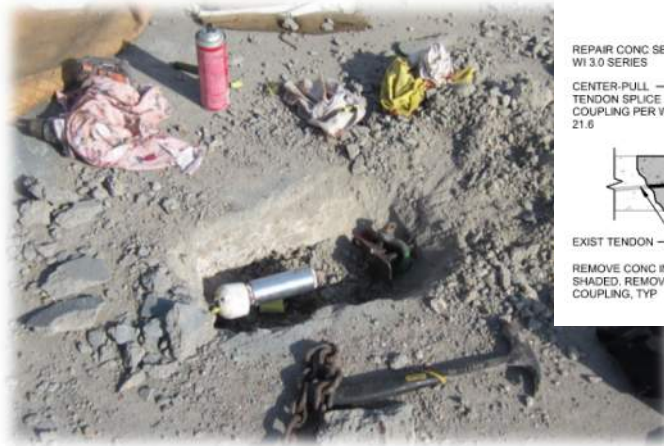
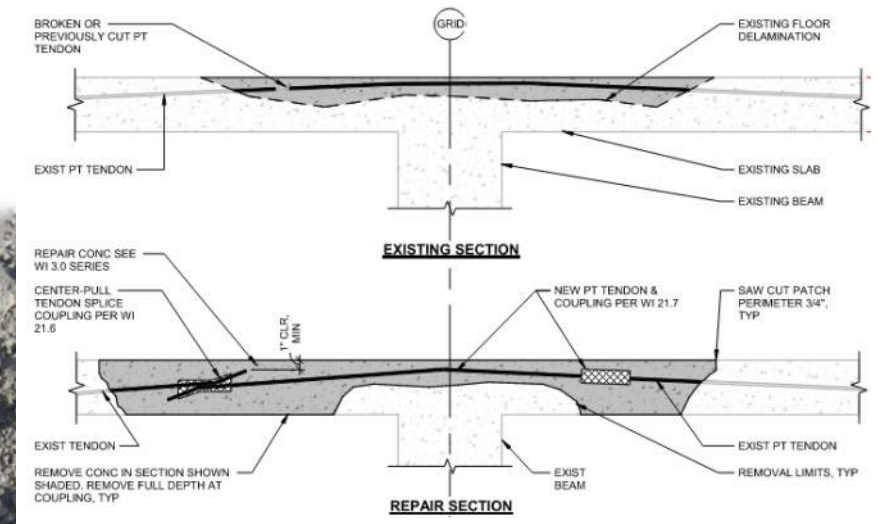
Construction Documents  
Industry often specifies  
spot-patching:

- Often dangerous and unpredictable
- Lots of openings
- Lots of rework

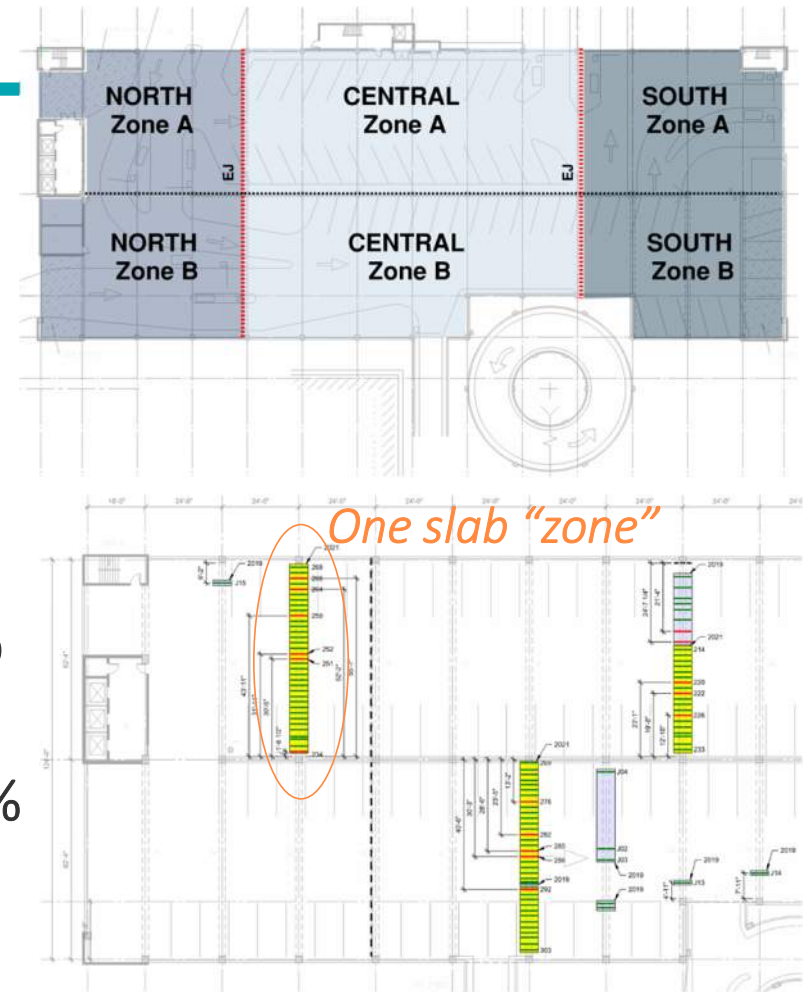
- 2018 Condition Assessment identified limited concerns... but tendons popping through slab undersides on Level 3-6
- Developed an investigative plan to gauge potential deterioration
- Facility has 986 tendon segments in 29 slab “zones”
- Traffic Needed to be kept operational to 80% of spaces – no more than  $\pm 6$  zones available for closure

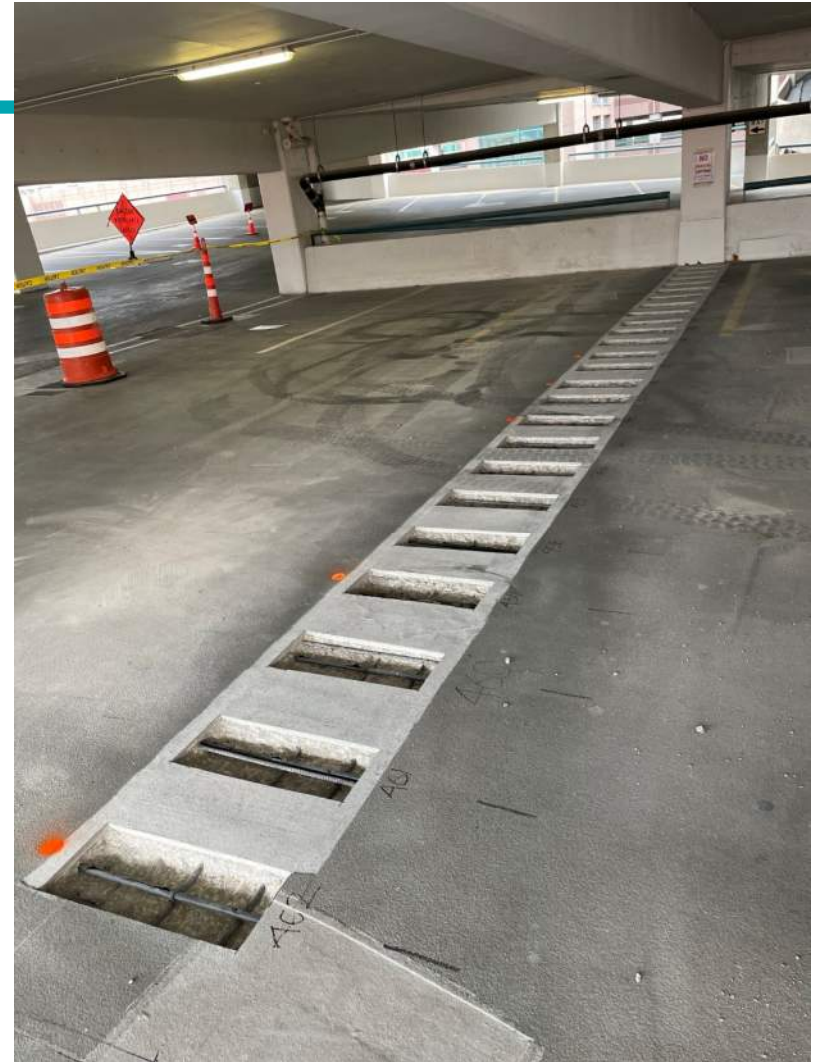
- Analysis indicated that by removing the LL, slab would have capacity some PT loss w/o shoring (2 tendons in 10 ft)
- Captured segments one at a time
- Walker Located tendons via GPR and marked out removal areas
- Exposed 8" x 24" openings
- Cover was 1.5 in. to 2 in. deep /  $\frac{3}{4}$ " clear space all around tendon

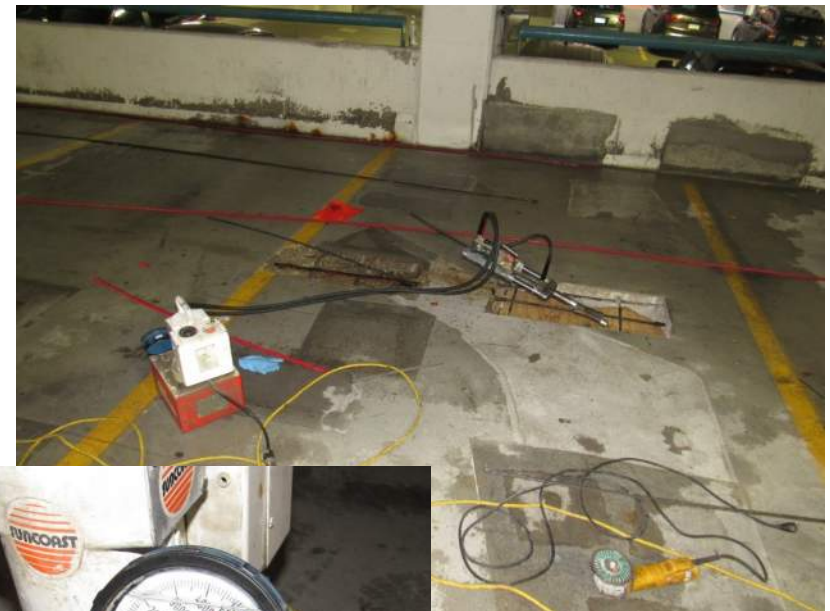
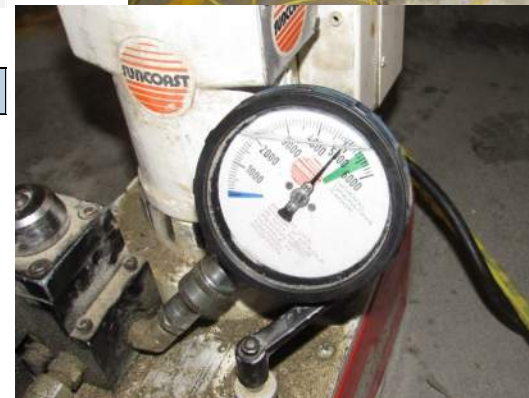
- Over the first 4 years, 113 tendons were identified as failed, and replaced full-length

- We anticipate 39 more for repair!

*Each replaced tendon was rethreaded, stressed, and observed by Walker prior to tendon acceptance + patching*

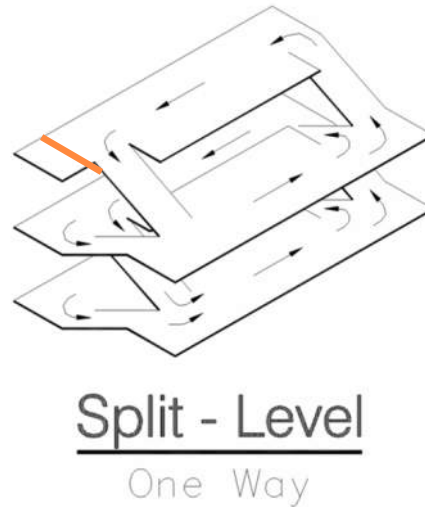
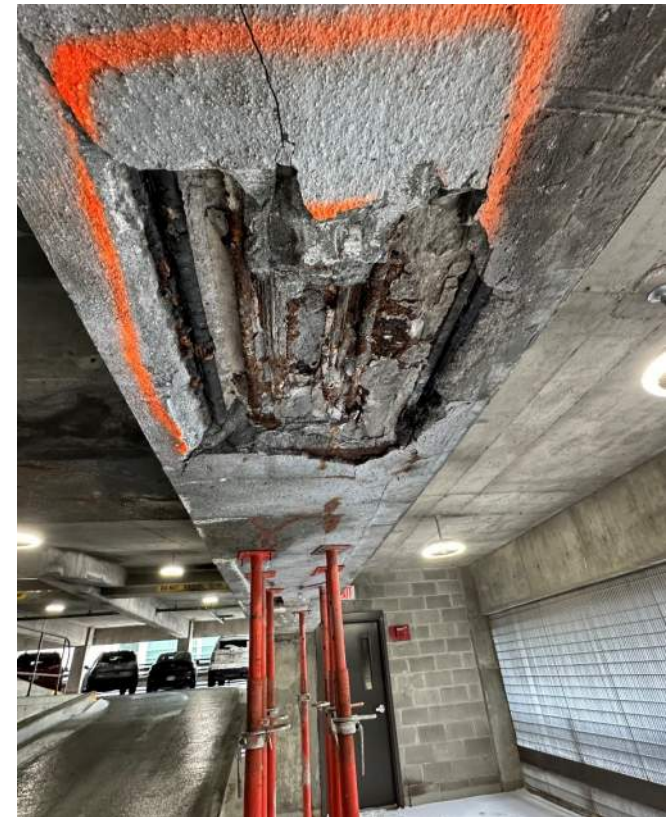
# Case Study – Beam Repair

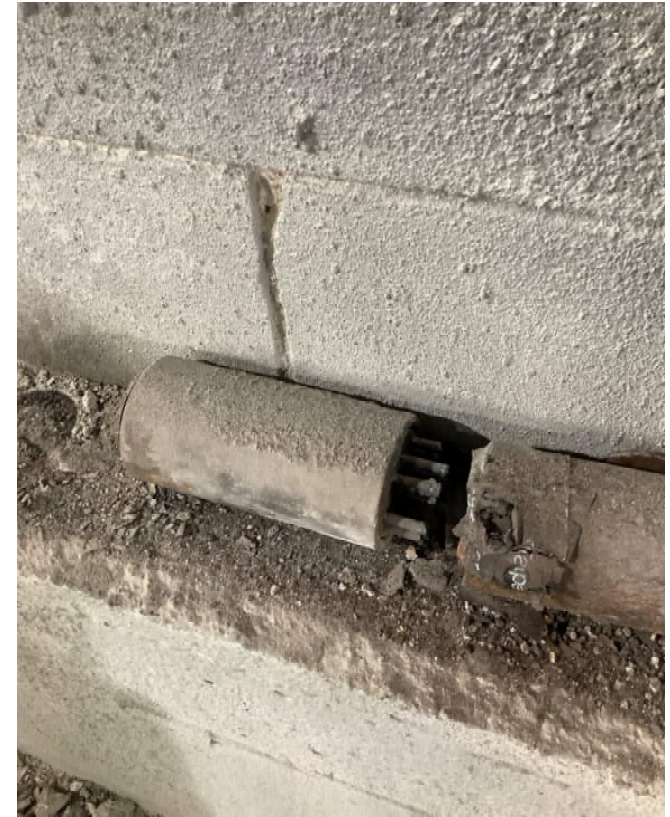
Field assessment indicated poor condition of original beam and strengthening

- Severe corrosion of original PT
- Replacement PT was poorly affixed to beam/column
